NC OSH Advisory Council Meeting

Is this safe? A construction case study

Associated Scaffolding – Charter Square Construction Project:

*Mast Climbing Scaffold Collapse during
Dismantling – 3/23/2015*

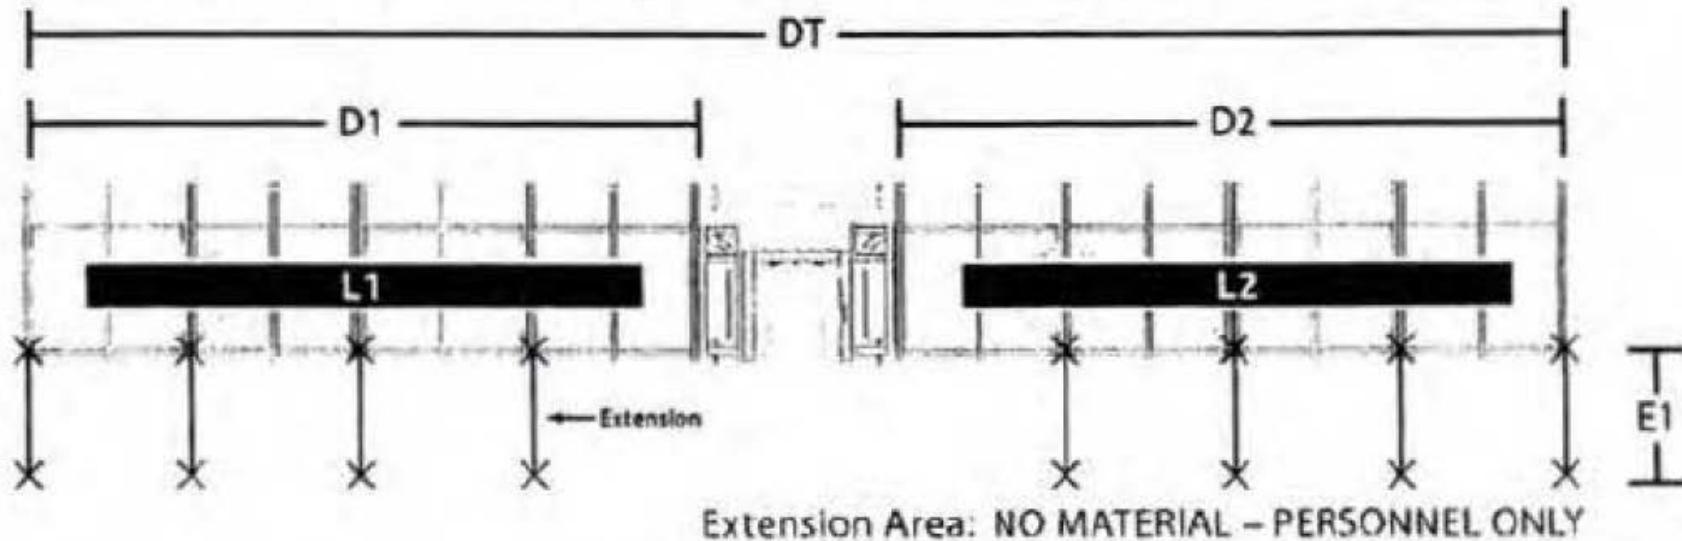
KLIMERLITE Single-Mast Layout

- ***Klimerlite Allowable Load*** - single mast with a free standing height of 40 feet with a 45 feet wide platform without rear extension was 3000 lbs. (includes weight of employees)
 - The 3000 lbs. had to be evenly distributed on each side of the main platform (1500 lbs. per each side)
 - Allowable for a standard configuration for a 45 feet wide platform with up to a 5 foot extension on the wall side (lower platform) and no rear extension

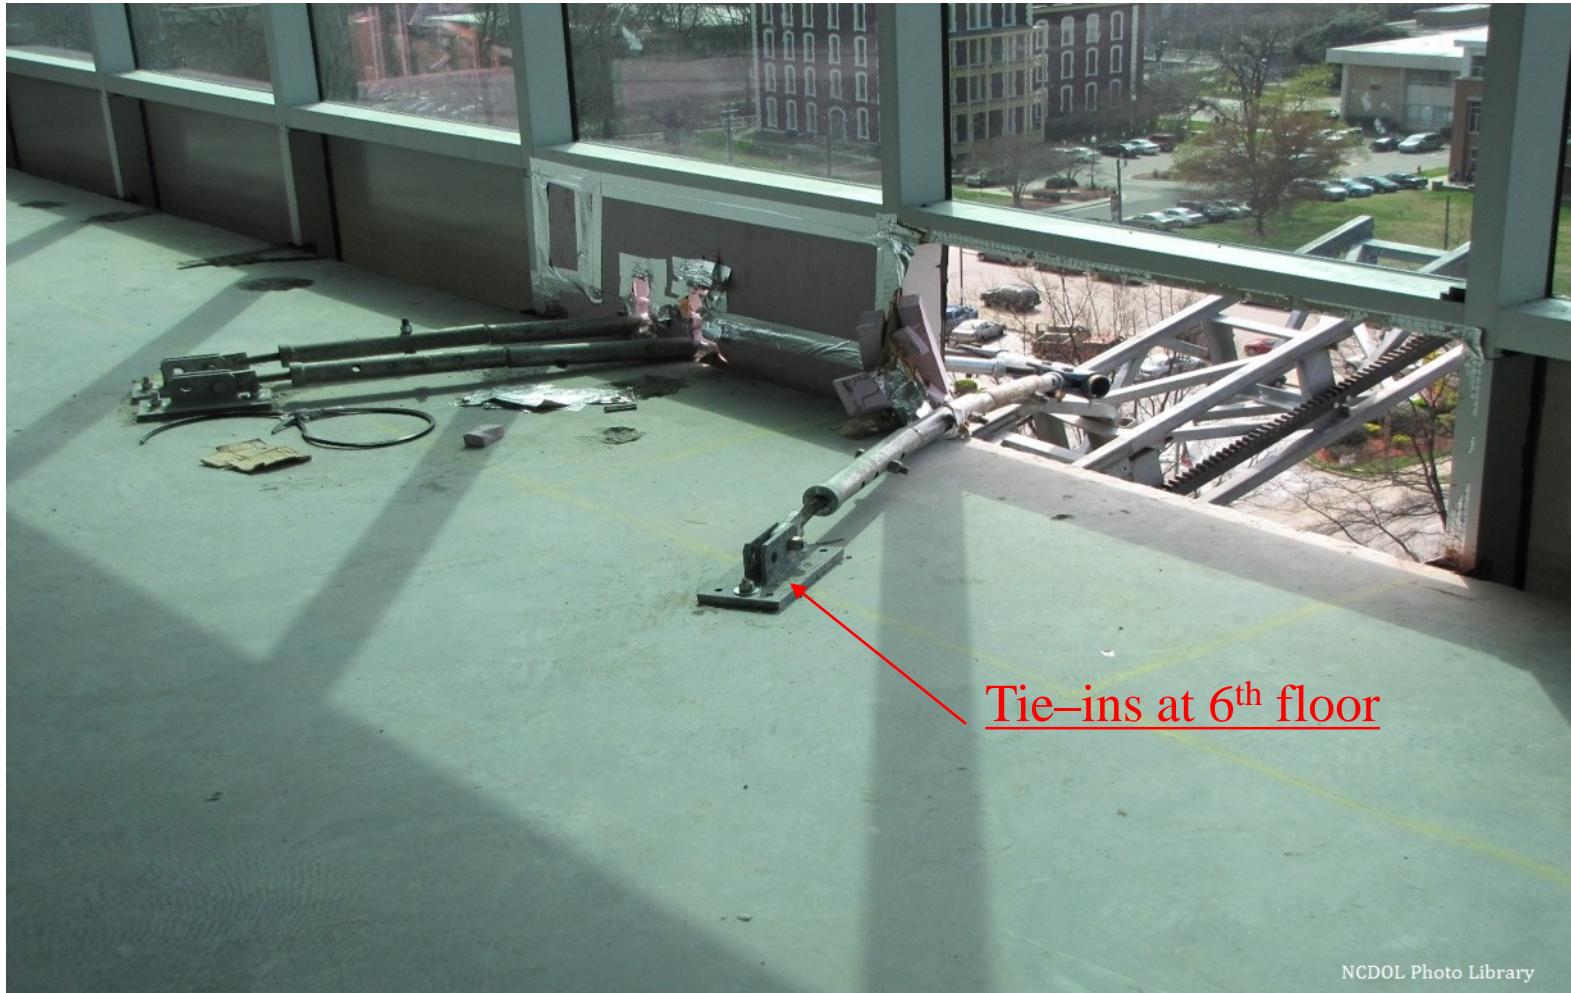
Mast Climbing Tie -Ins

- Manufacturer recommended tie-ins no greater than 40 feet
- Spacing between the:
 - 3rd and 6th floor ties: 47 ft
 - 6th and 9th floor ties: 47 ft.
 - 9th and 11th floor ties: 31 ft.
 - 11th and roof ties: 25 ft.

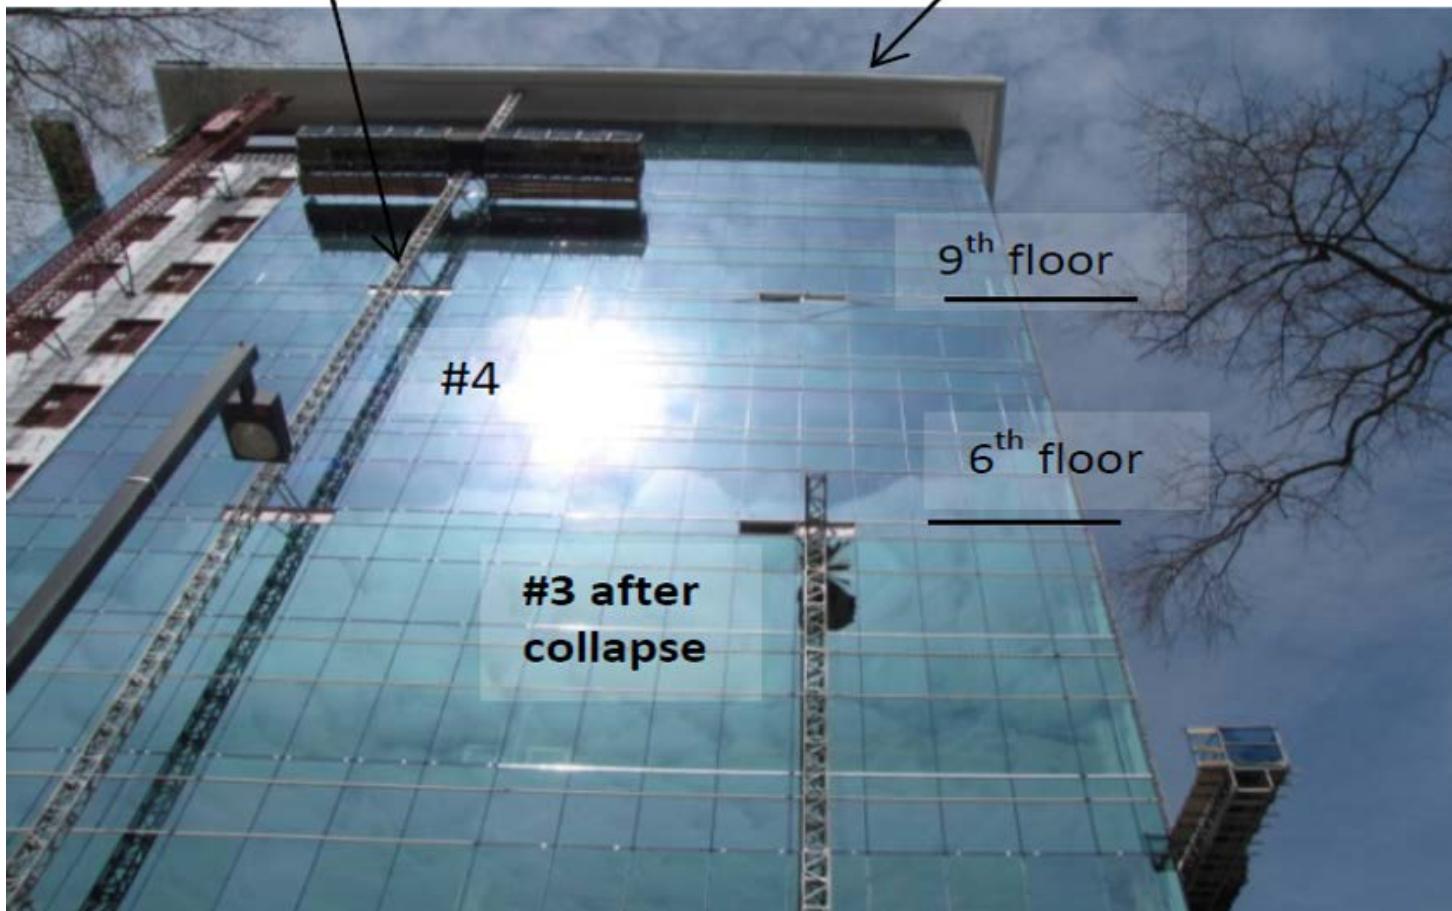
Lateral ties (typ.)

Roof wing

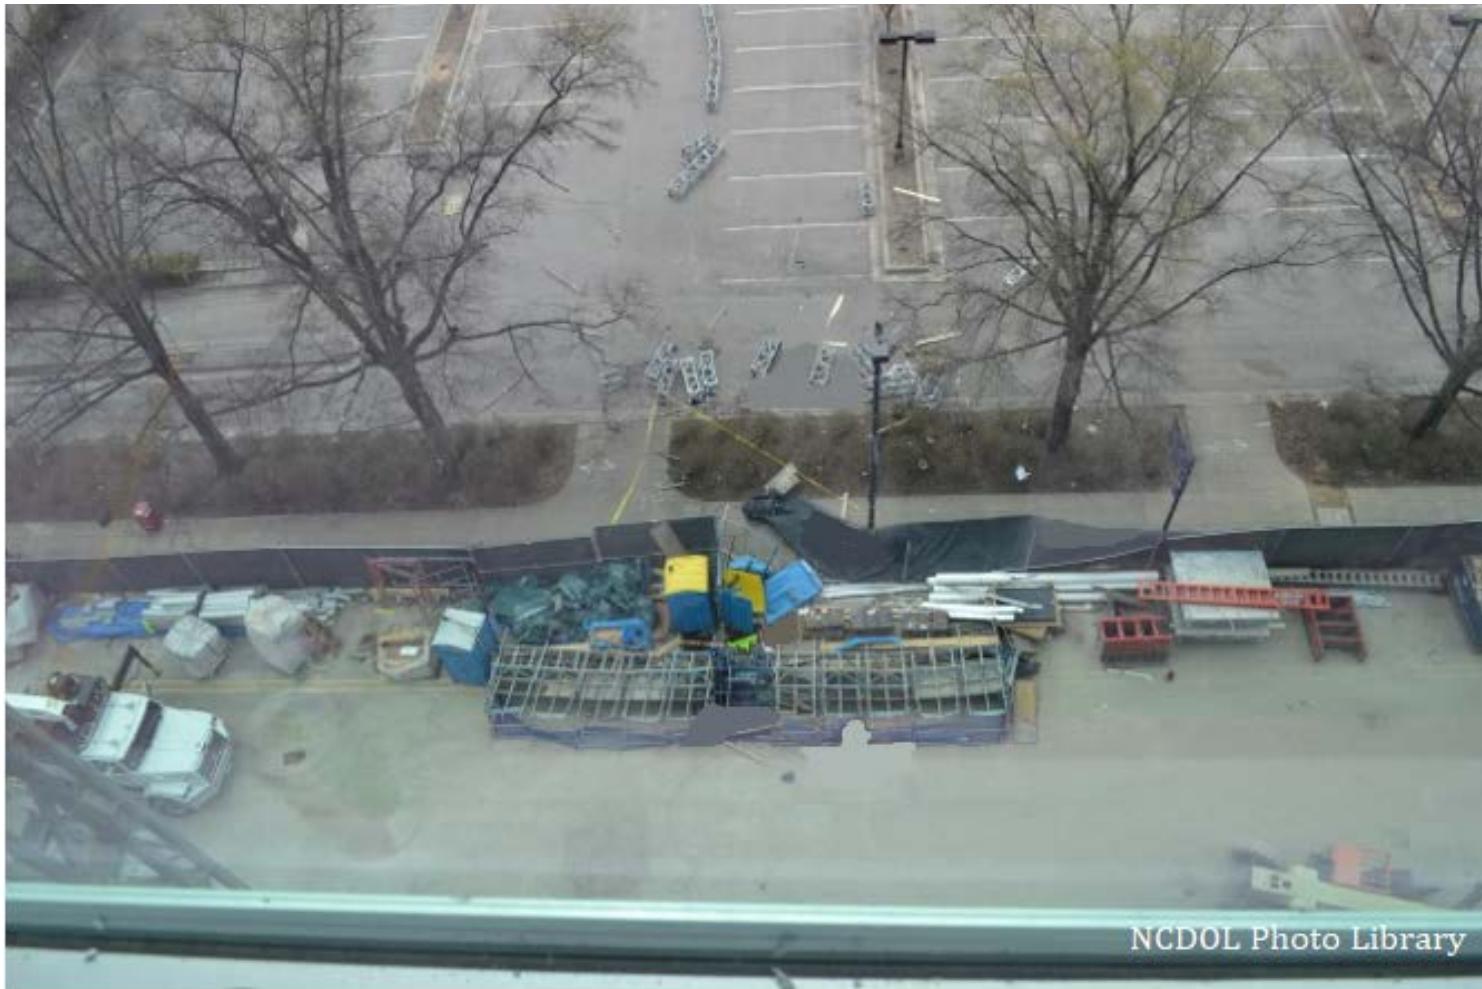
- The platform and mast began to lean from the building
- The Jannawall employee working inside the building reached for one of the Jannawall employees that was on the MCWP #3 platform and could not hold onto him because he was attached to the platform by his personal fall arrest system
- It was determined that strain was placed at the 6th floor tie-ins causing the mast sections to fall to the ground in three parts
- The 45 ft. platform fell and landed close to the building

After Collapse

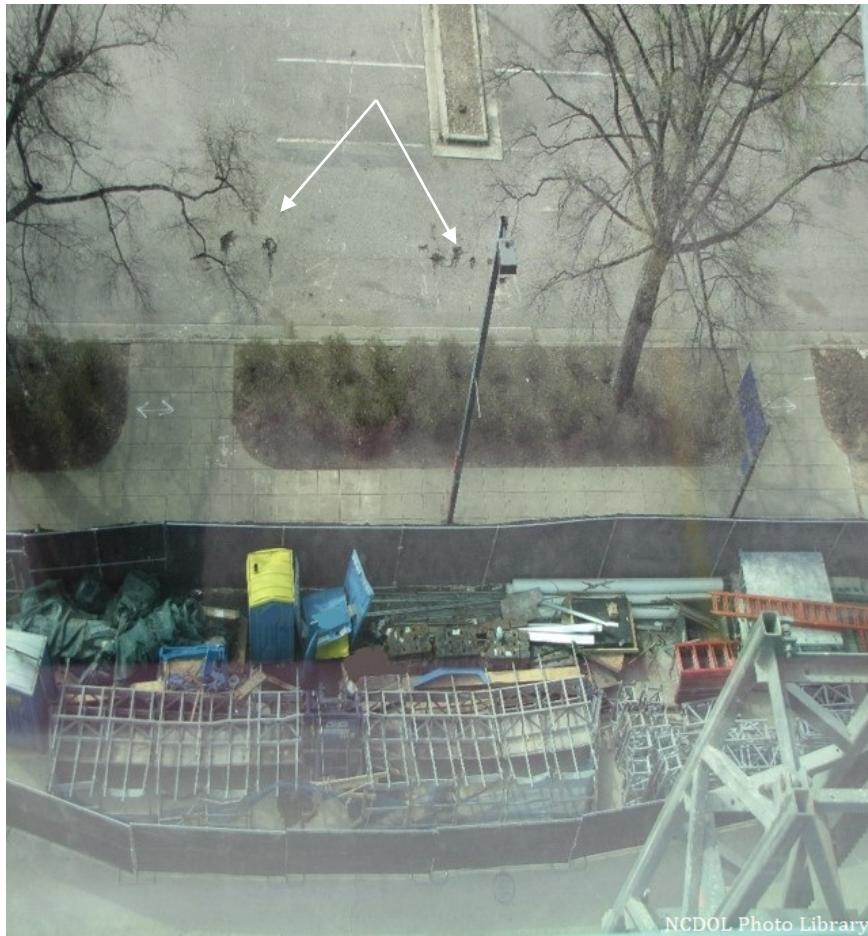
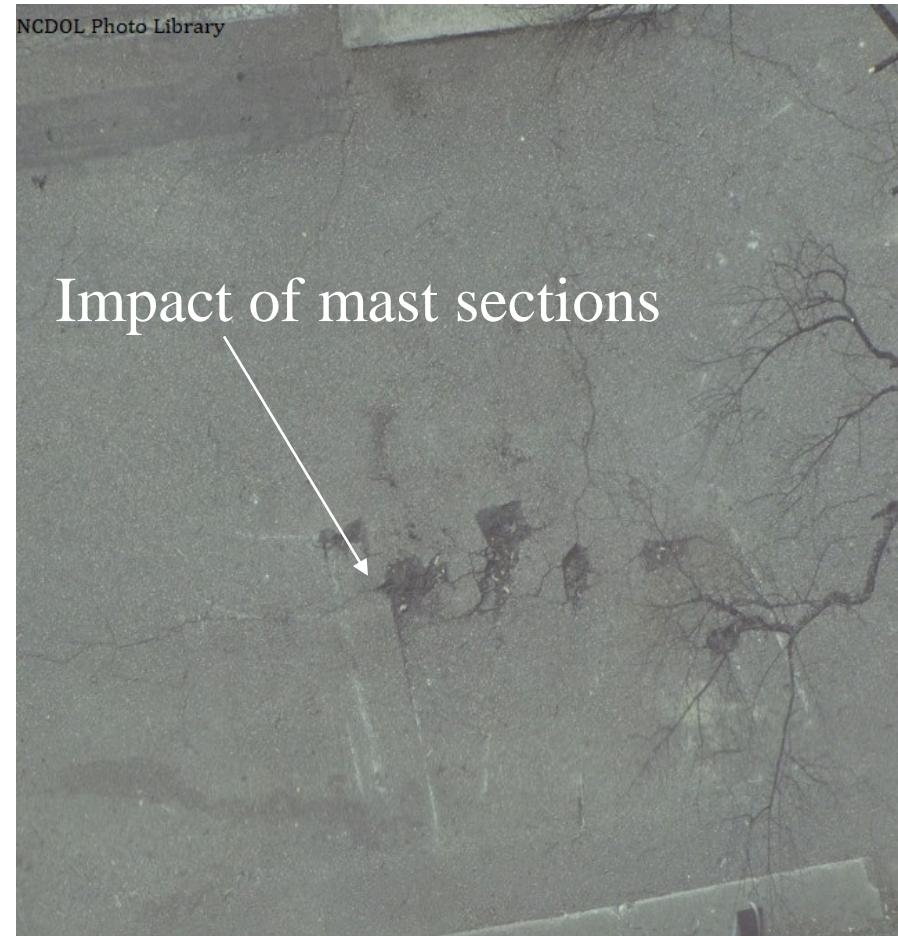
MWCP #3

After Collapse
