# Machine Guarding

- *The CSHO's Guide to Answering  
"There's No Way to Guard That"*

**Presented by:** Ted R. Hendrix, CSP

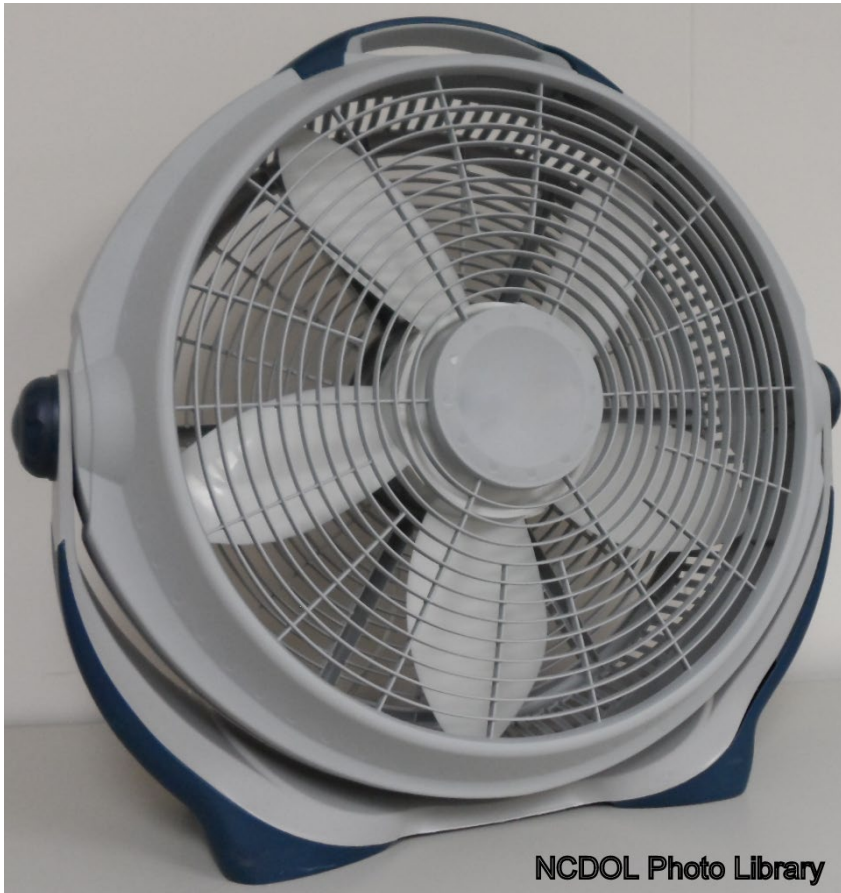
Properly guarded fan

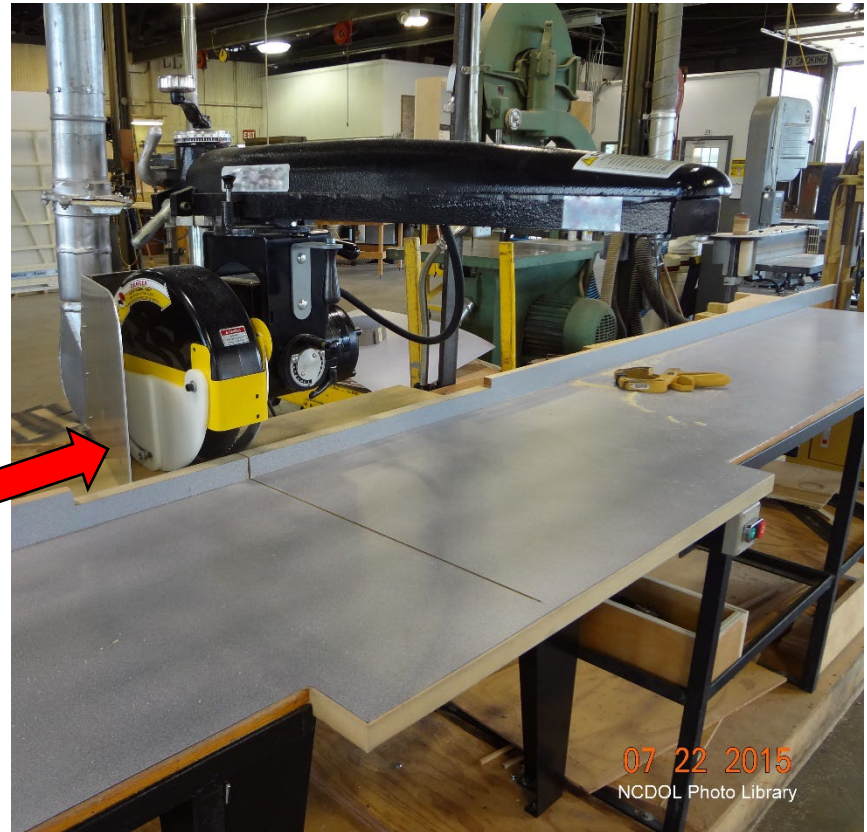
This saw meets the  
requirement

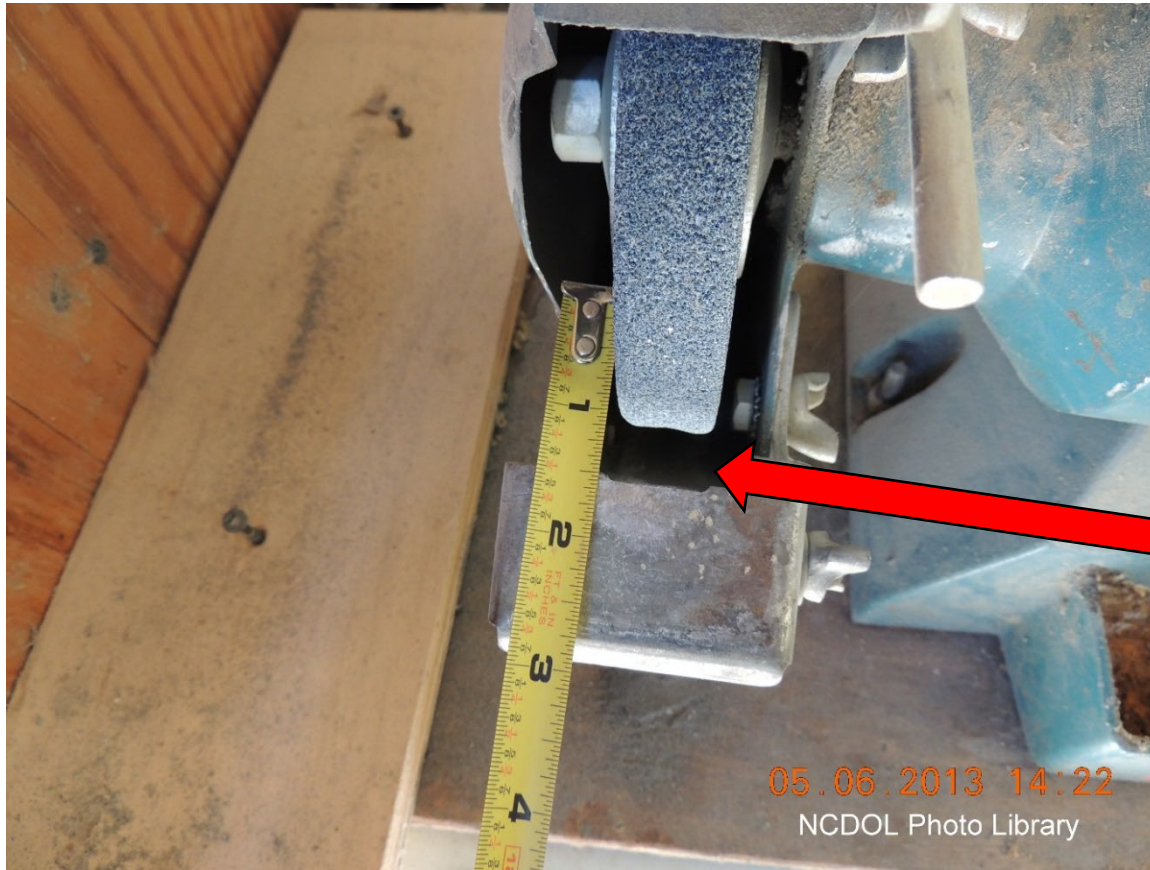
Work rest is  
out of  
adjustment

- Corrective Action
  - *Properly adjust the work rest and tongue guard to allowable openings*

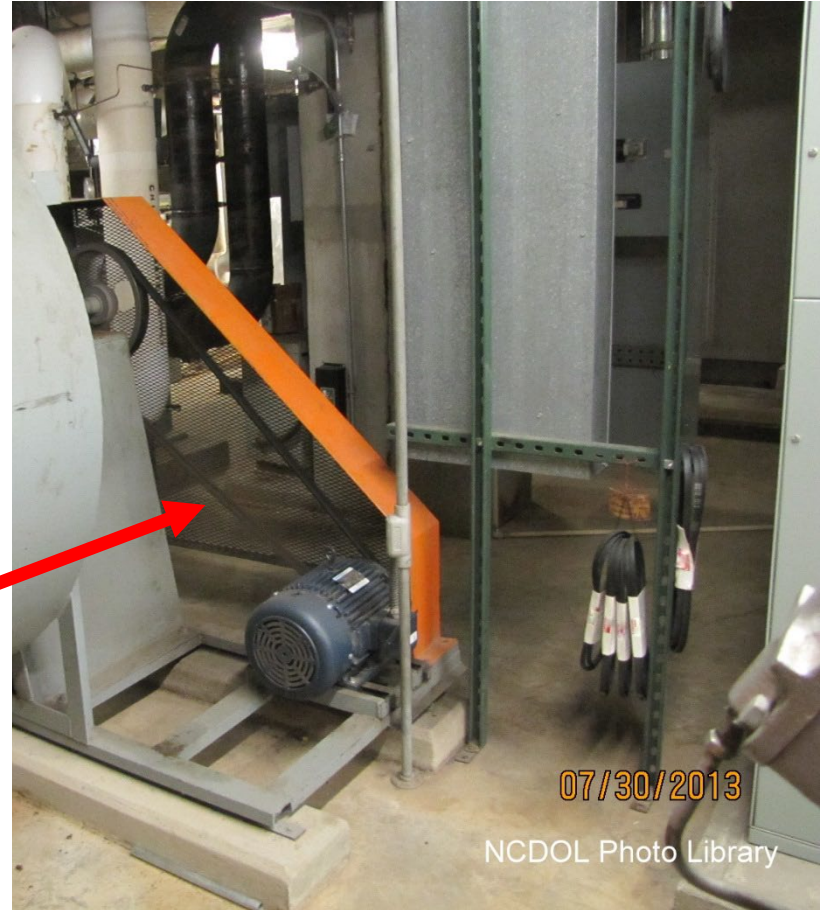
This does not comply with the requirement

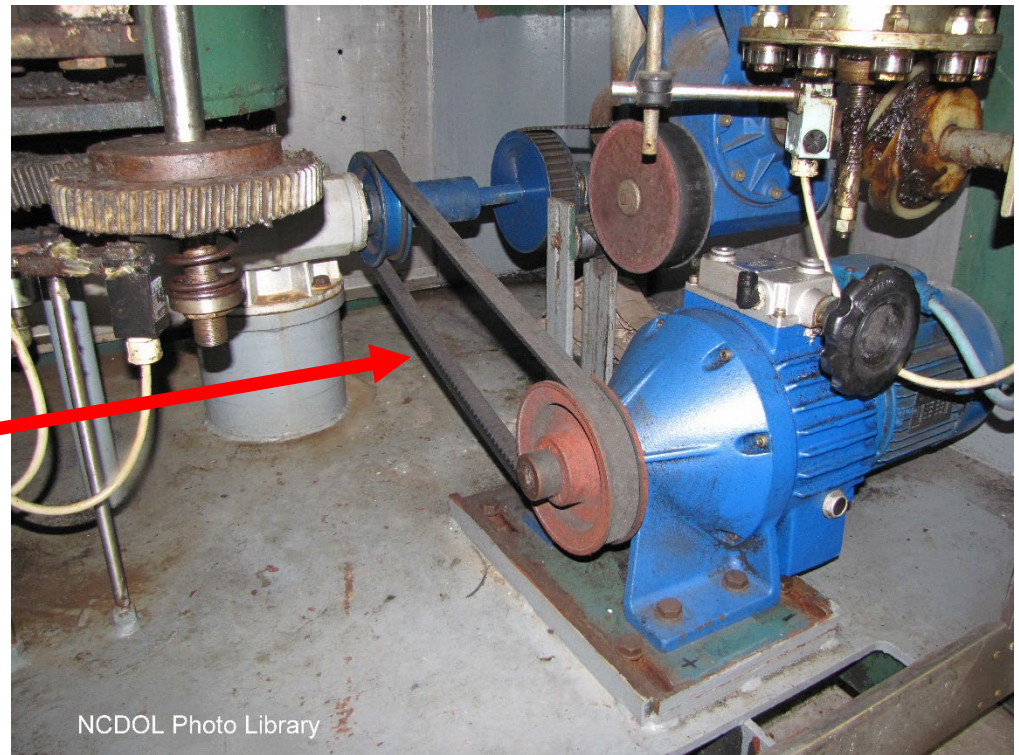
This does not comply with the requirement

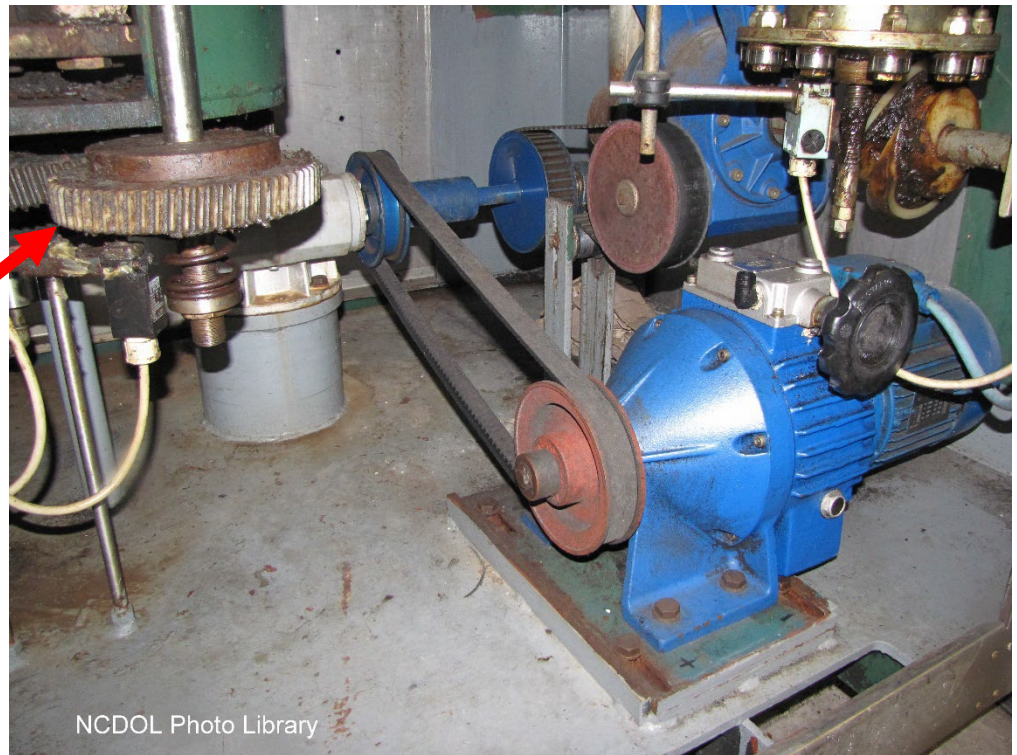
This does not comply with the requirement

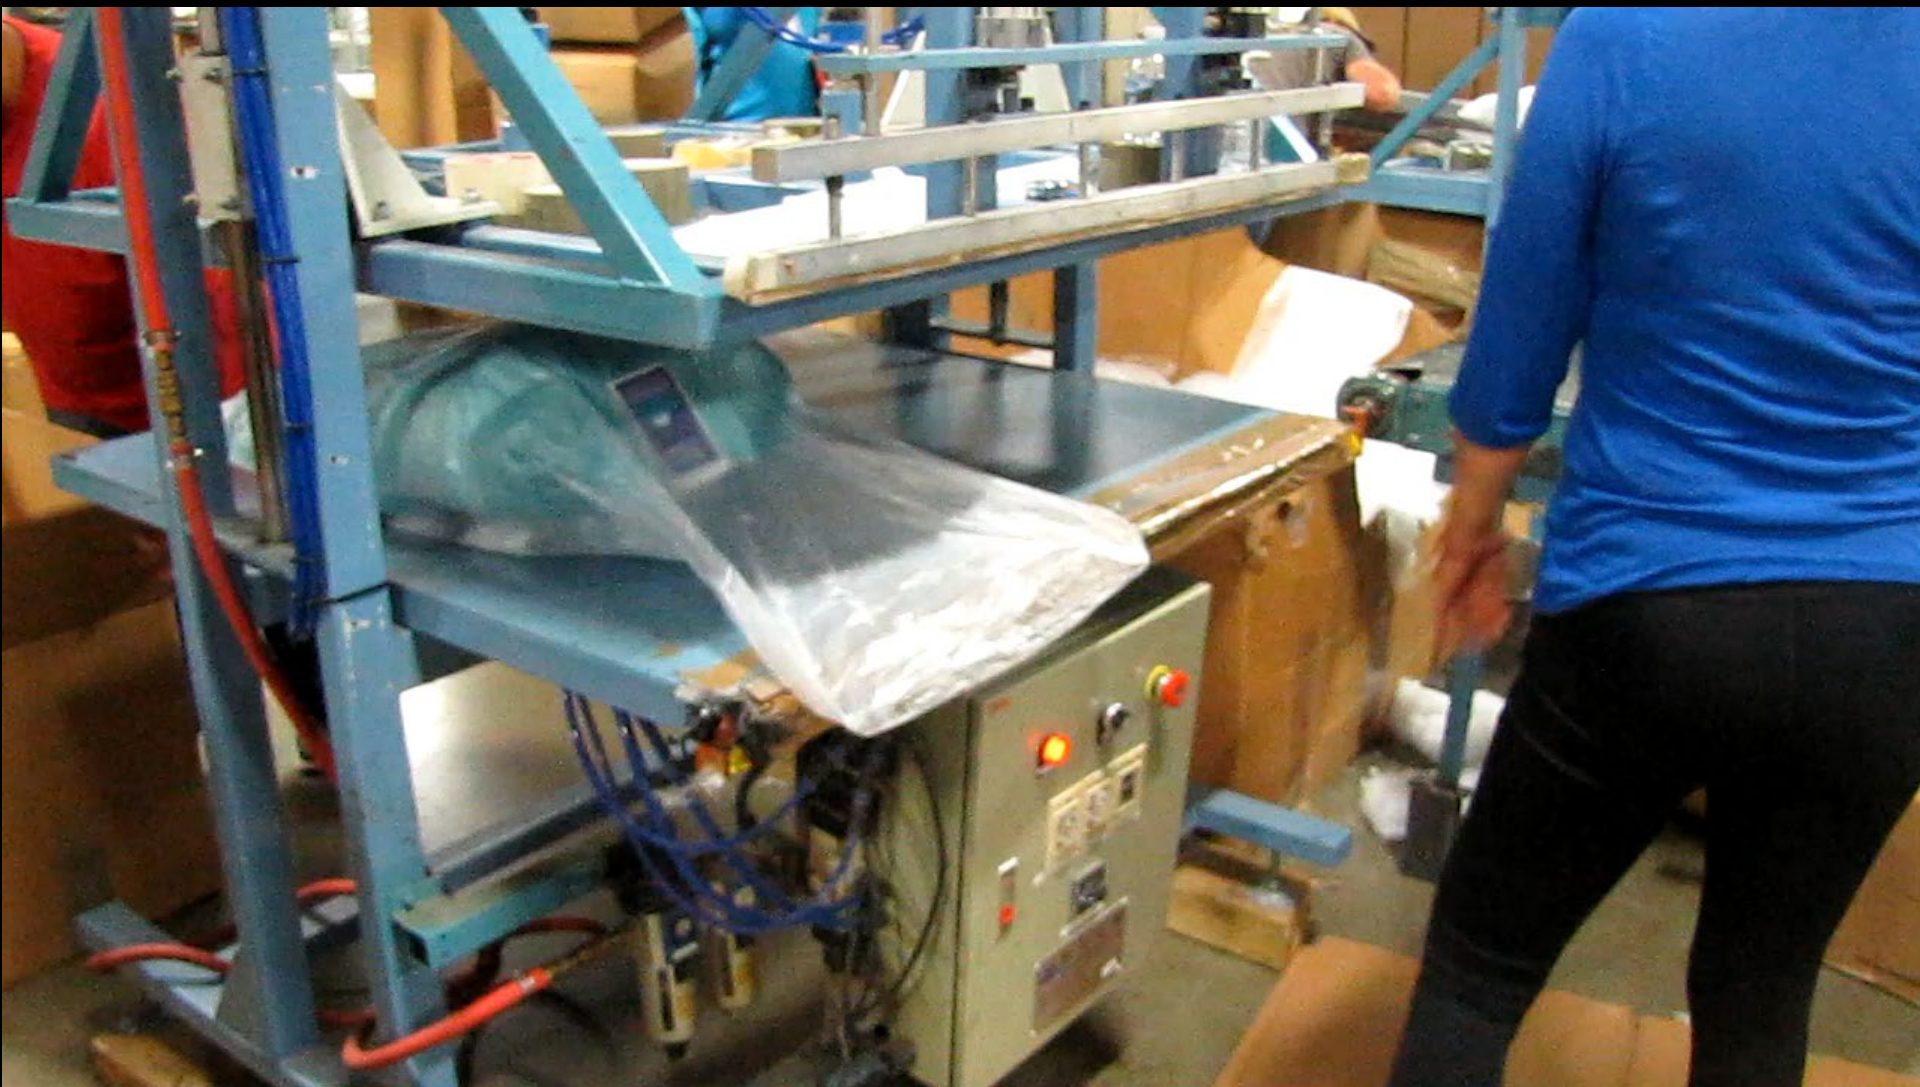
a) pillow presses – where the point of operation was not guarded, exposing employees to the hazard of being struck by and/or caught in the press.

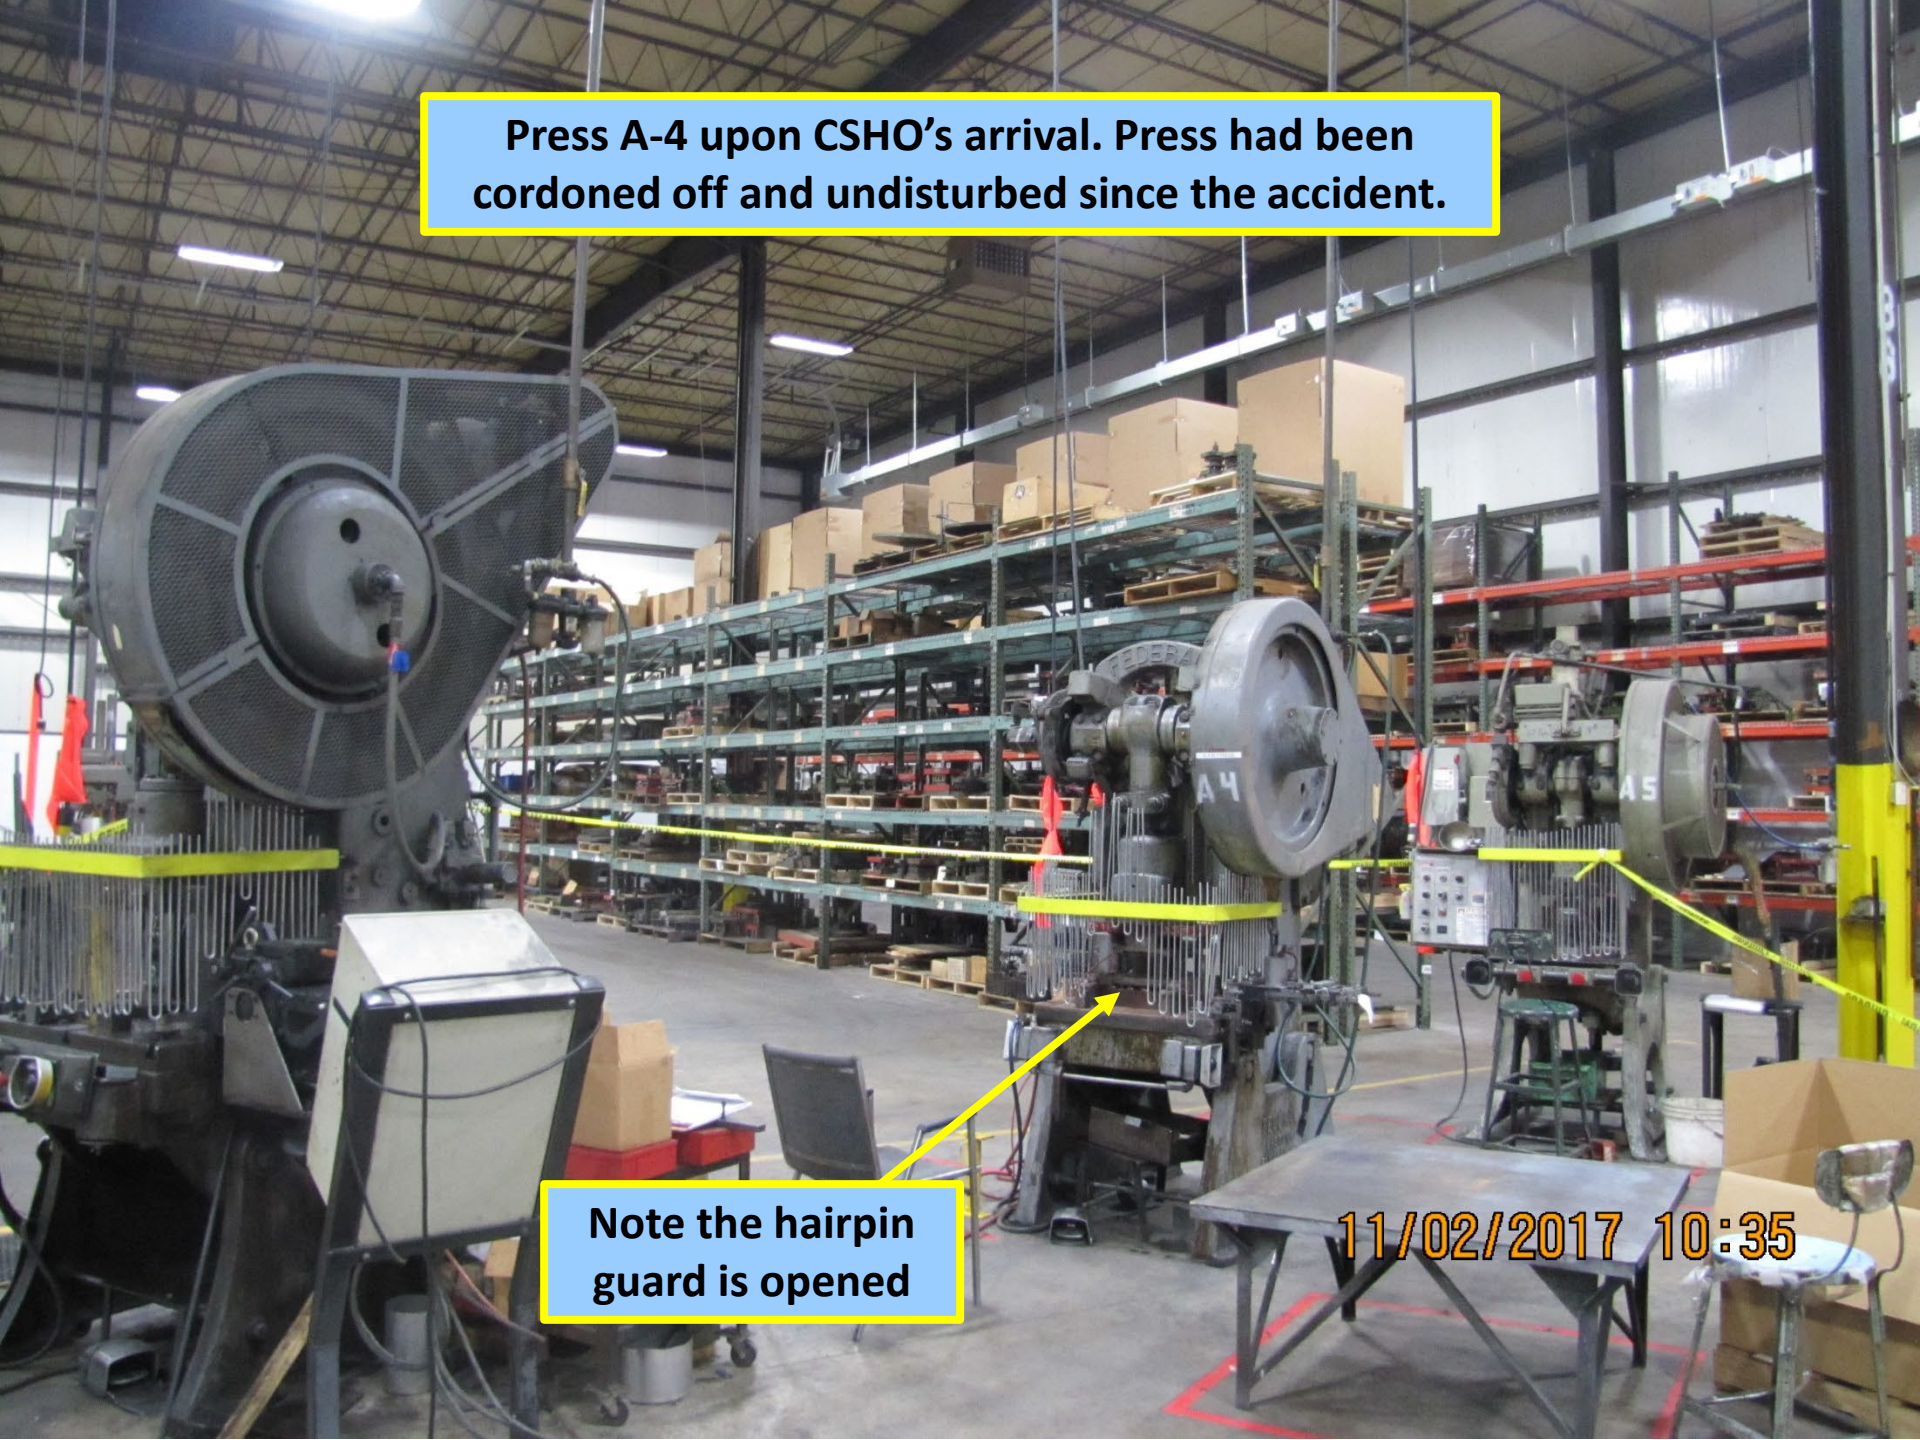
**Press A-4 upon CSHO's arrival. Press had been cordoned off and undisturbed since the accident.**

**Note the hairpin guard is opened**

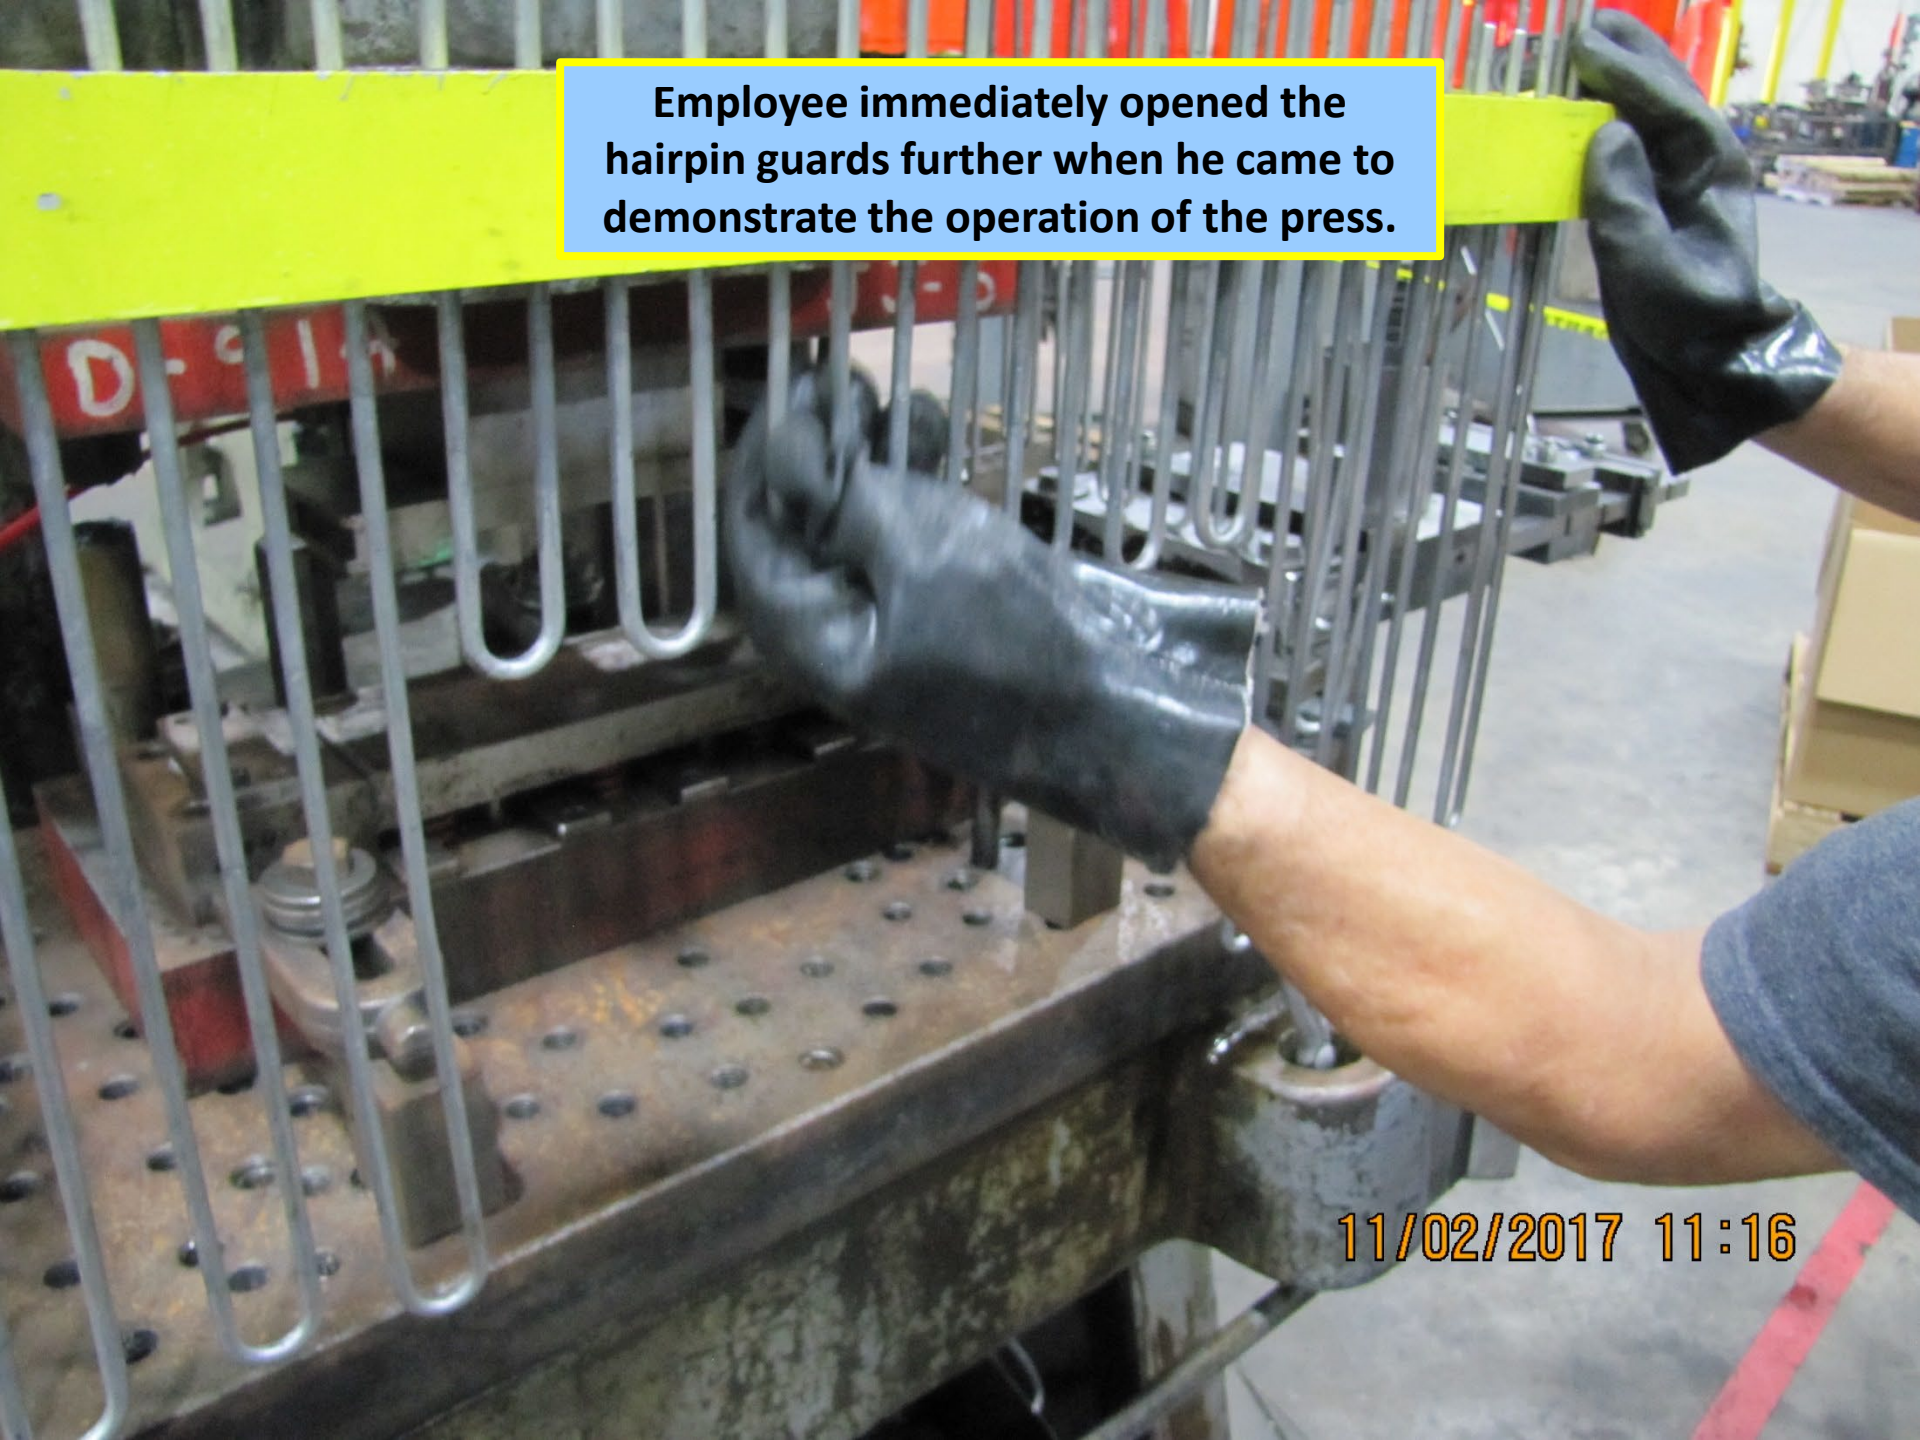
**Employee immediately opened the hairpin guards further when he came to demonstrate the operation of the press.**

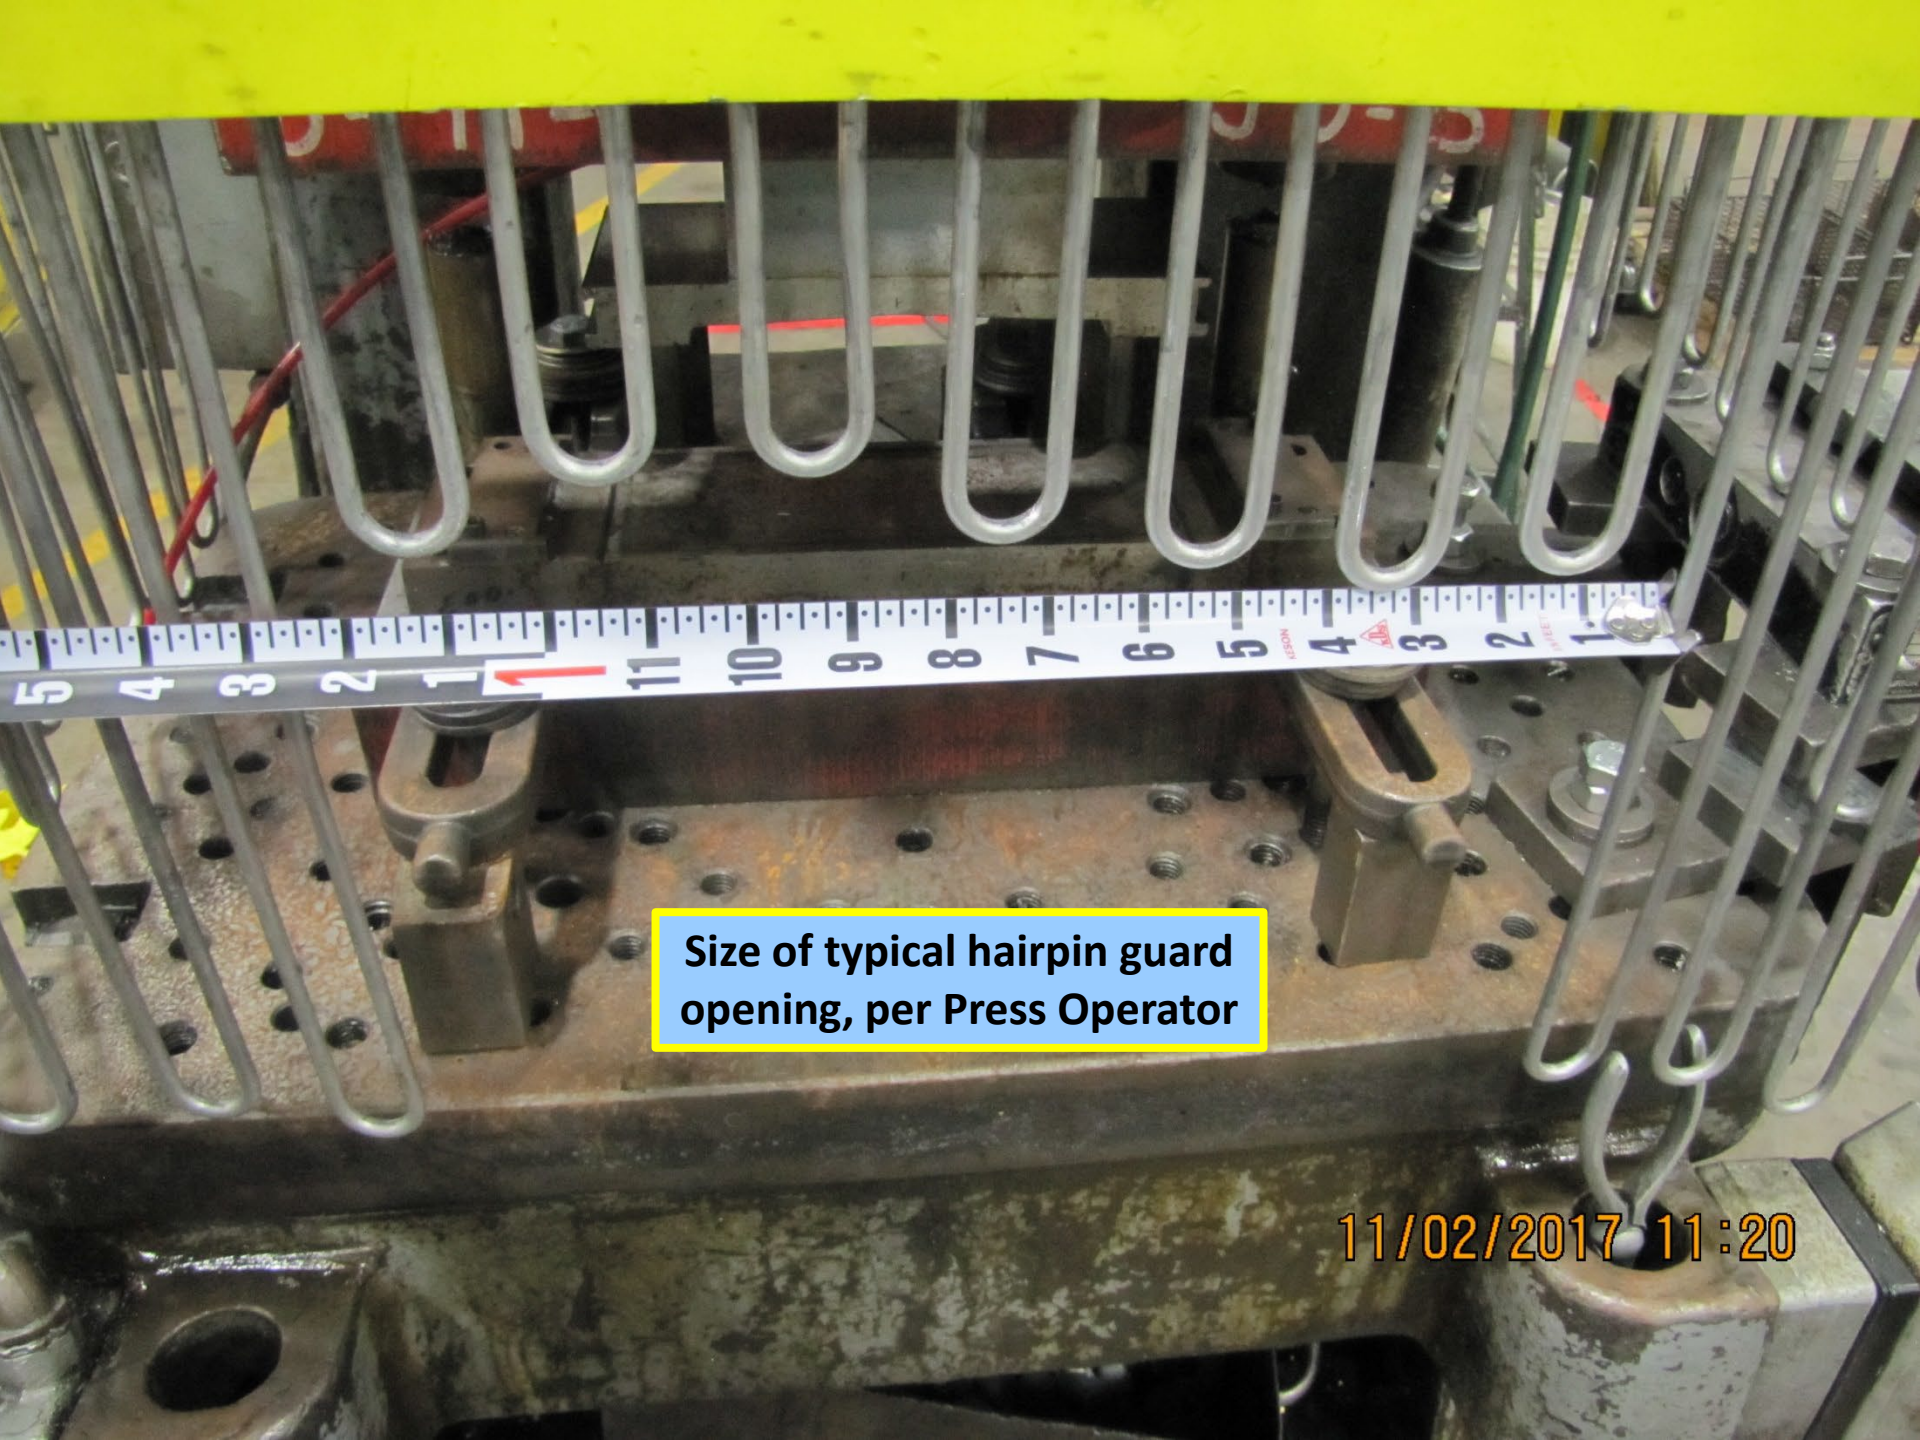
Size of typical hairpin guard opening, per Press Operator

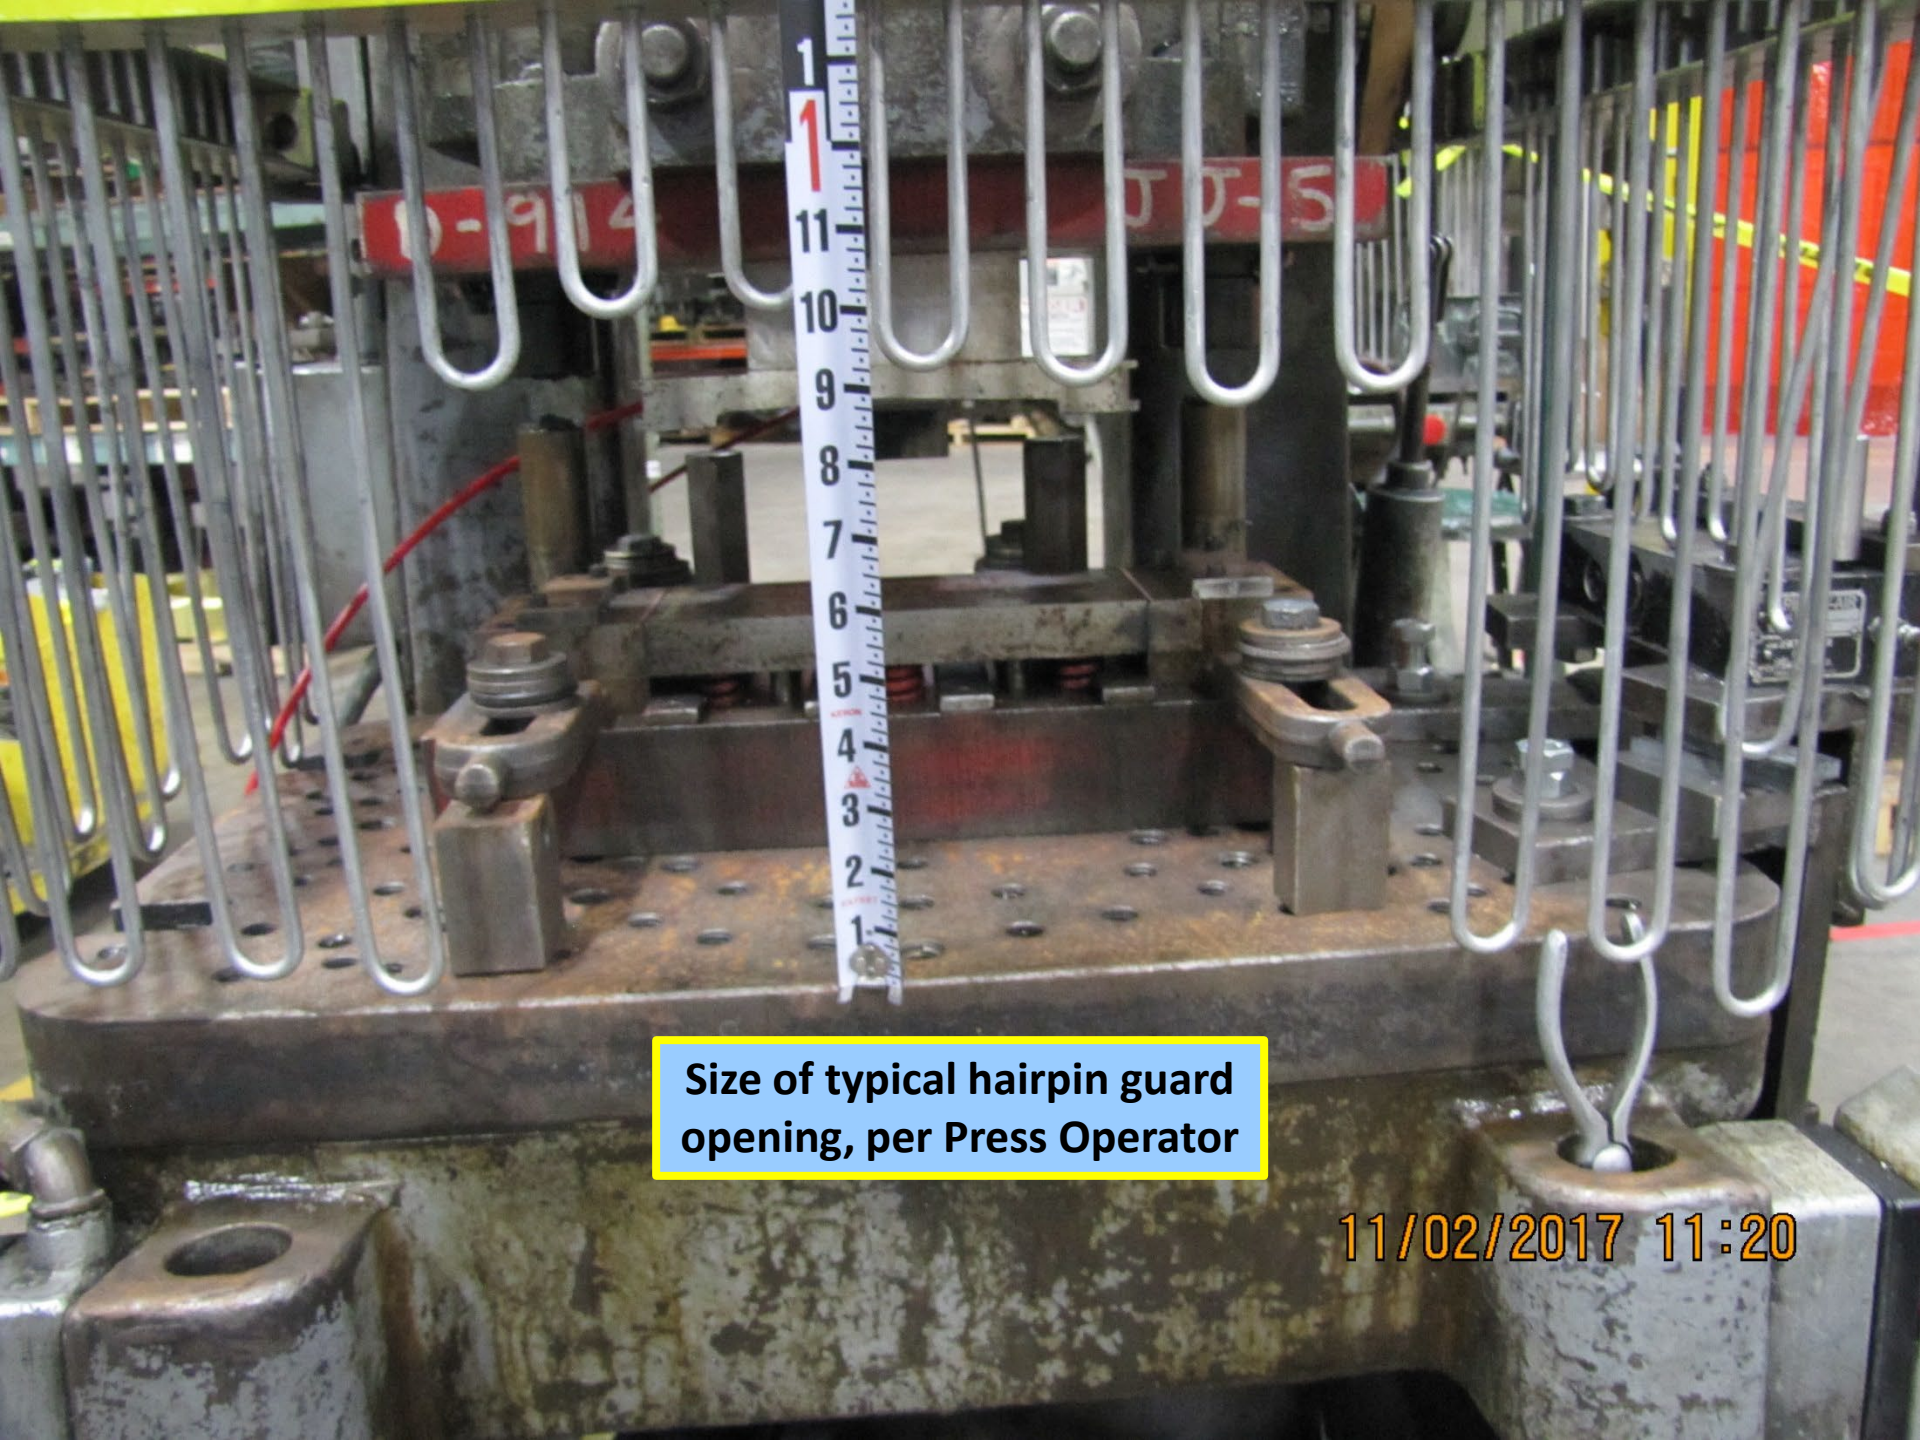
Size of typical hairpin guard opening, per Press Operator

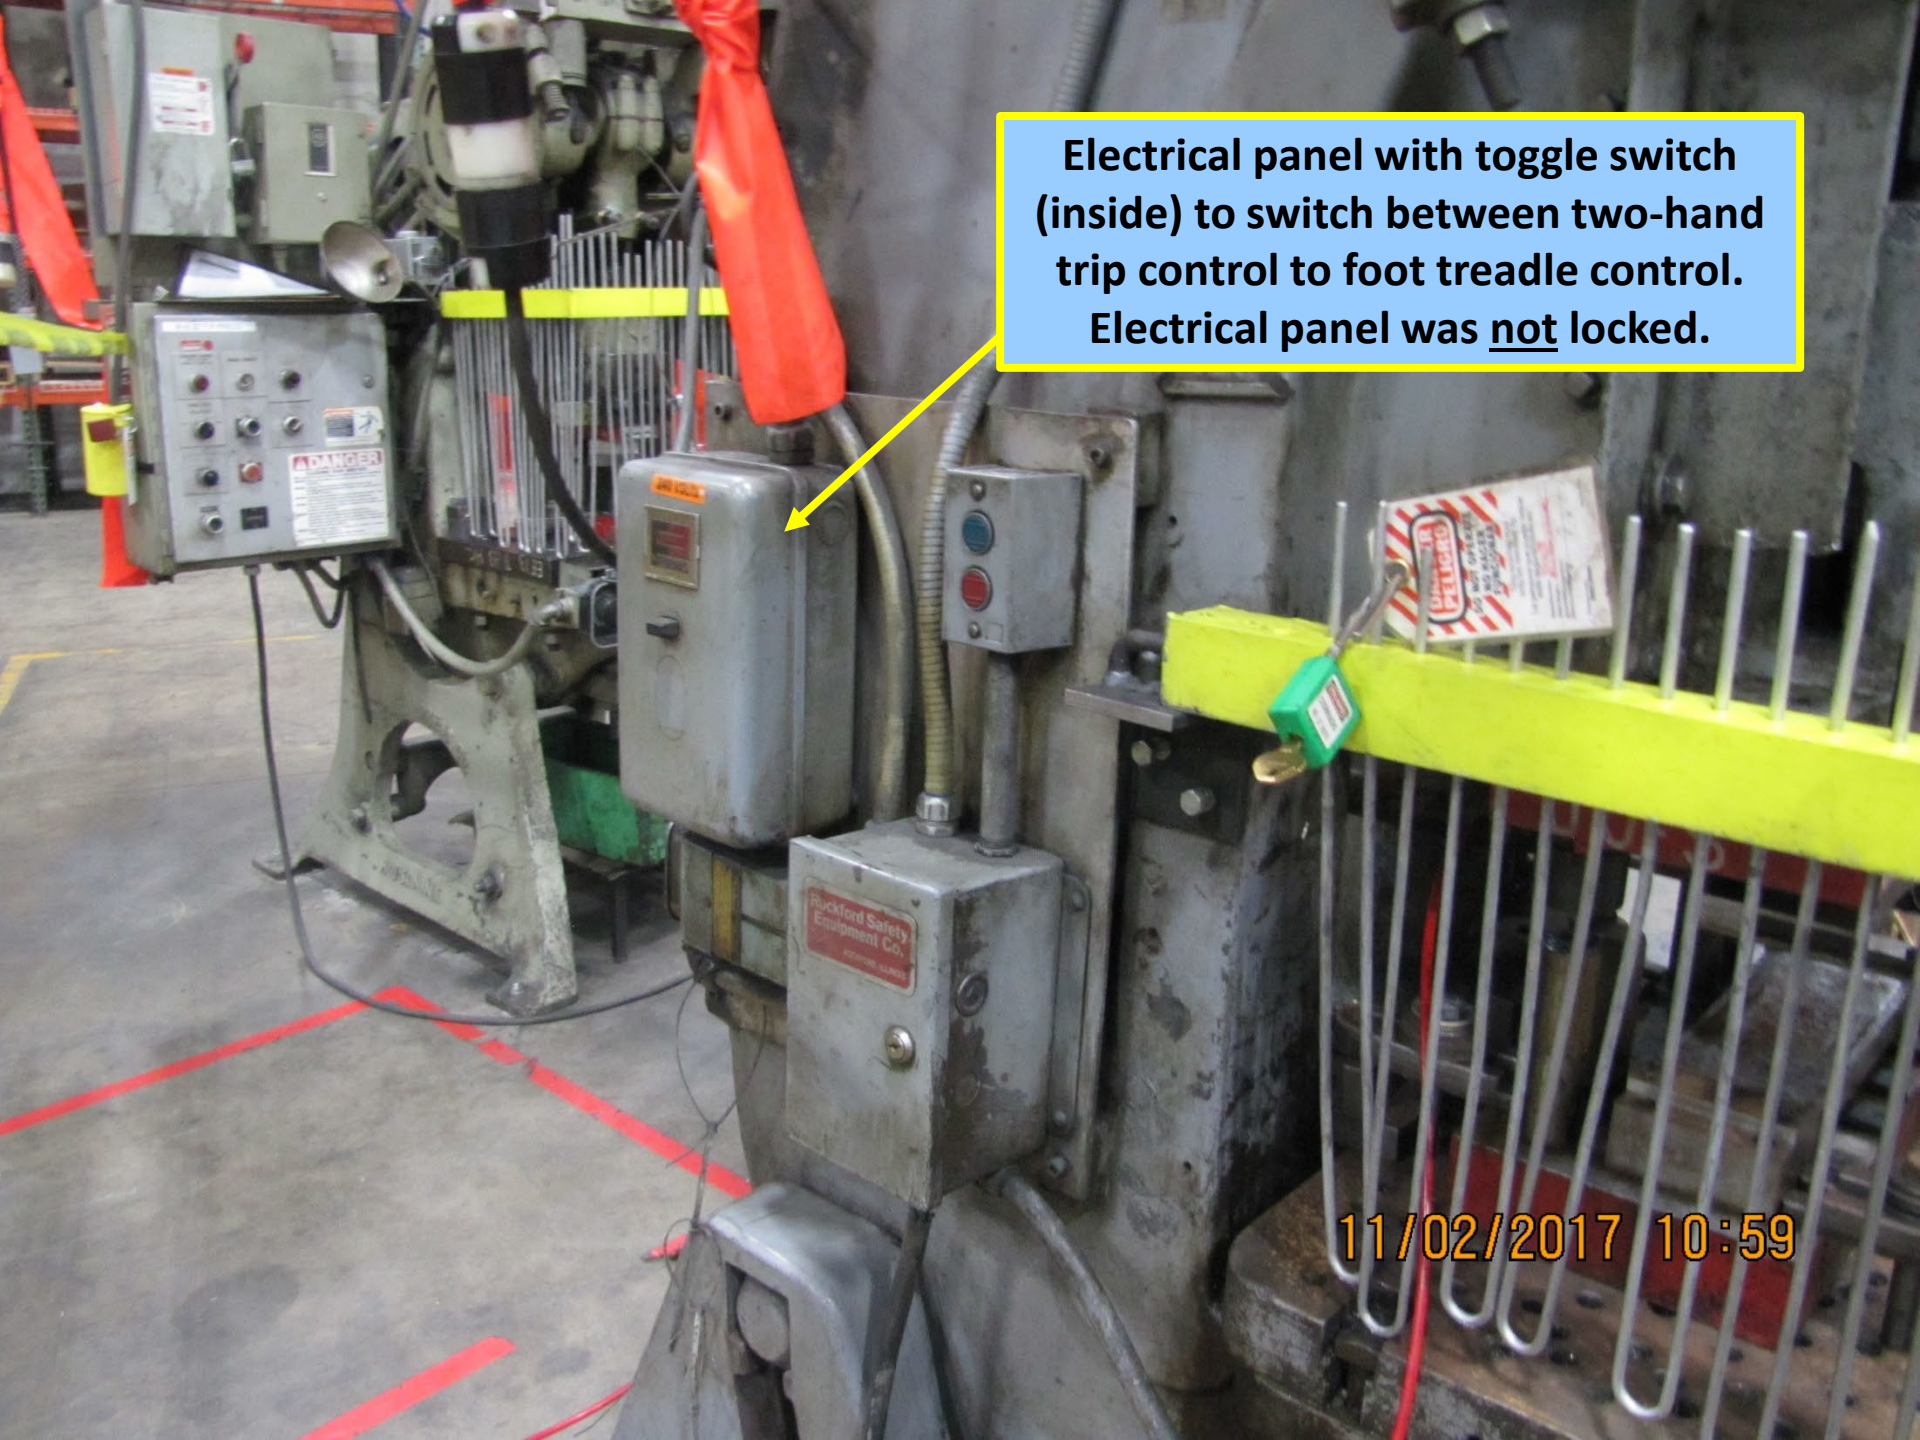
Electrical panel with toggle switch  
(inside) to switch between two-hand  
trip control to foot treadle control.  
Electrical panel was not locked.

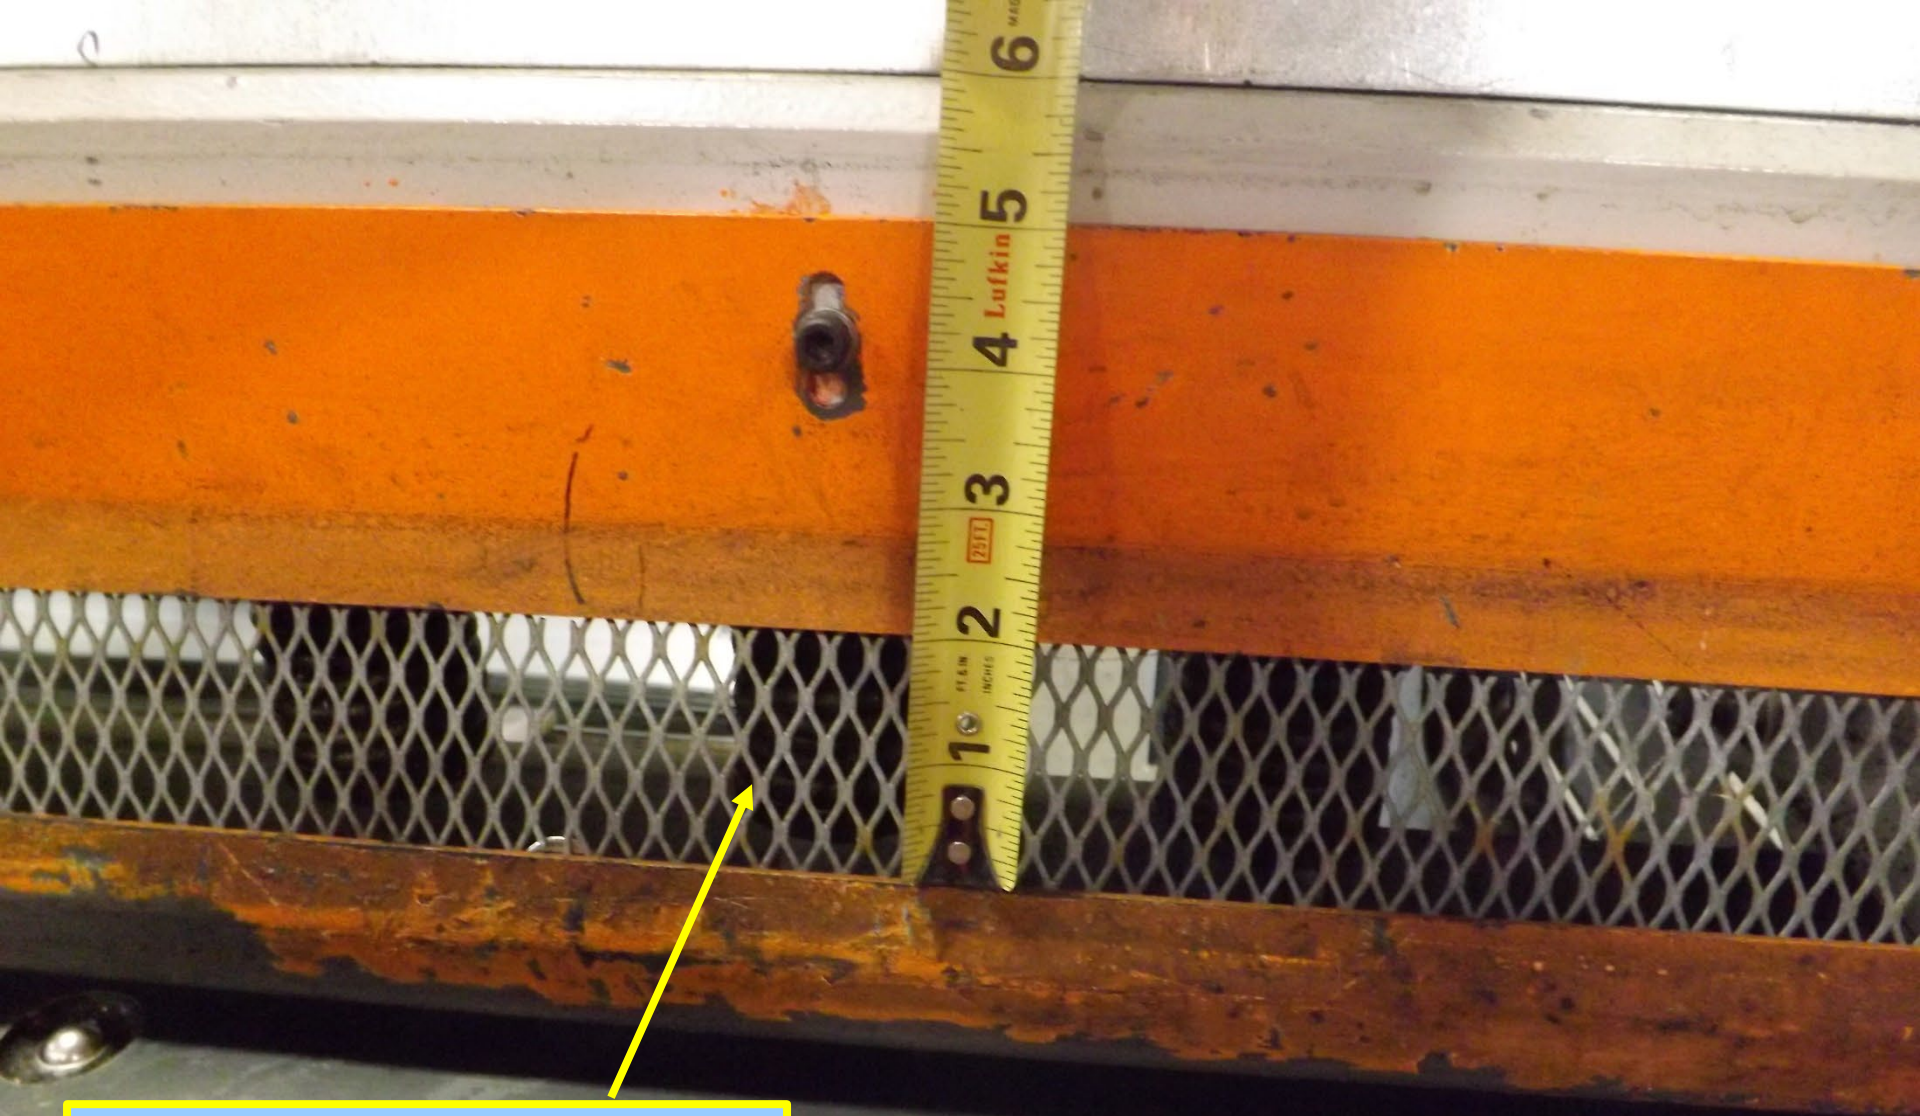
Orange guard was in place, but  
expanded metal insert was added  
AFTER the amputation injury.

**Two-inch gap in guard formerly had a Plexiglas window, which had been missing for several months.**

a) press department - where a two-inch wide section, running the length of the Ermaksan CNC Hydraulic Swing Beam Shear (HGD), of the point of operation guard was missing. On or about 9/20/2018, an employee had portions of two fingers amputated while using the aforementioned shear.
