# Machine Guarding

- *The CSHO's Guide to Answering  
"There's No Way to Guard That"*

**Presented by:** Ted R. Hendrix, CSP

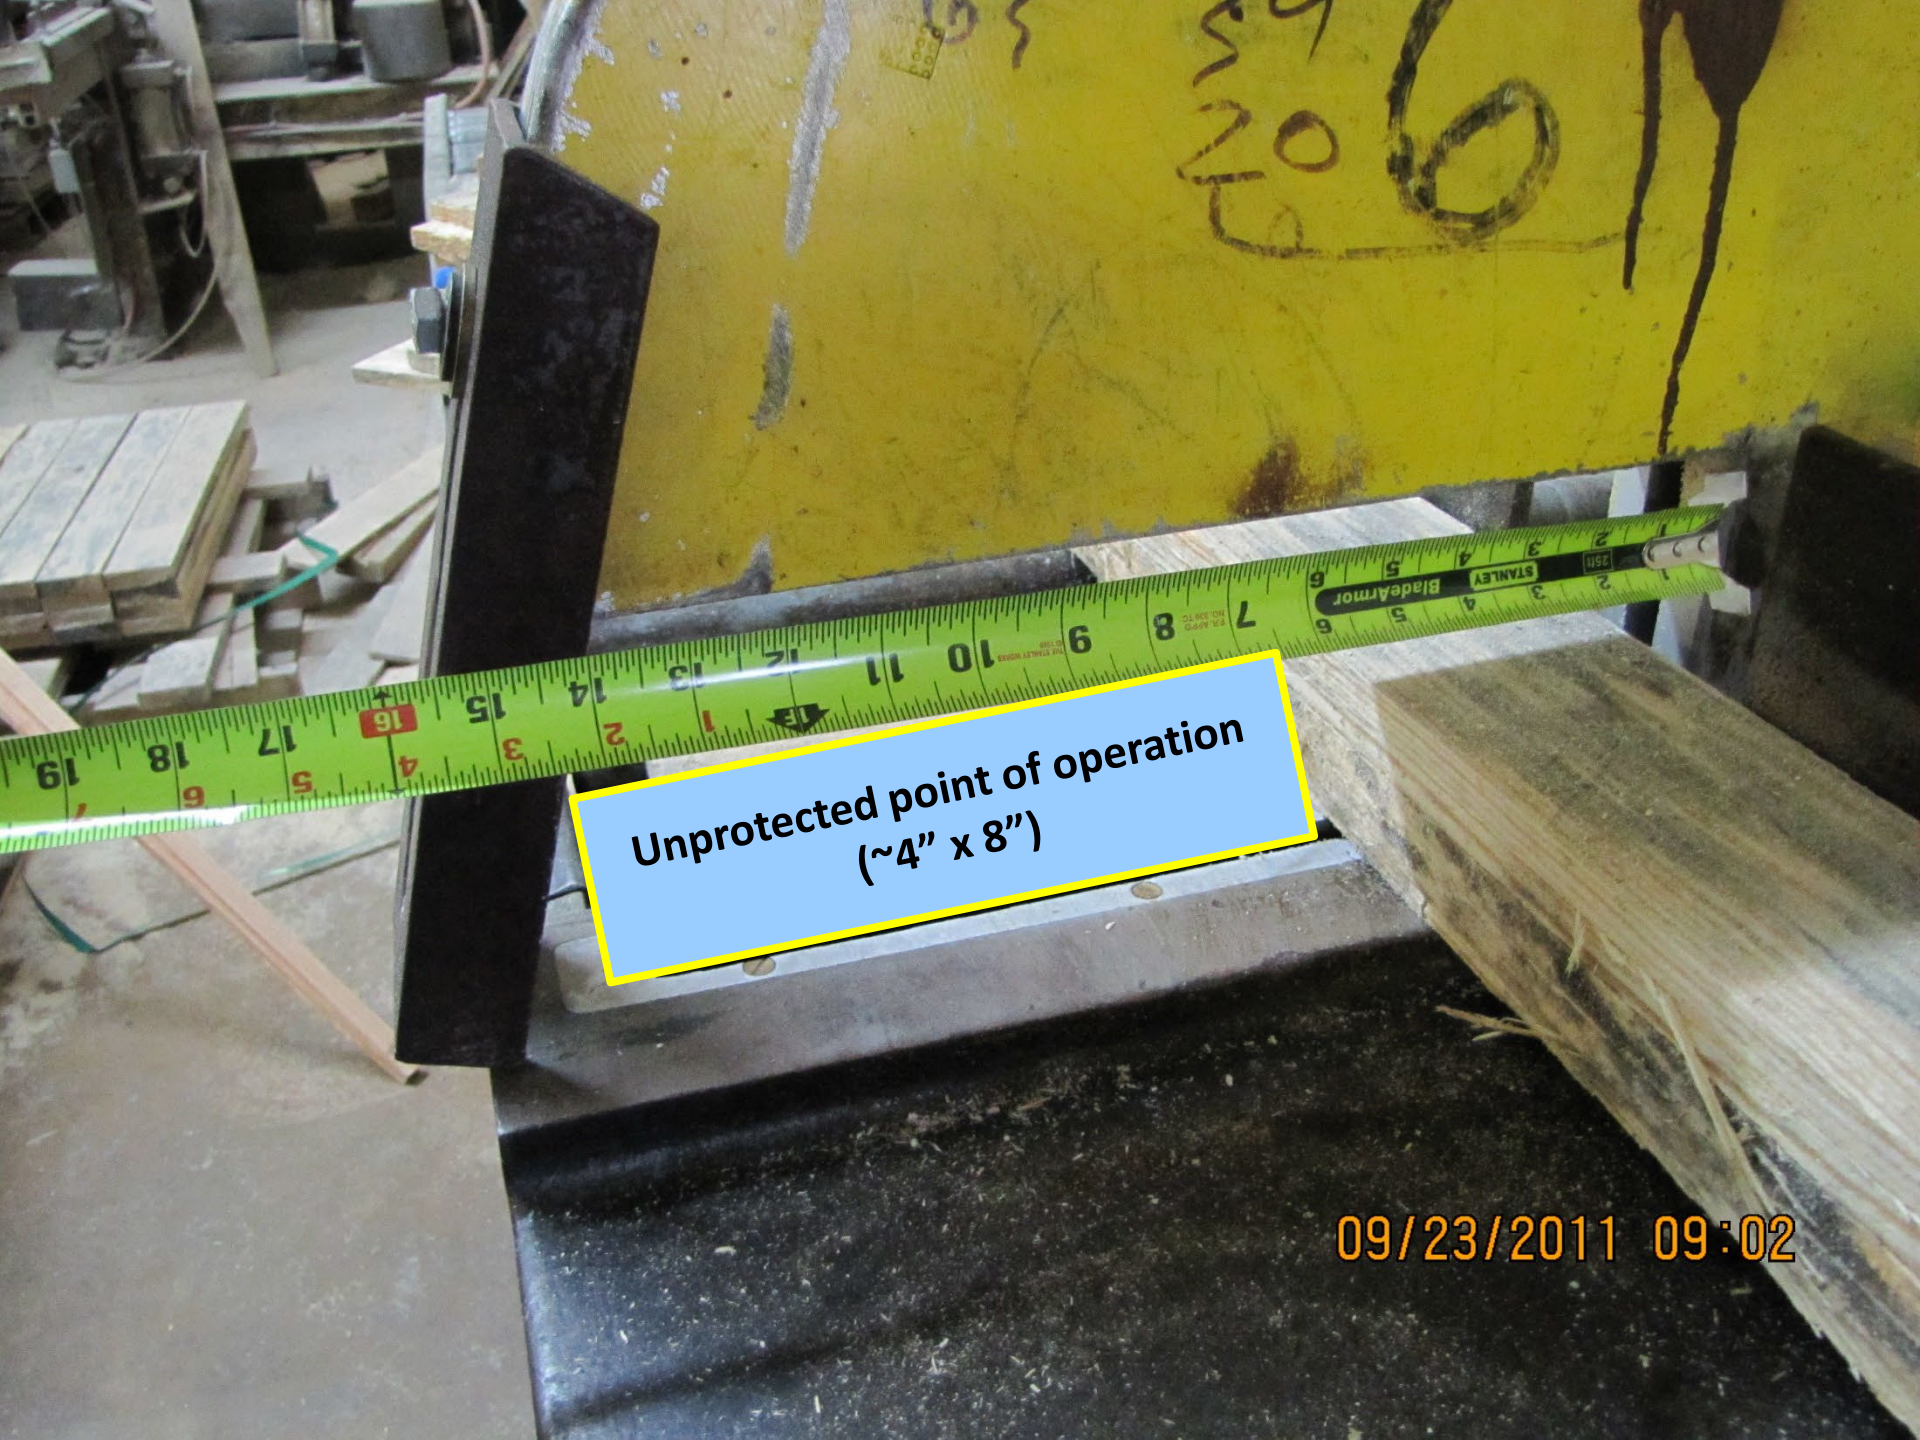
Unprotected point of operation  
(~4" x 8")

**29 CFR 1910.213(r)(4):** Suitable guard(s) were not provided to reduce to a minimum the hazard due to the point of operation of woodworking machines not mentioned in paragraphs (a) through (r) of this section:

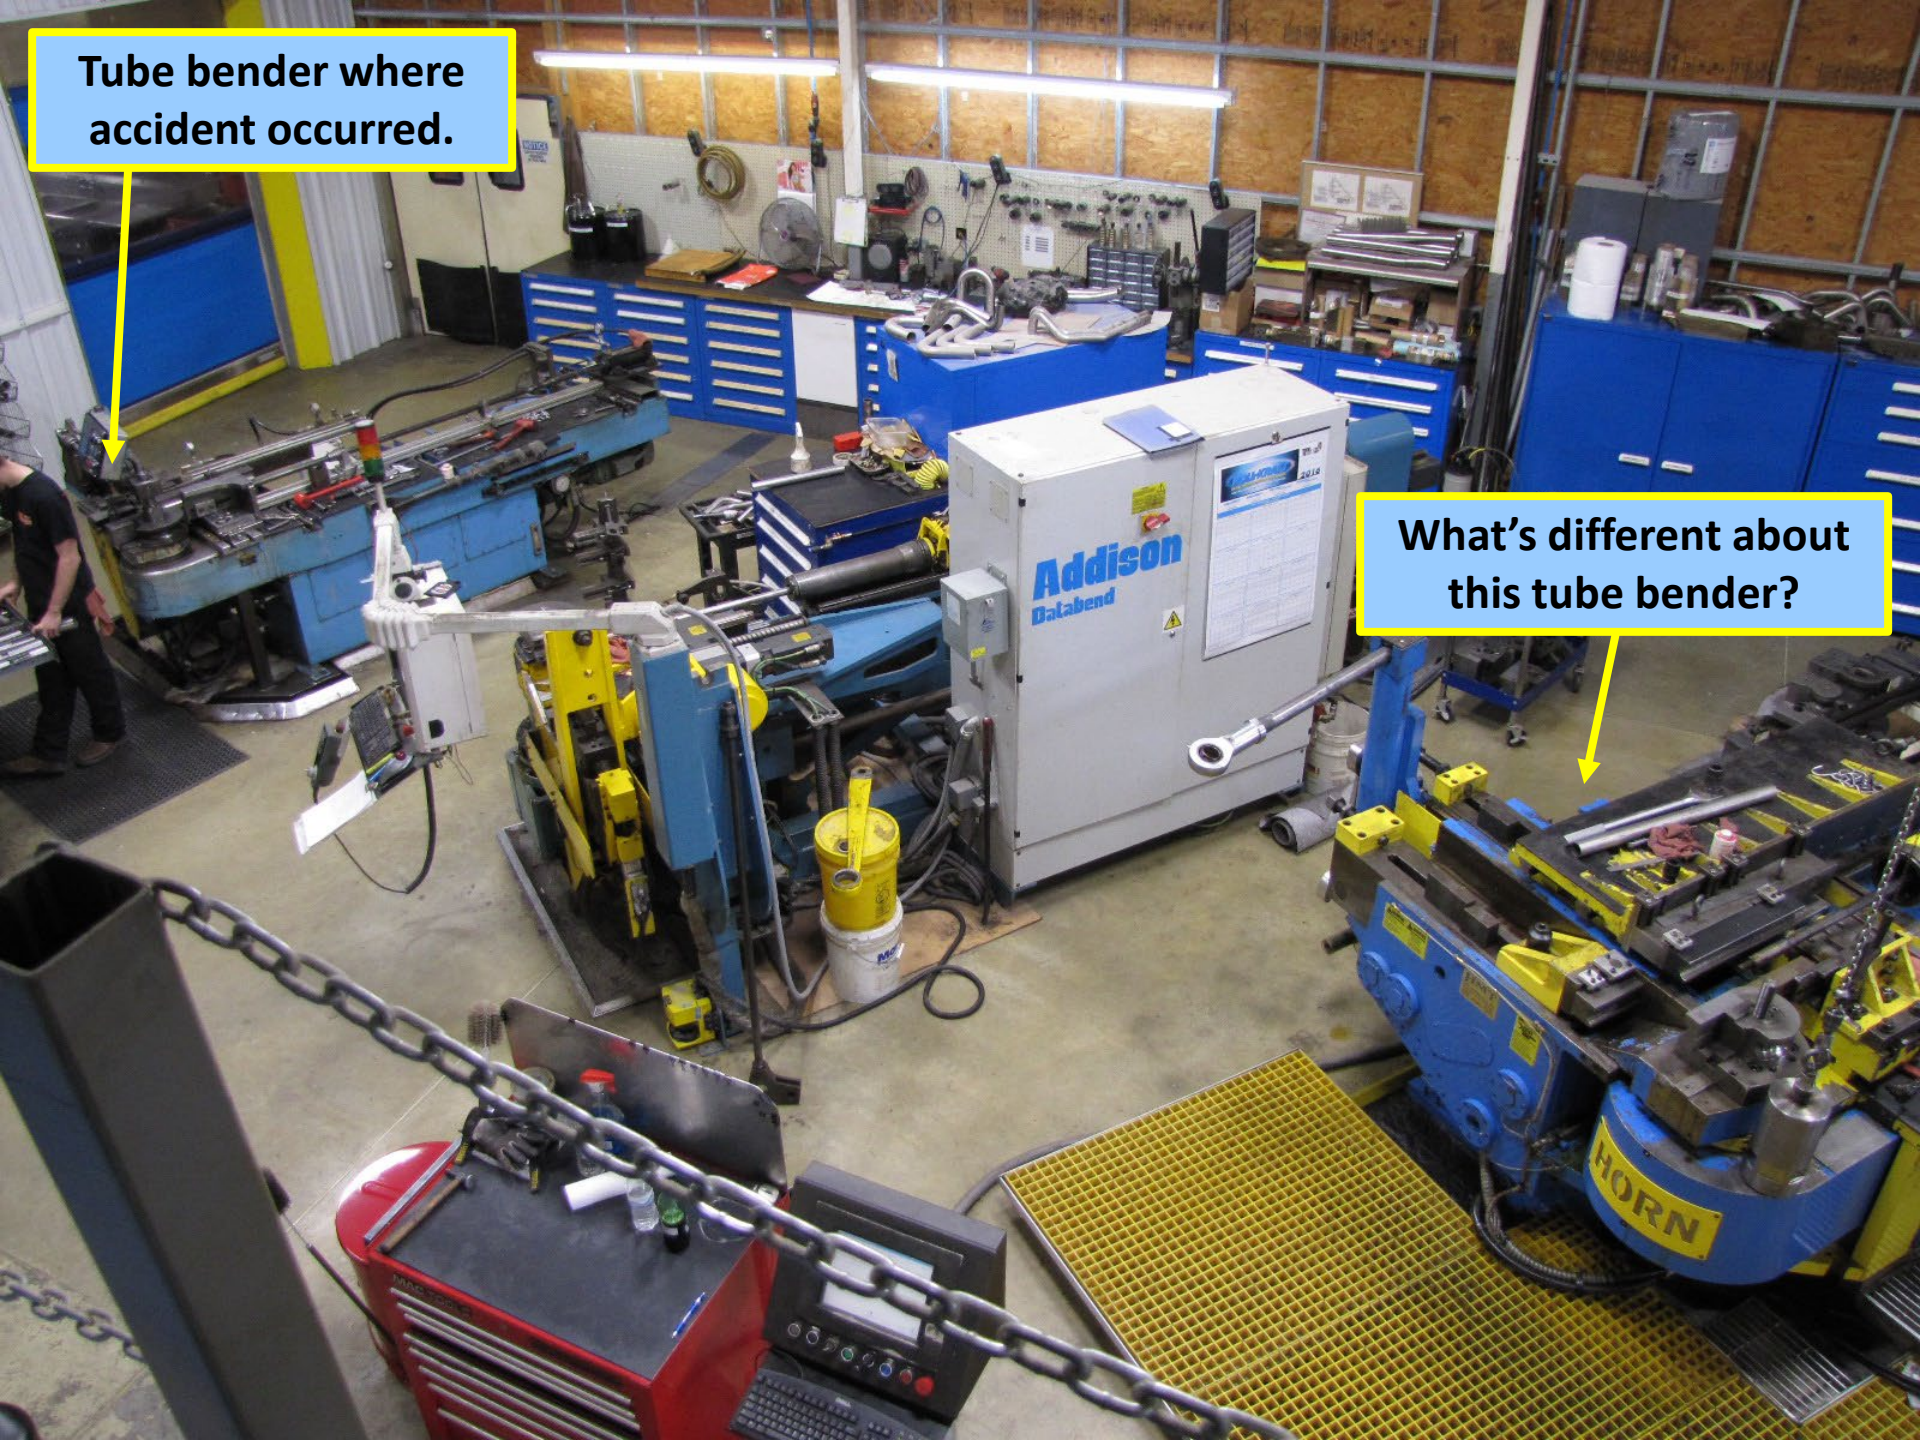
**Tube bender where  
accident occurred.**

a) facility, tube bending area, Clark Lewis hydraulic tube bender, model # CL300, serial # 0062 - where guarding methods were not provided to prevent employee exposure to caught-between hazards. On or about March 3, 2016, an employee was holding a steel tube against the pressure die in preparation for bending when the bend cycle suddenly started. The employee's right index, middle and ring fingers were caught-between the tube and clamp die resulting in amputations of each finger at the first joint.

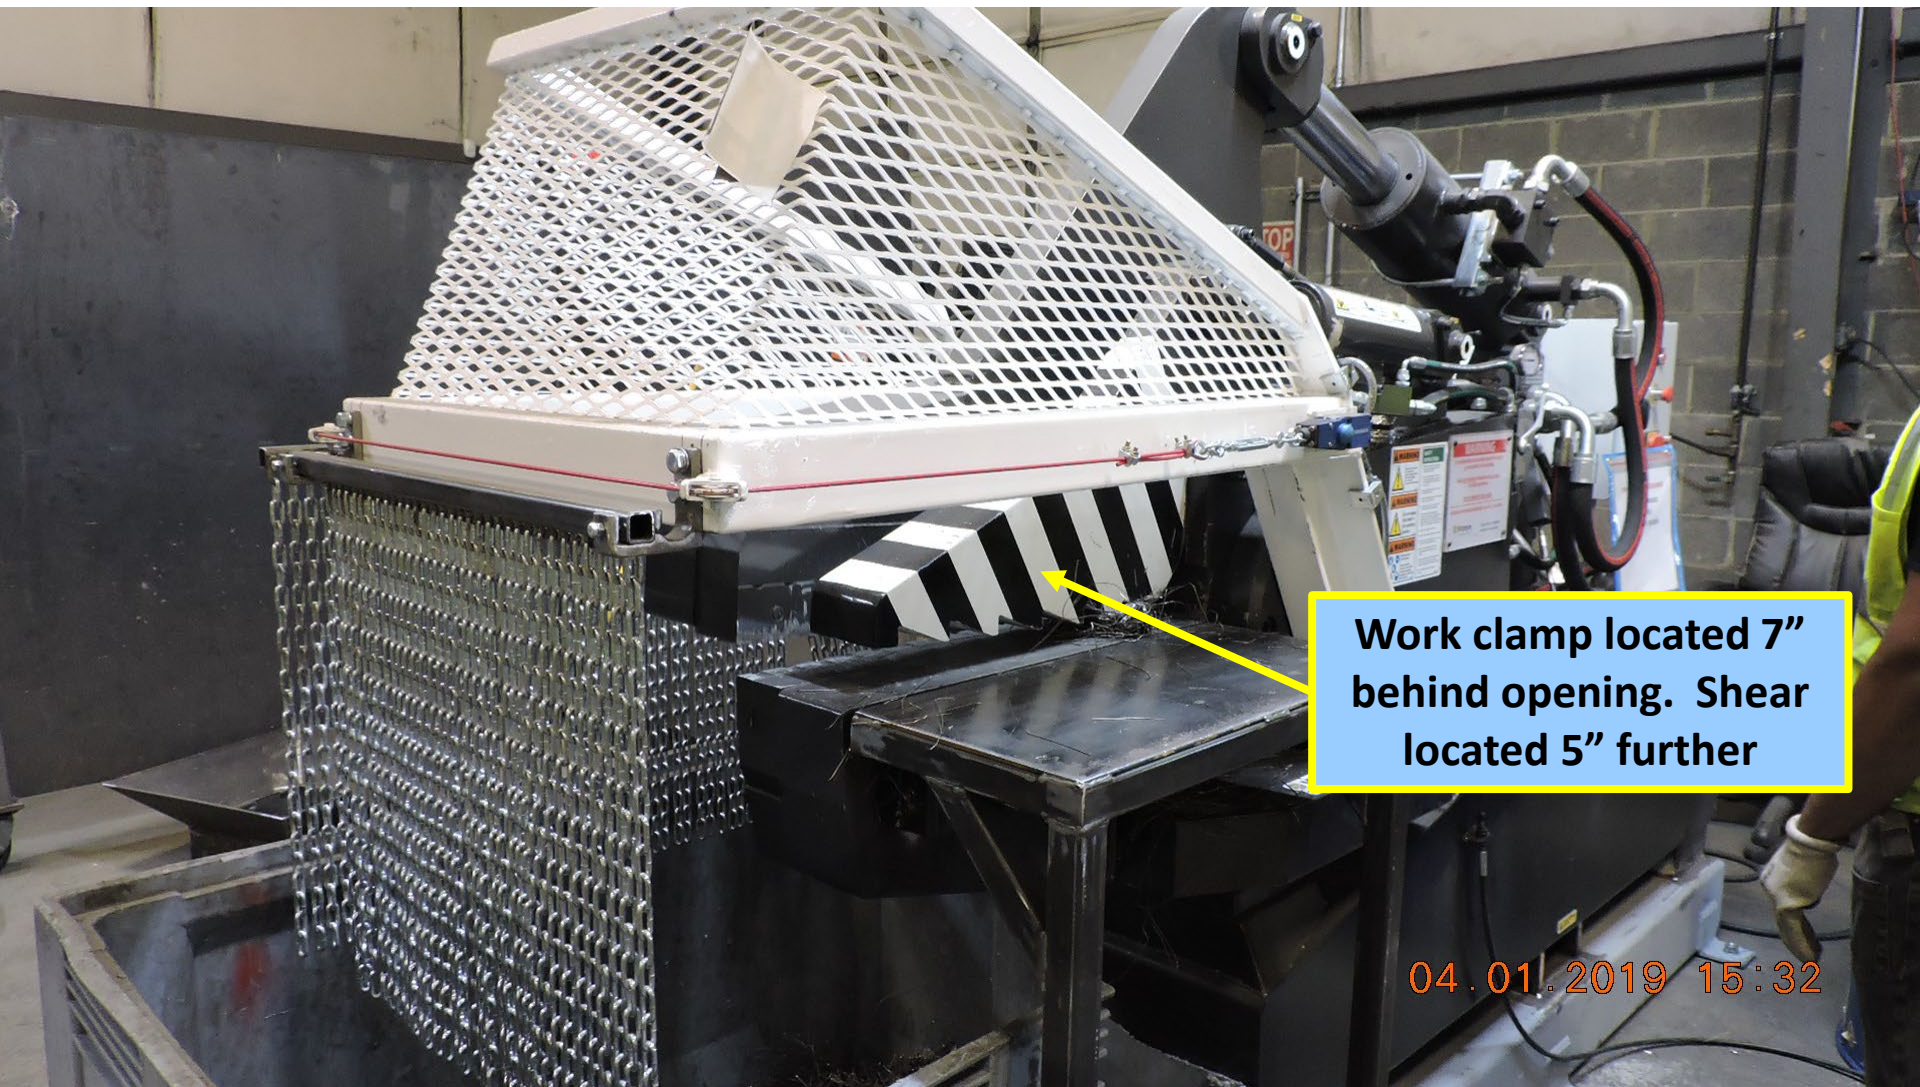
**8" x 30"  
Fixed Opening**
