PRODUCT NOTICE — SNAPHOOKS

Capital Safety is aware of an assembly issue with snaphooks manufactured by a supplier. These snaphooks are widely used components in fall protection products. The issue concerns missing or improperly installed rivets (see photograph below). The manufacturer symbol is a stamped "Y" as shown in the photograph.

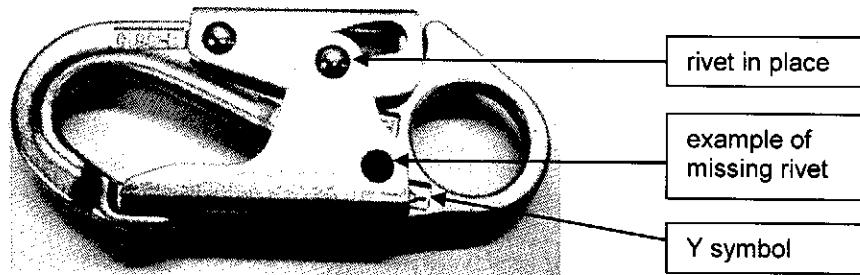
The picture above is a representative model snaphook – other models are also affected.

Capital Safety has verified that the supplier implemented an appropriate corrective action program. The supplier's notification (above) has an imbedded video demonstration of its revised process.

We want to remind users to conduct a pre-use inspection of all fall protection safety equipment prior to use as per instructions in the user manuals. If a missing or incompletely installed rivet is identified in a snaphook on a Capital Safety product, the product should be removed from service and returned via distribution for replacement under warranty. (See figure 1 & 2 below.)
