US Transmission Safety Information Notification

1/5/10

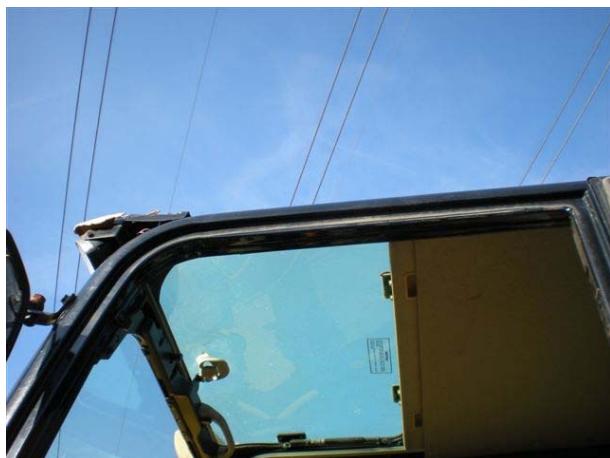
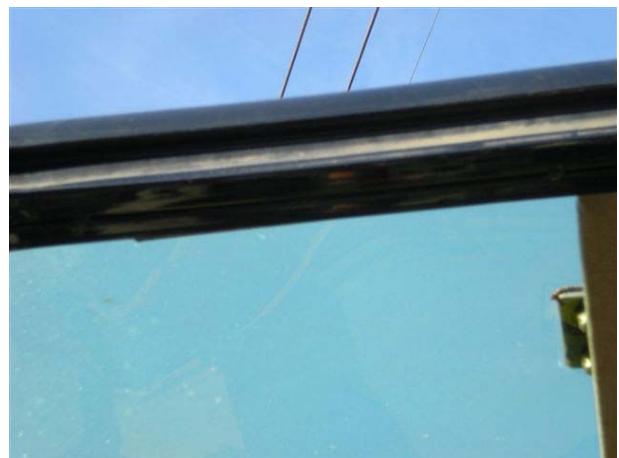
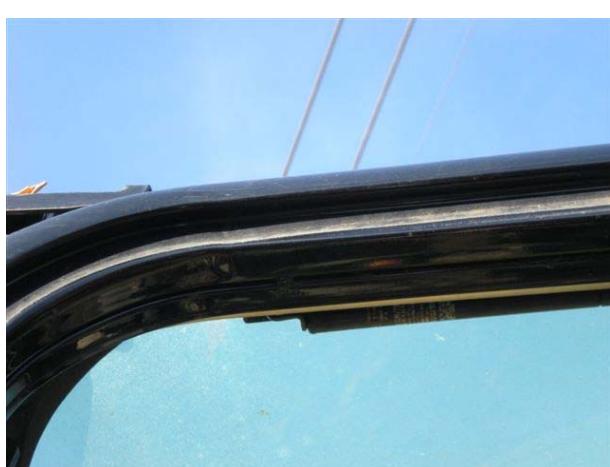
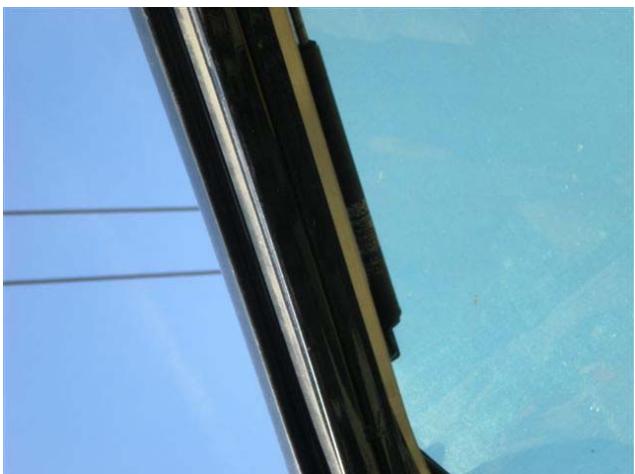
This hazardous condition was observed in the field as a National Grid Transmission line crew was using a crane with a glass sun roof to allow better viewing of the load. As you can see by the pictures below, the overhead Transmission lines are not viewable through the glass. This optical illusion poses a significant risk to the operator and those working with the crane as the minimum approach distance may be violated.

This is the first time this has been observed with our National Grid owned equipment or equipment that we have rented. This safety alert is intended to make our workers aware of this possible hazard of glass sun roofs. This should be discussed during the job brief and if this condition exists, the glass should be removed if possible or additional spotters used when approaching minimum approach clearances.
