NC DOL INDUSTRY ALERT

Tilt-Up Wall Construction Can Be Deadly

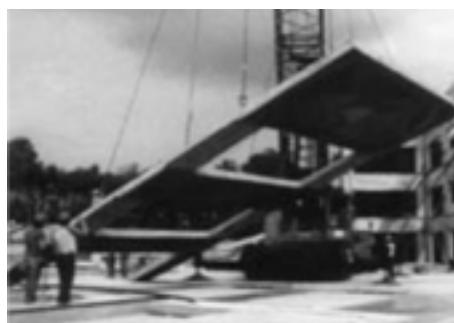
Contractors at the Home Depot site were largely unaware of tilt-up construction requirements.

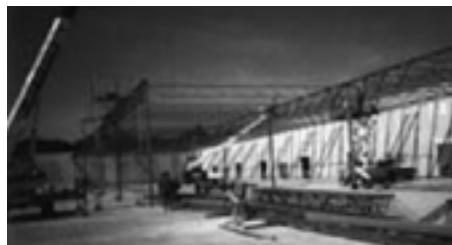
Workers having lunch by the wall did not know the 40,000-pound panel was free standing.
