# Machine Guarding

- *The CSHO's Guide to Answering  
"There's No Way to Guard That"*

**Presented by:** Ted R. Hendrix, CSP

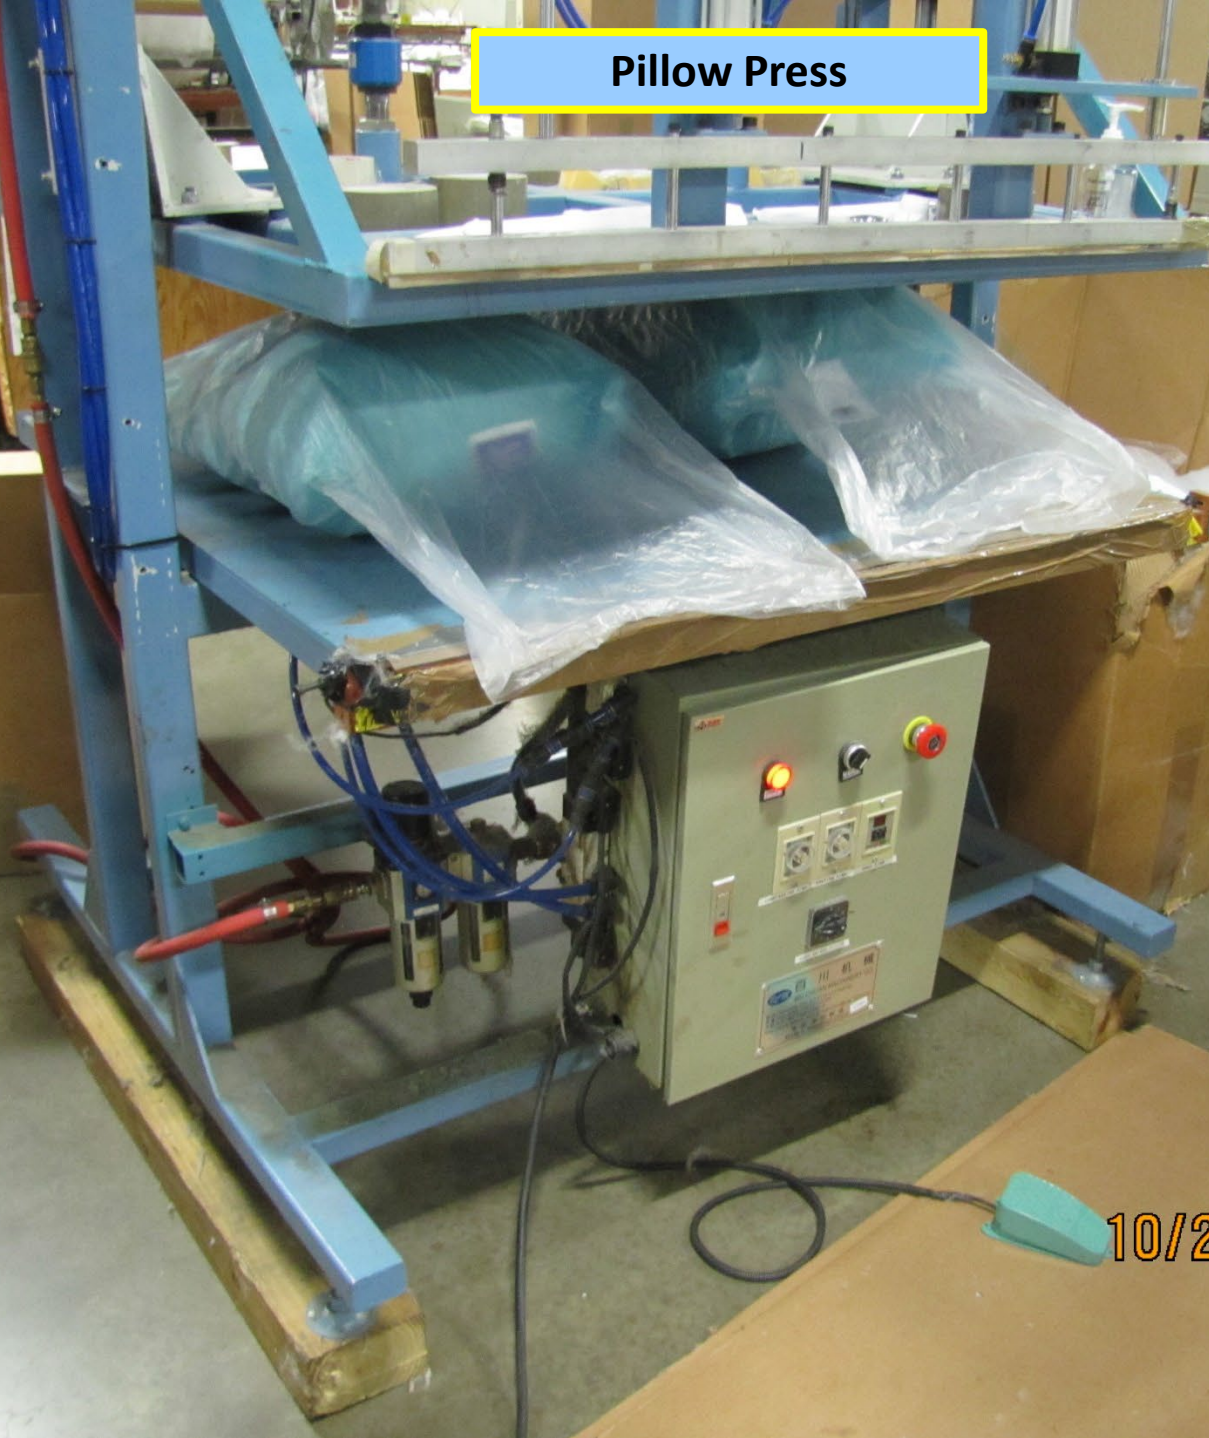
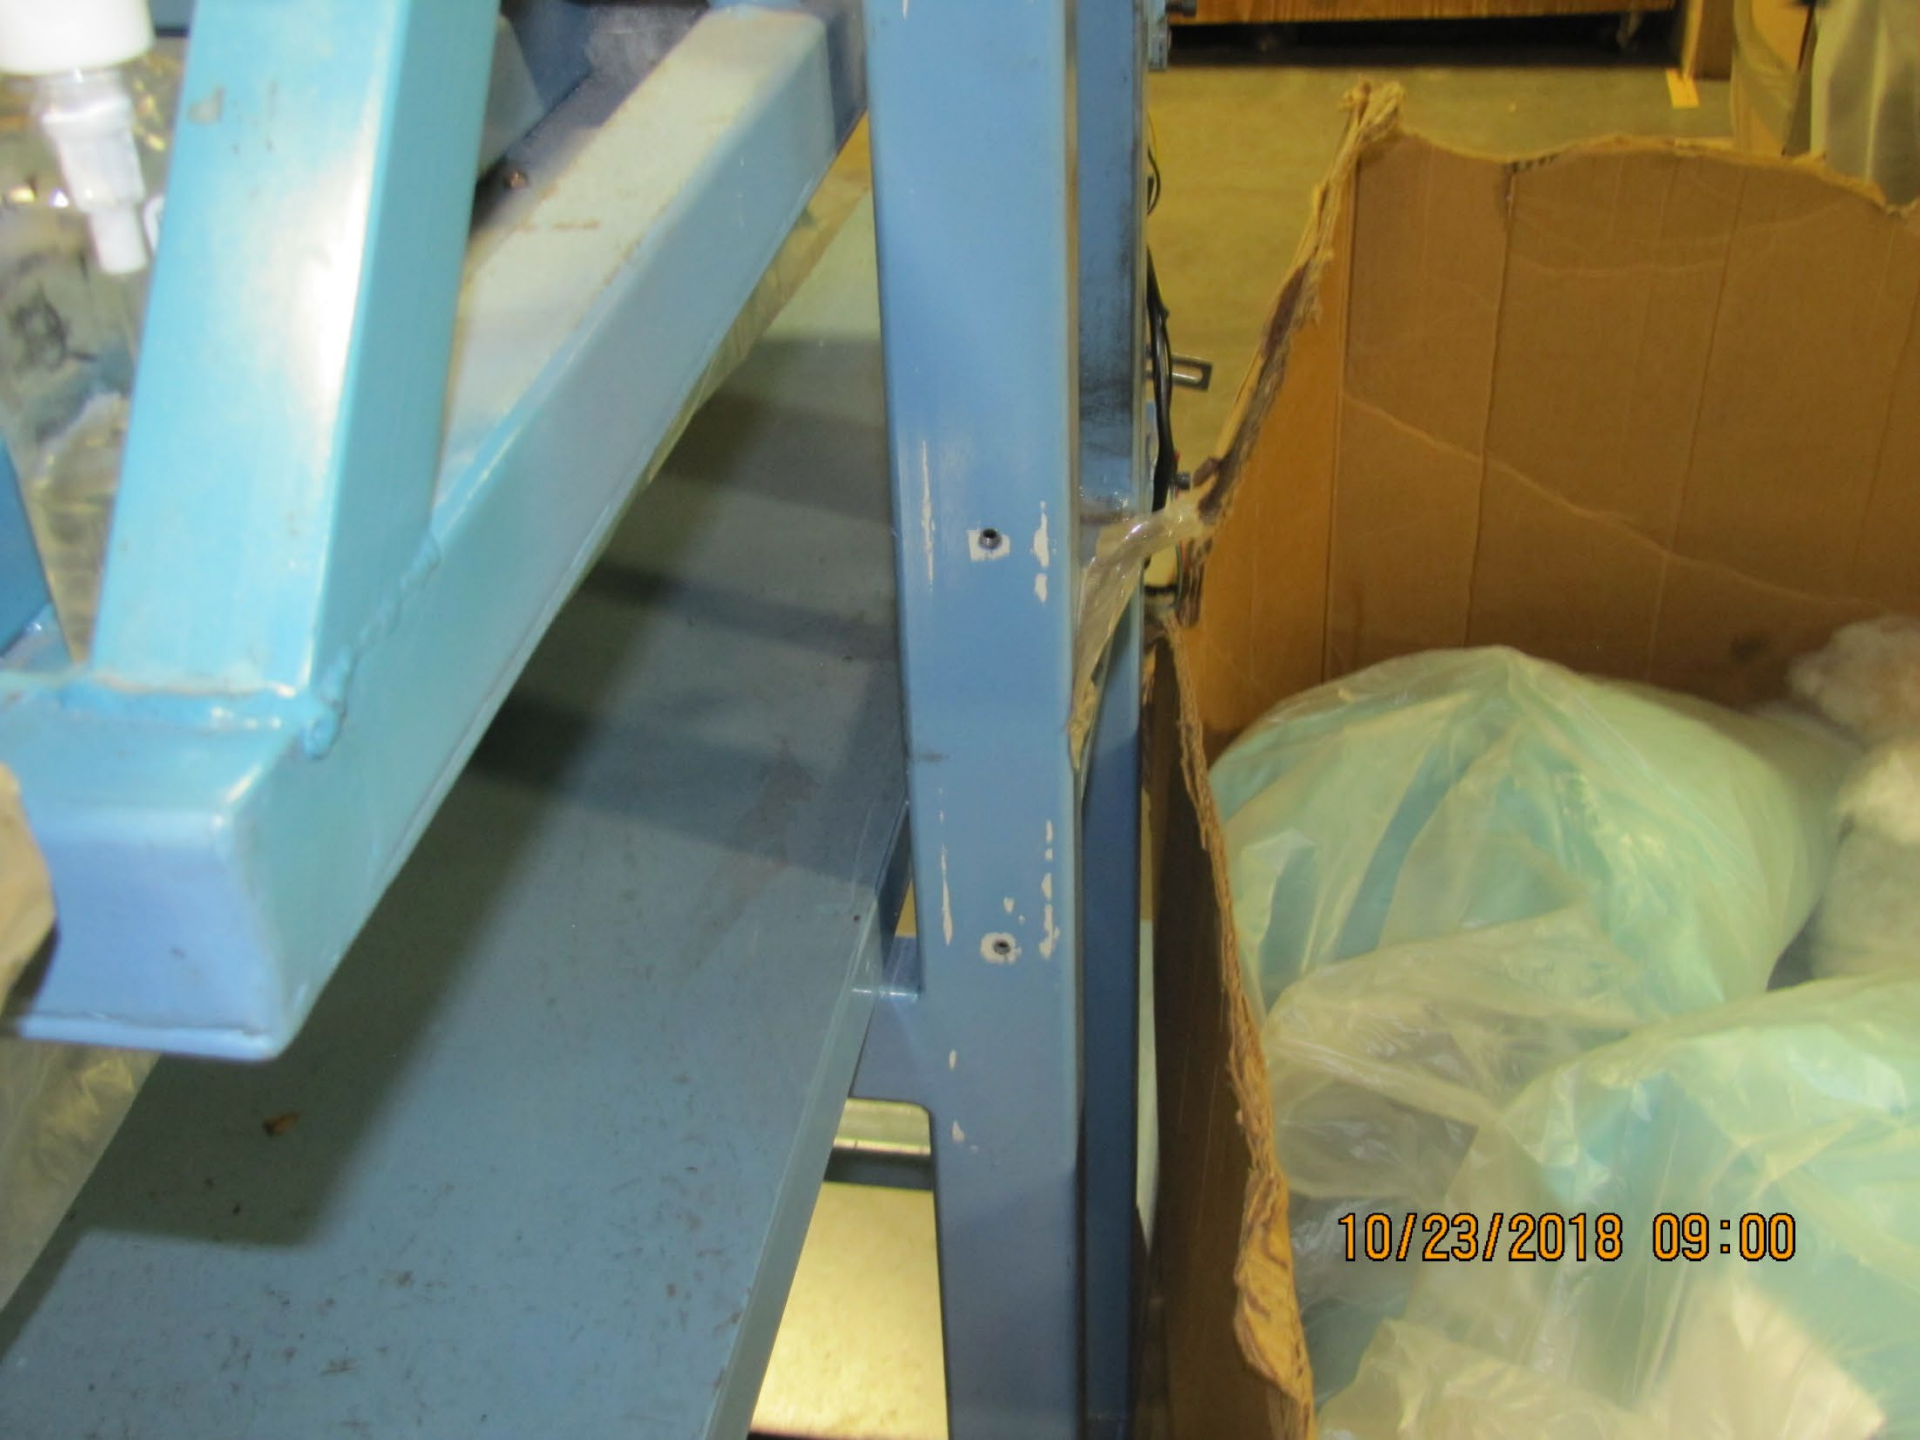
# Pillow Press

a) pillow presses – where the point of operation was not guarded, exposing employees to the hazard of being struck by and/or caught in the press.

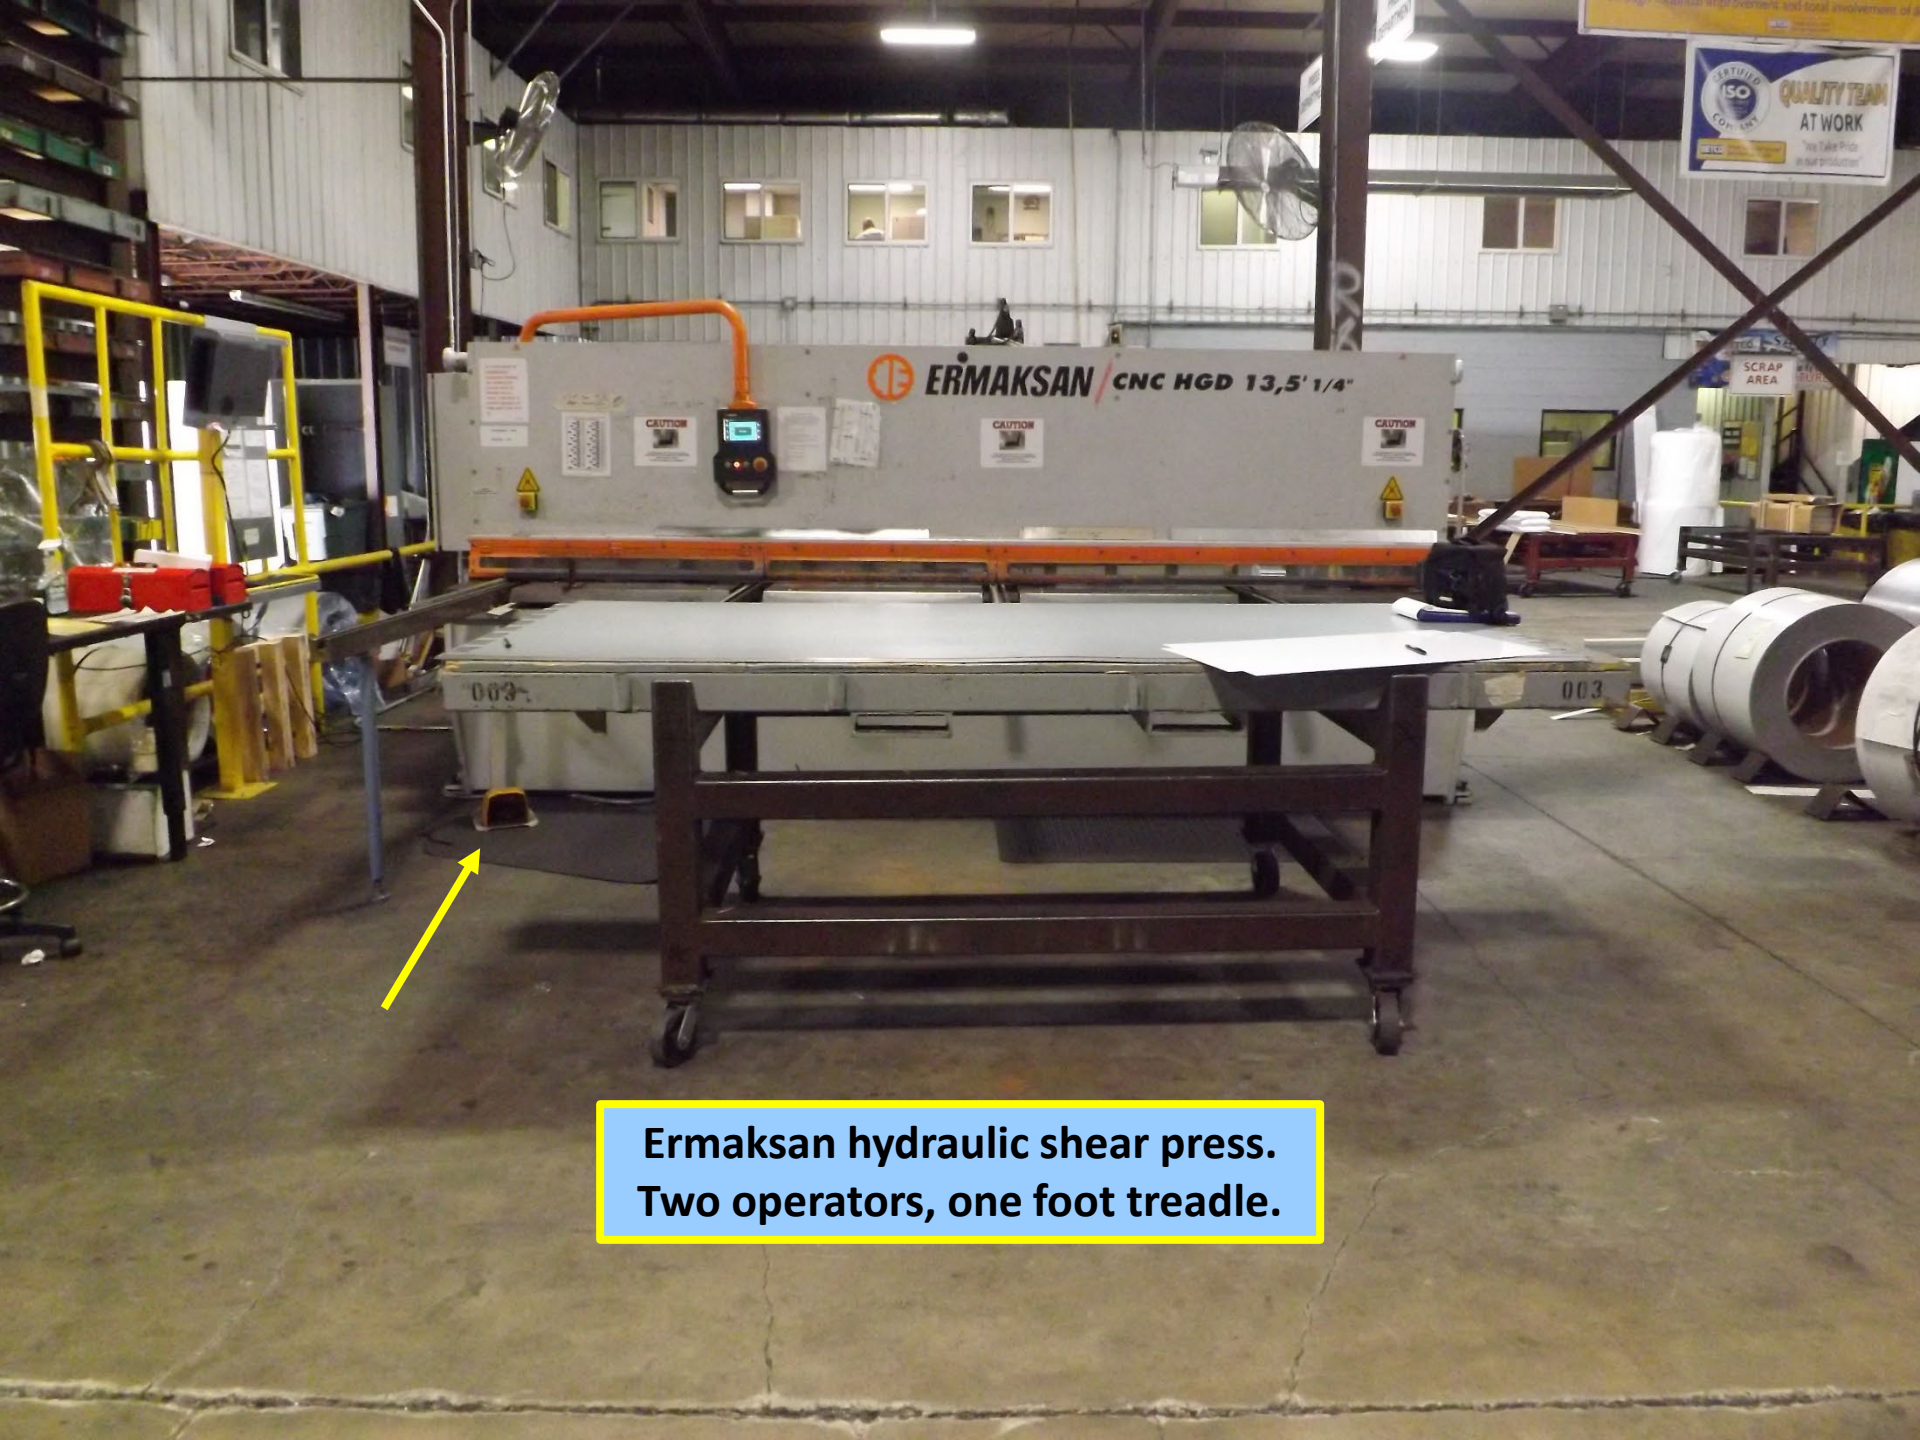
**Ermaksan hydraulic shear press.  
Two operators, one foot treadle.**

**Two-inch gap in guard formerly had a Plexiglas window, which had been missing for several months.**

a) press department - where a two-inch wide section, running the length of the Ermaksan CNC Hydraulic Swing Beam Shear (HGD), of the point of operation guard was missing. On or about 9/20/2018, an employee had portions of two fingers amputated while using the aforementioned shear.

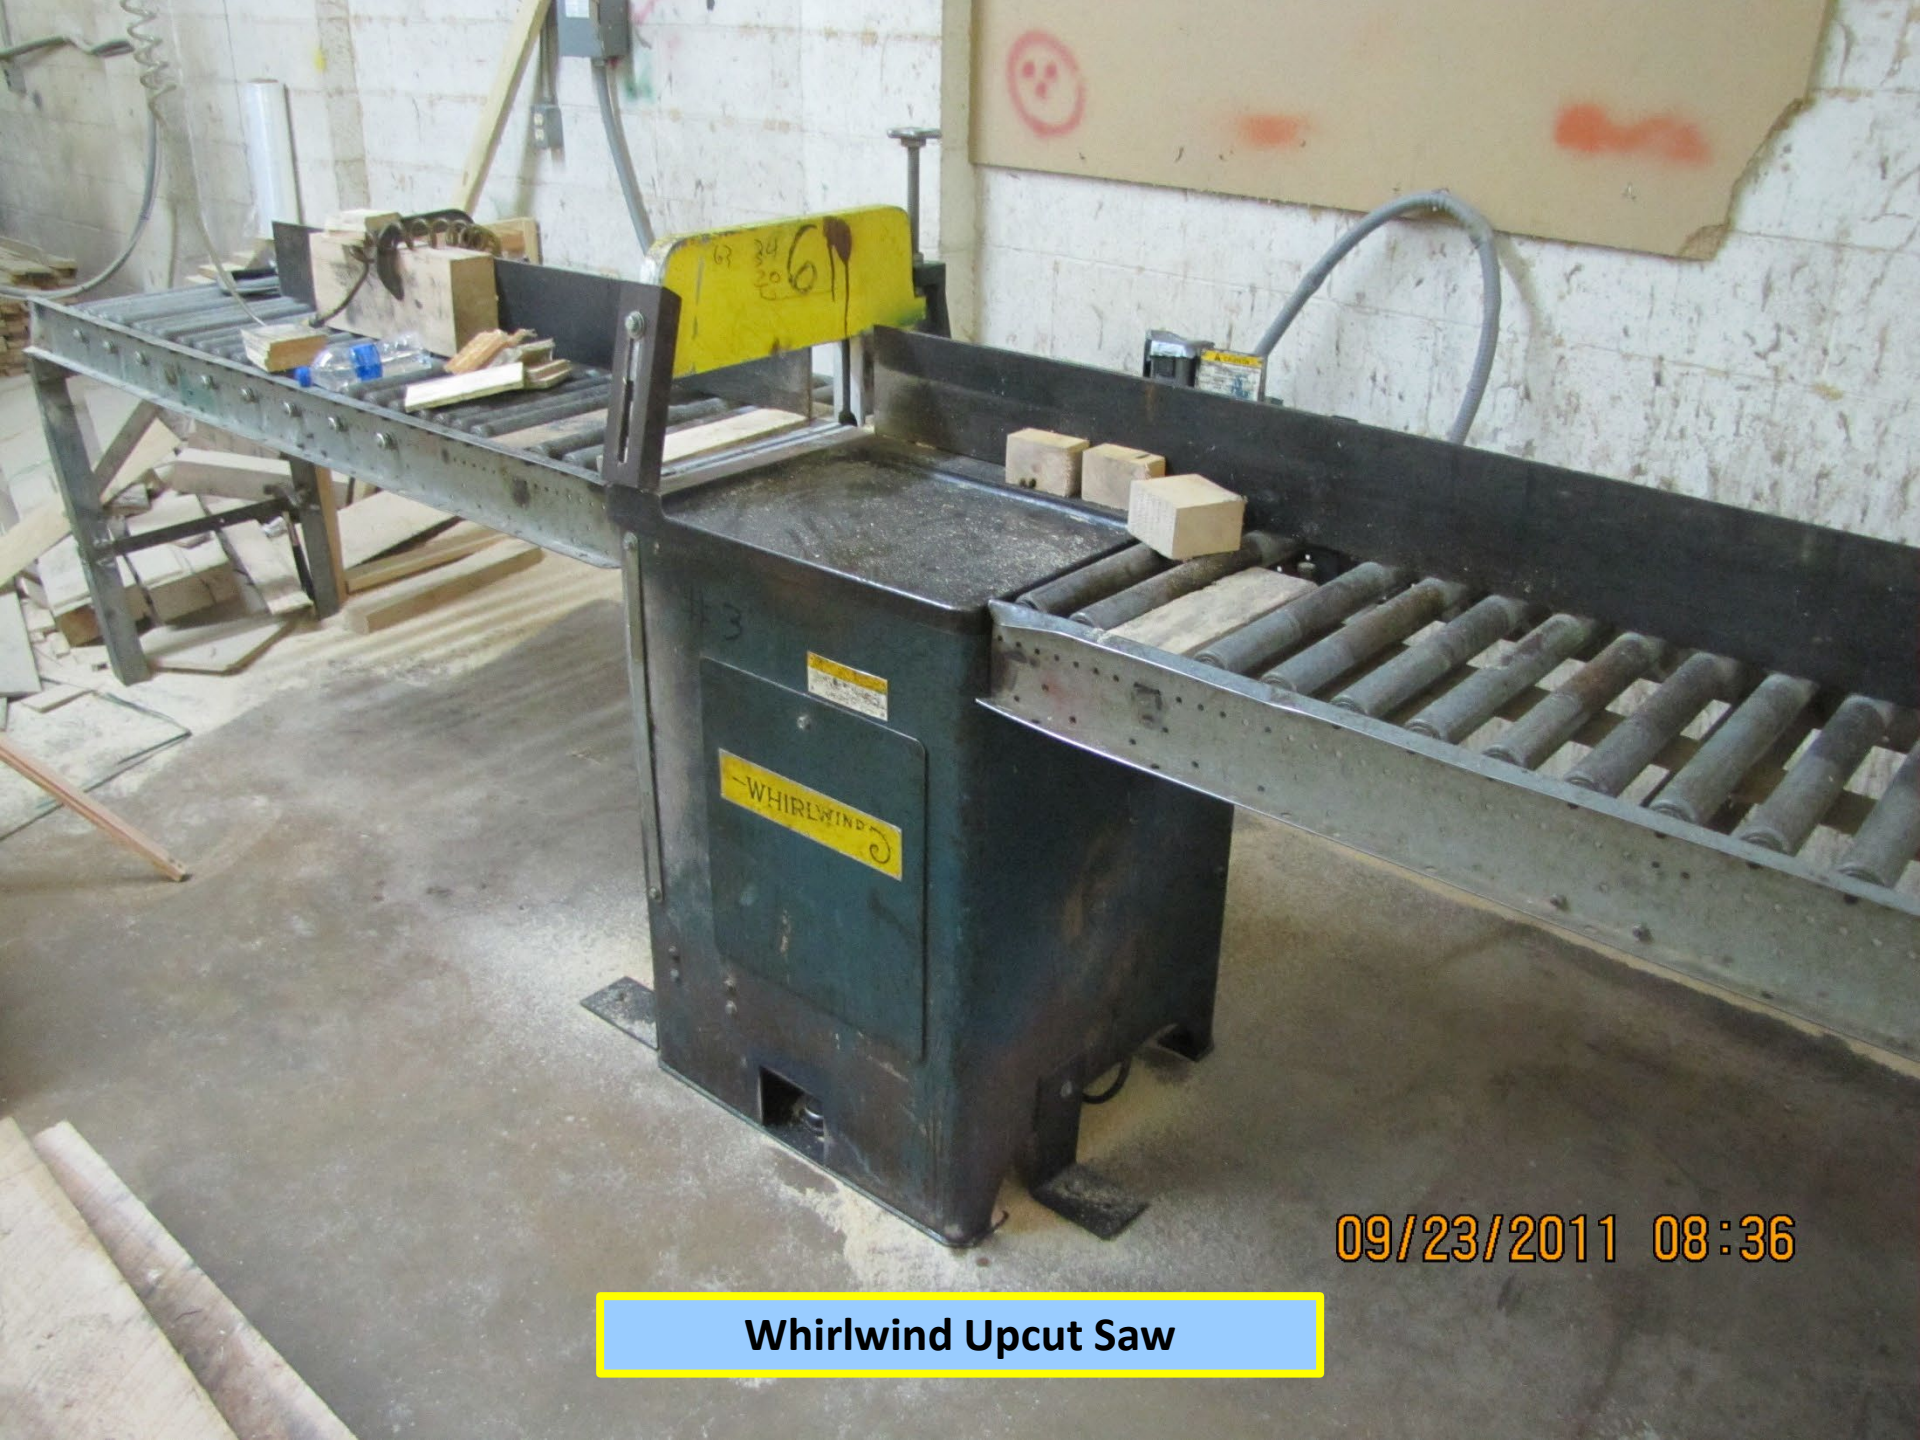
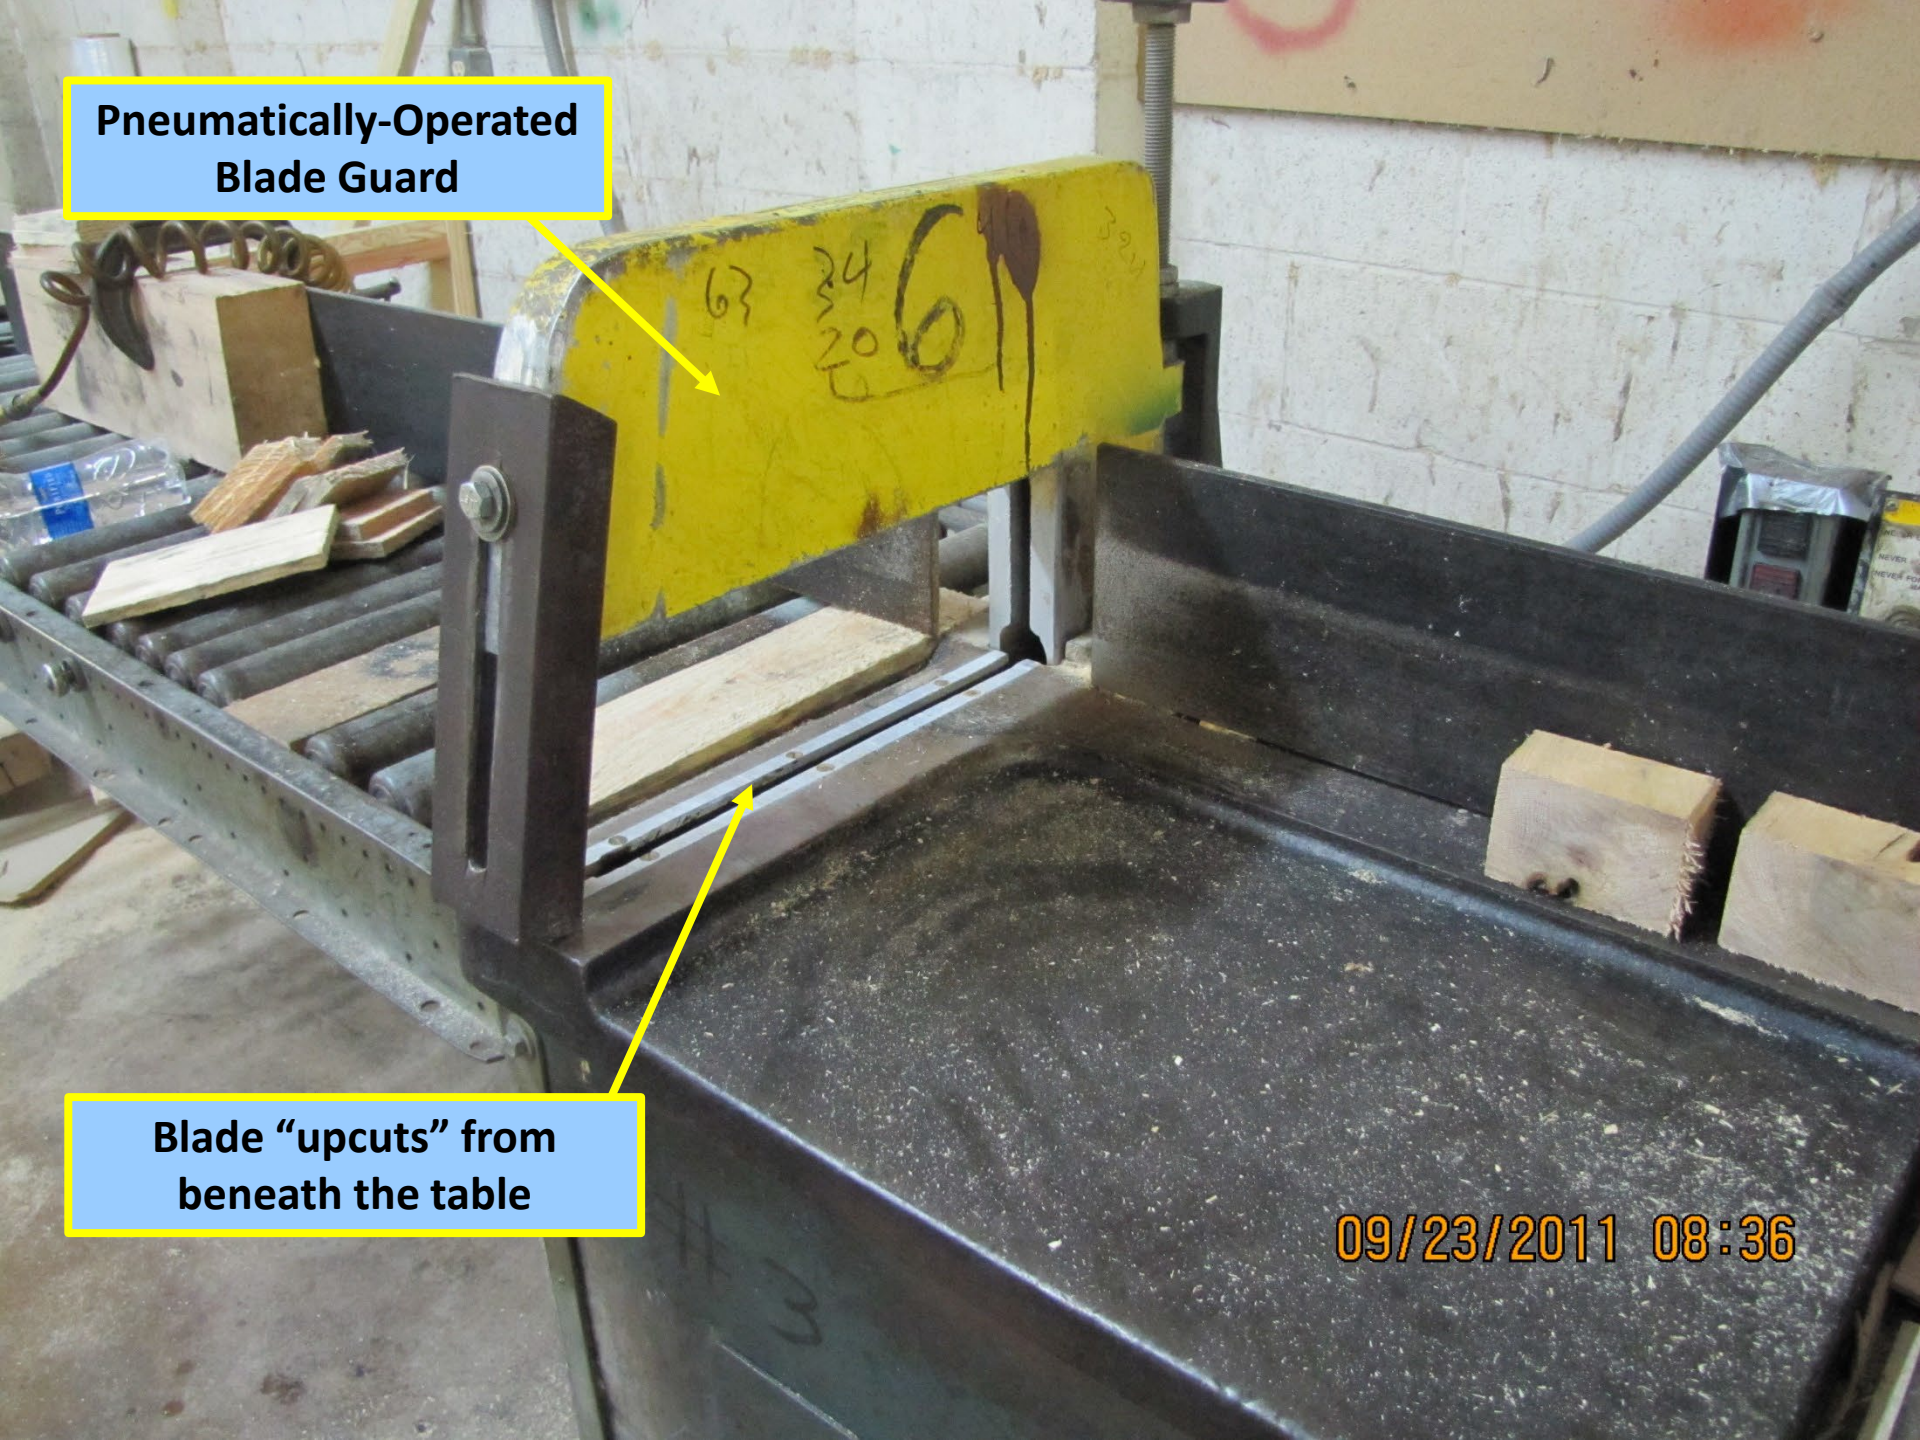
Whirlwind Upcut Saw

**Blade “upcuts” from  
beneath the table**

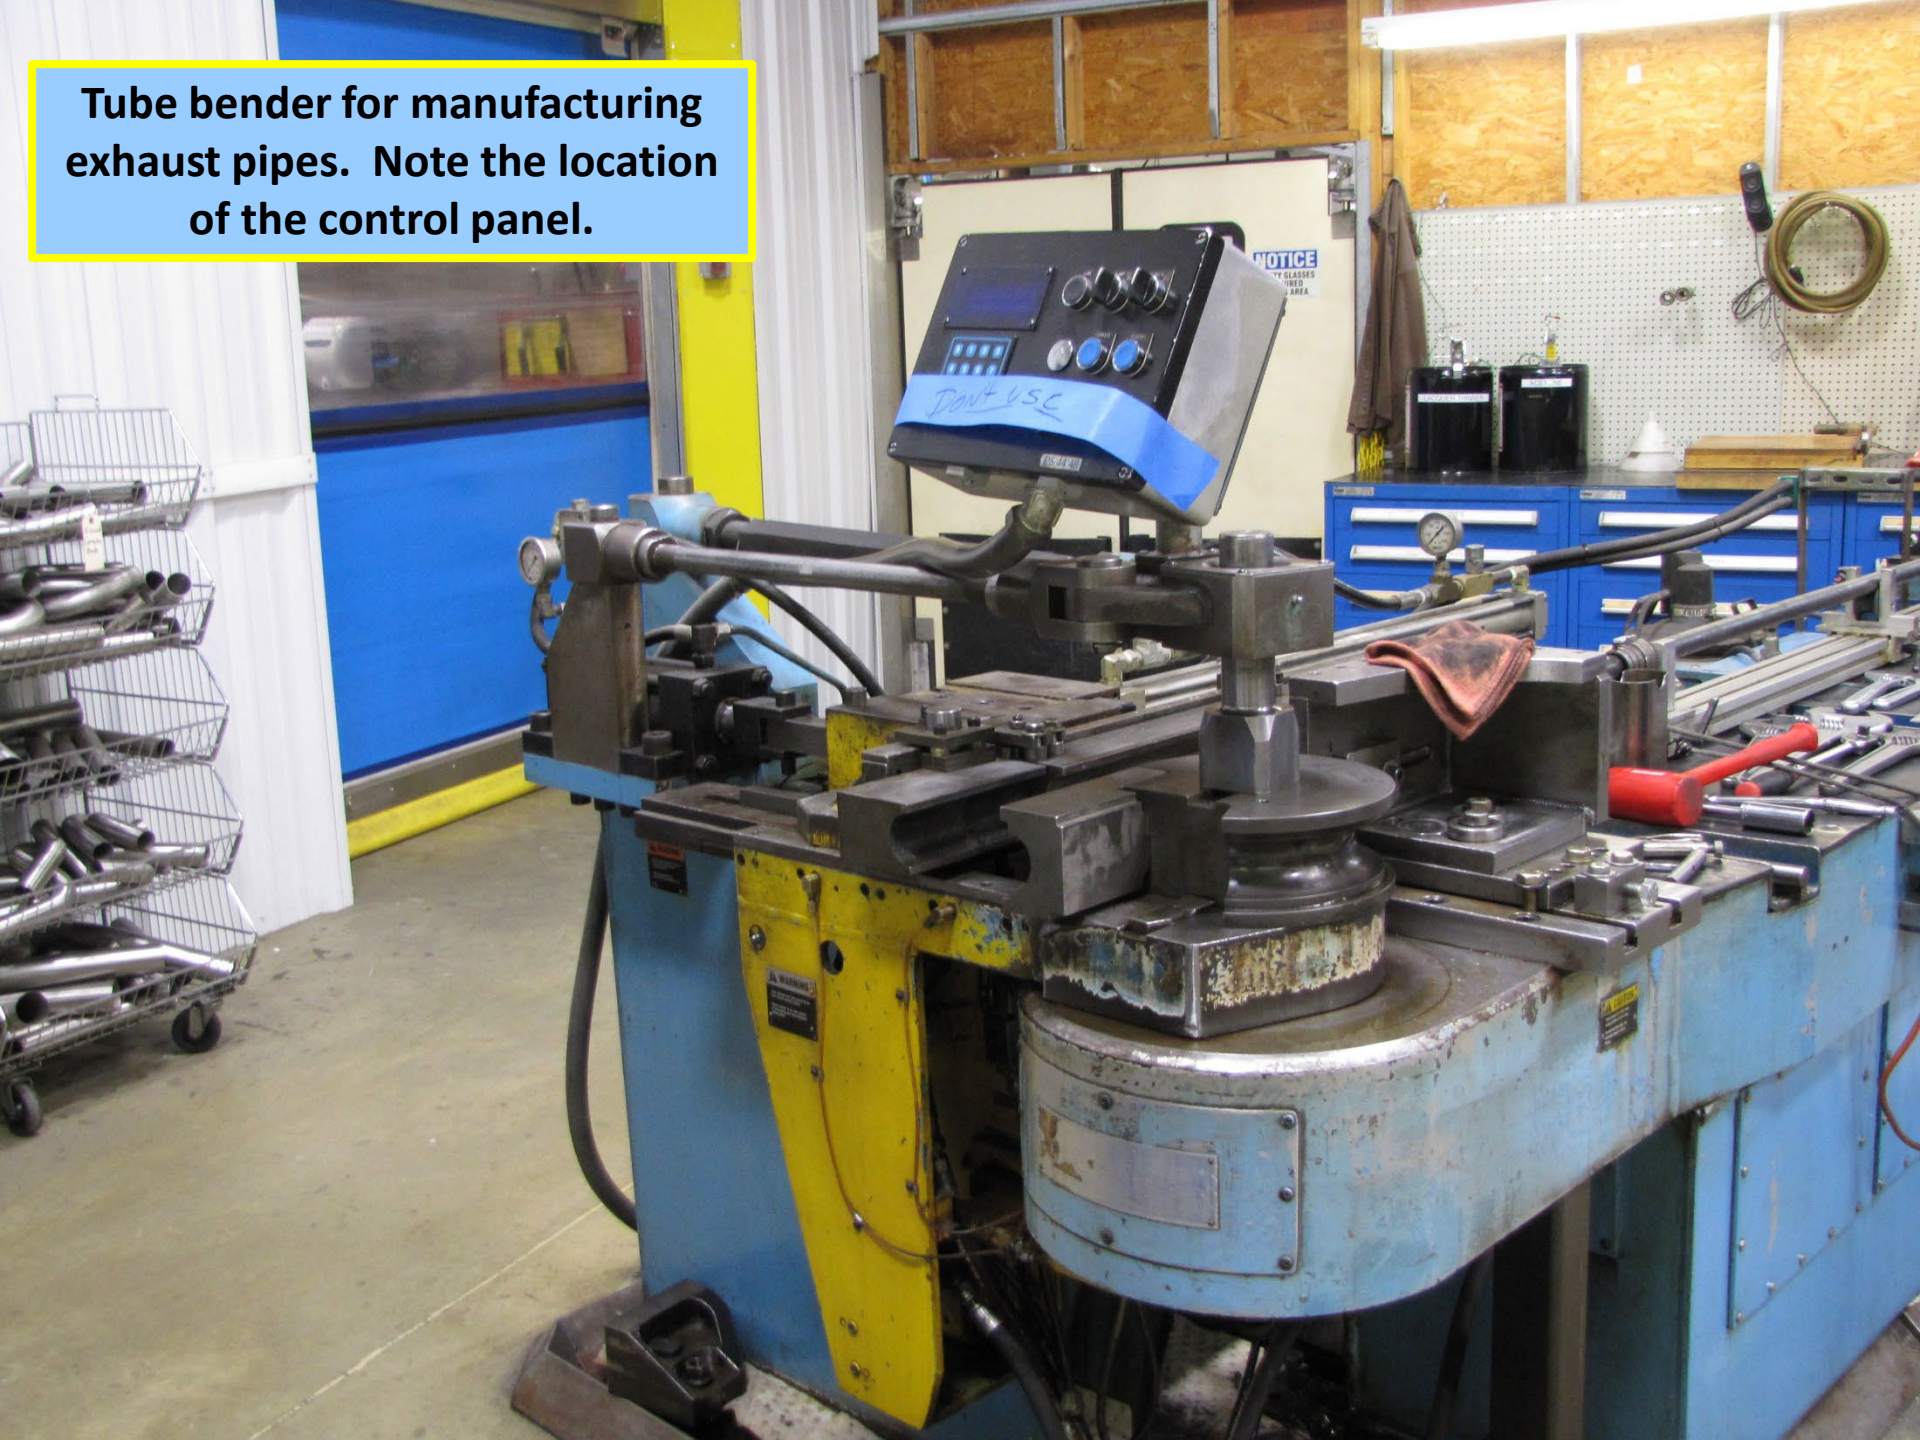
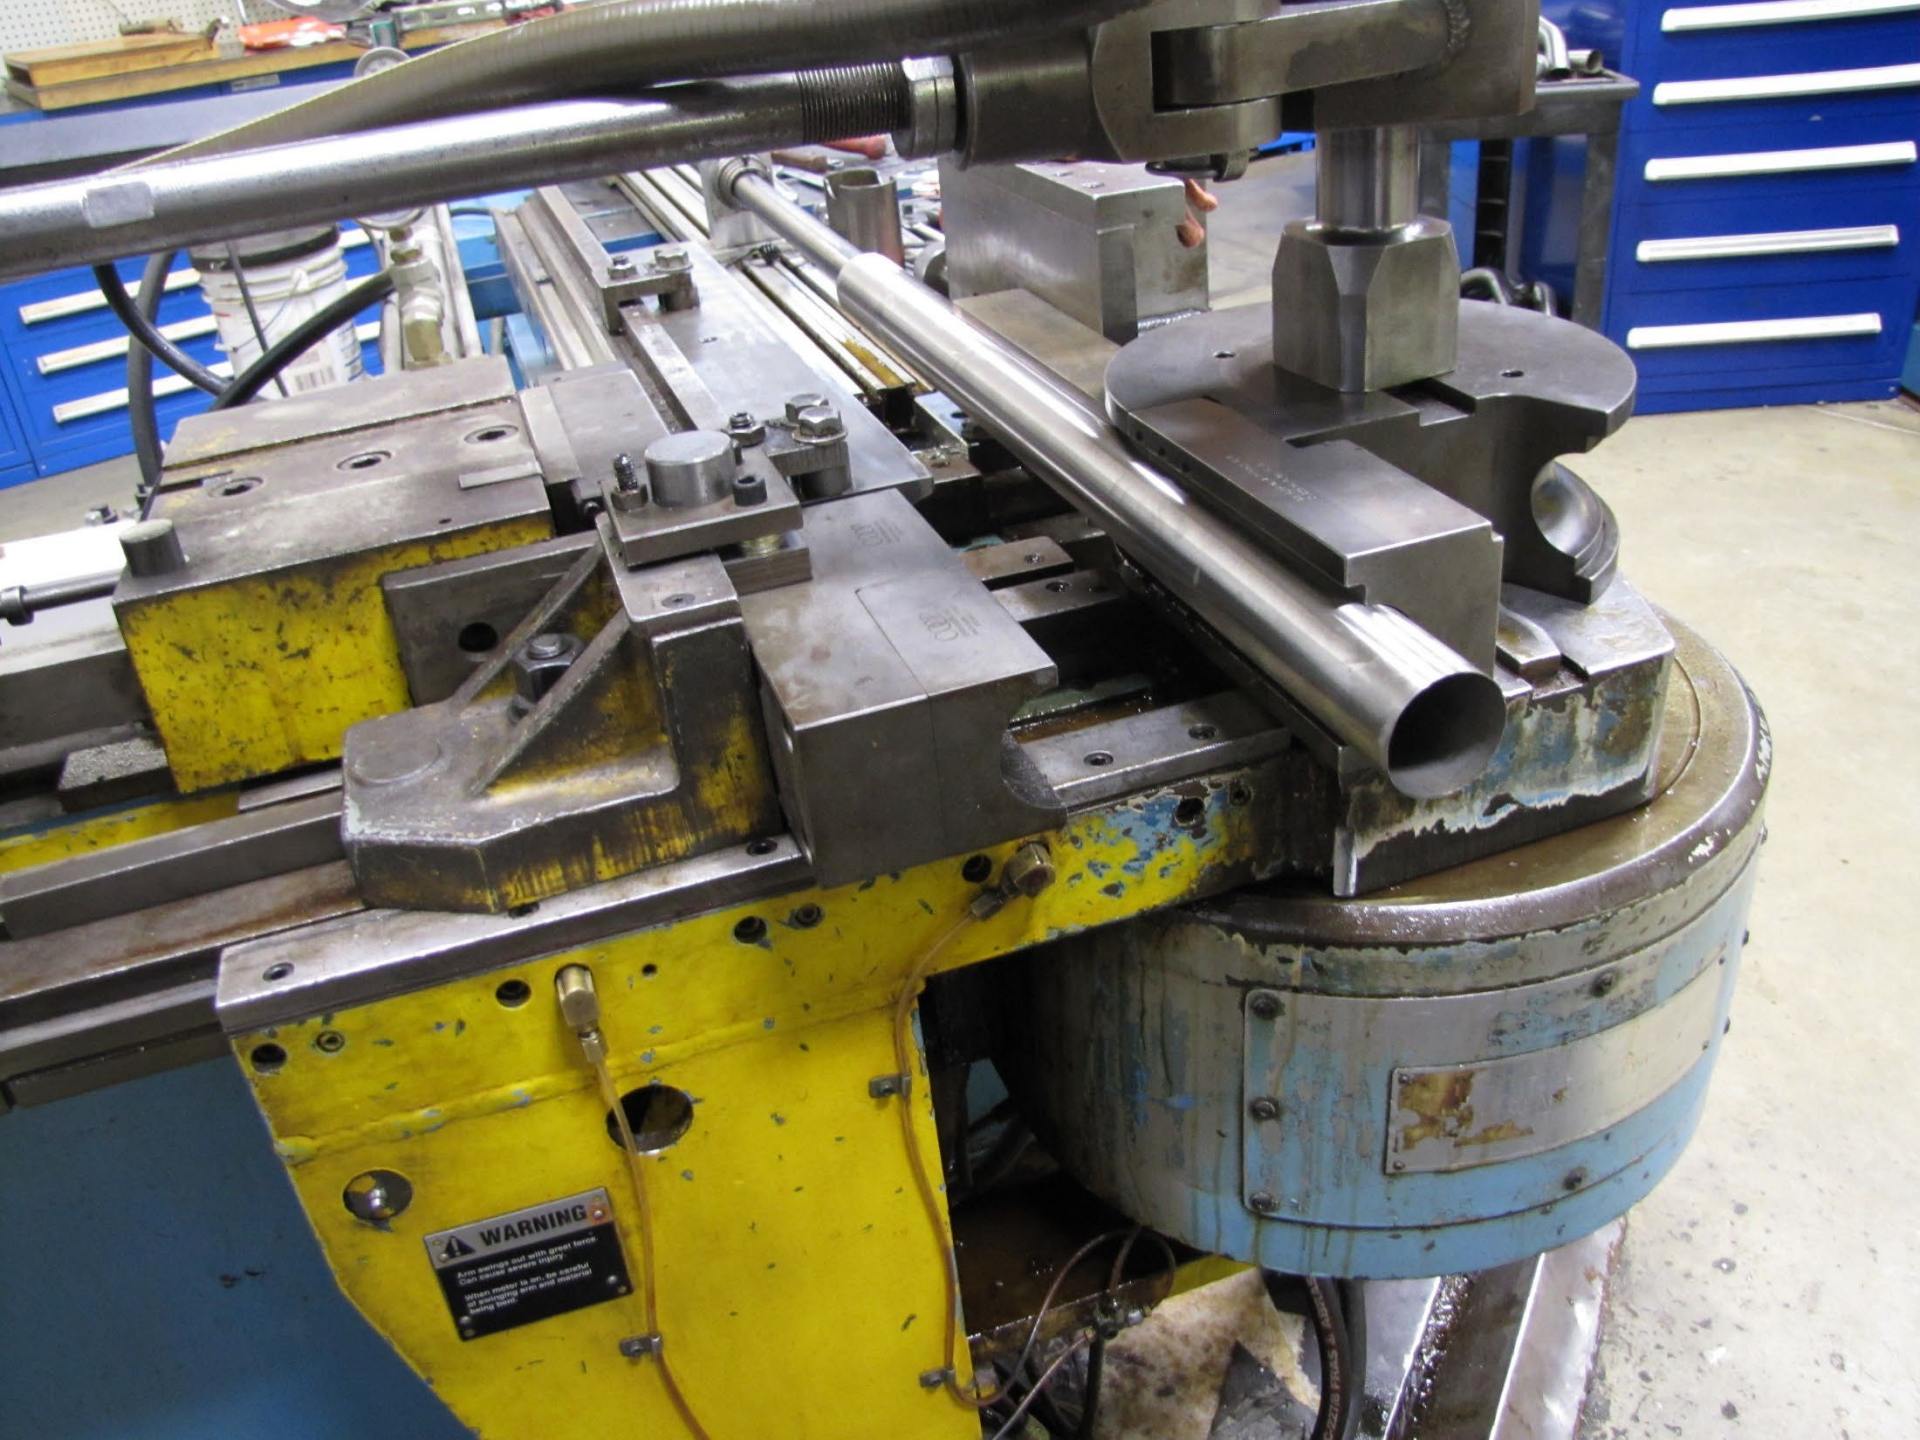
**Tube bender for manufacturing exhaust pipes. Note the location of the control panel.**

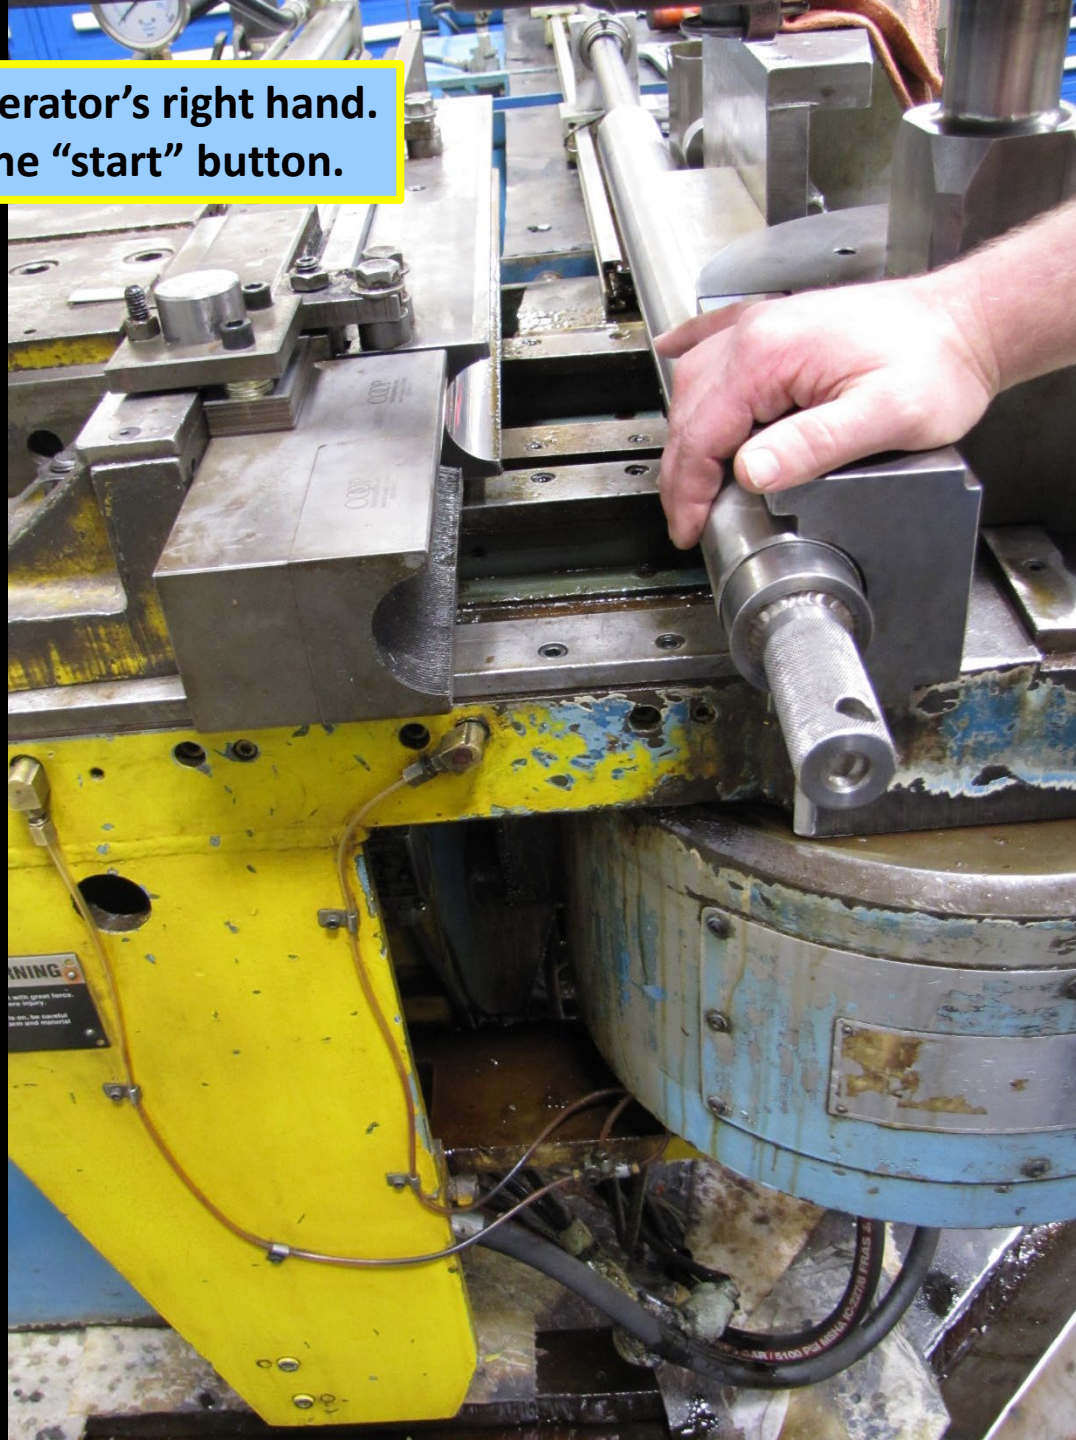
**Location of the operator's right hand.  
Left hand is on the "start" button.**

**Tube bender where  
accident occurred.**

a) facility, tube bending area, Clark Lewis hydraulic tube bender, model # CL300, serial # 0062 - where guarding methods were not provided to prevent employee exposure to caught-between hazards. On or about March 3, 2016, an employee was holding a steel tube against the pressure die in preparation for bending when the bend cycle suddenly started. The employee's right index, middle and ring fingers were caught-between the tube and clamp die resulting in amputations of each finger at the first joint.
