# Machine Guarding

- *The CSHO's Guide to Answering  
"There's No Way to Guard That"*

**Presented by:** Ted R. Hendrix, CSP

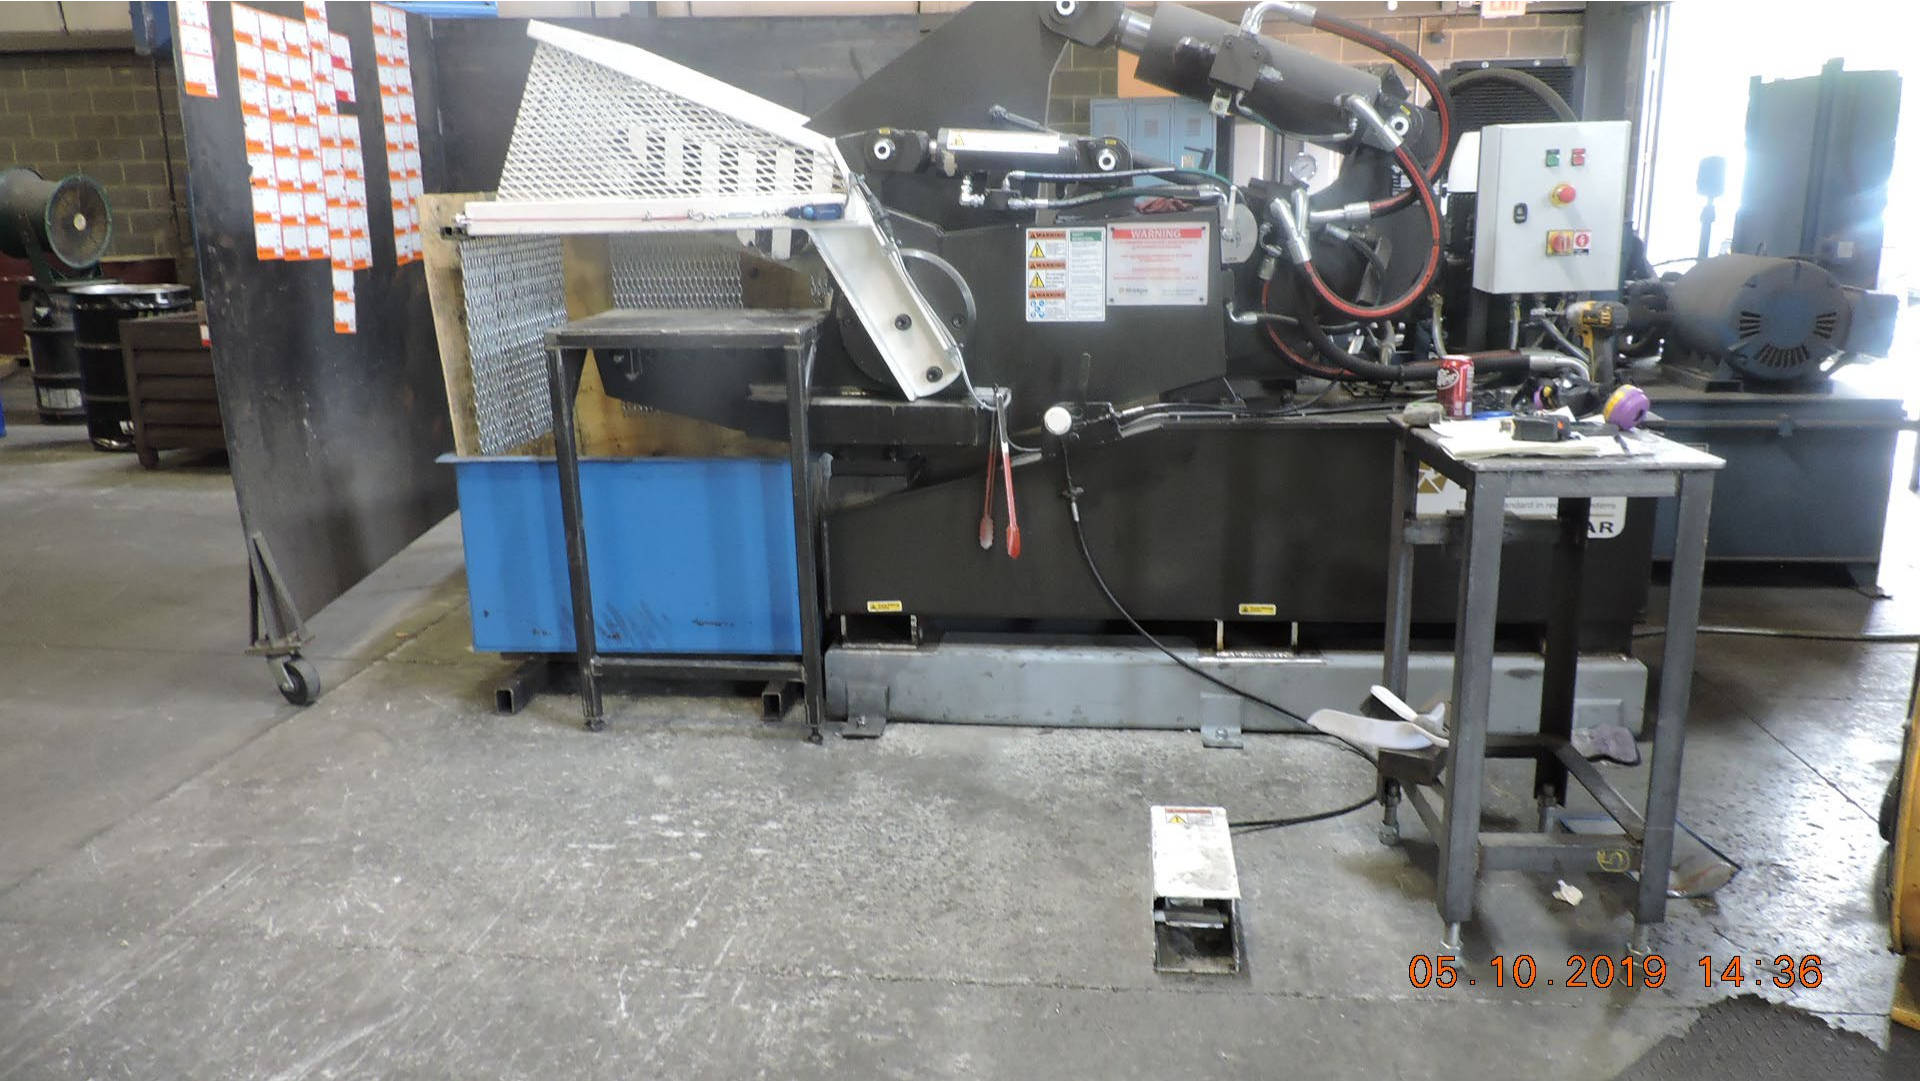
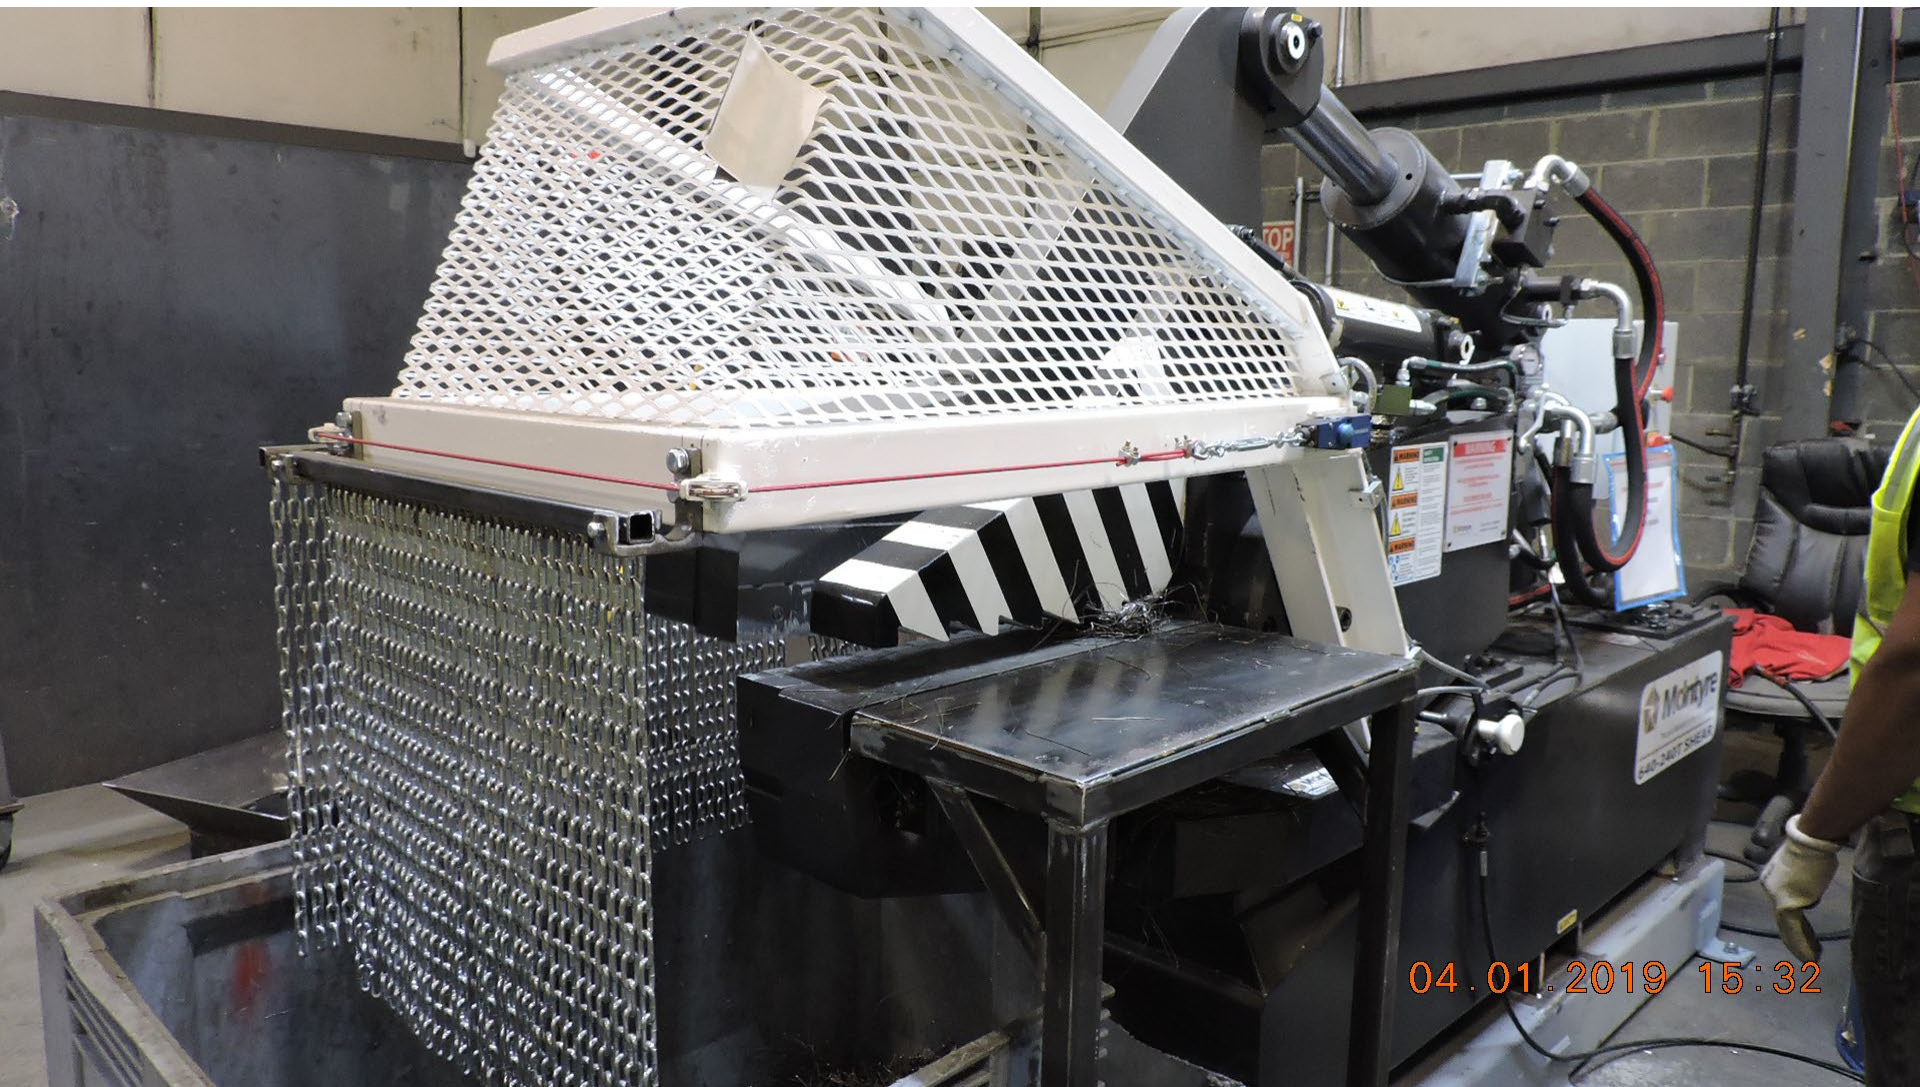
# Alligator Shear

a) facility - where one or more methods of machine guarding was not provided to protect employees from the hazard created by the point of operation of the McIntyre Alligator Shear (model 640-240T, Serial# 449, 10HP, 440V). On or about March 30, 2019, an employee sustained amputations to his left middle and index fingers due to contacting the shear's blade.

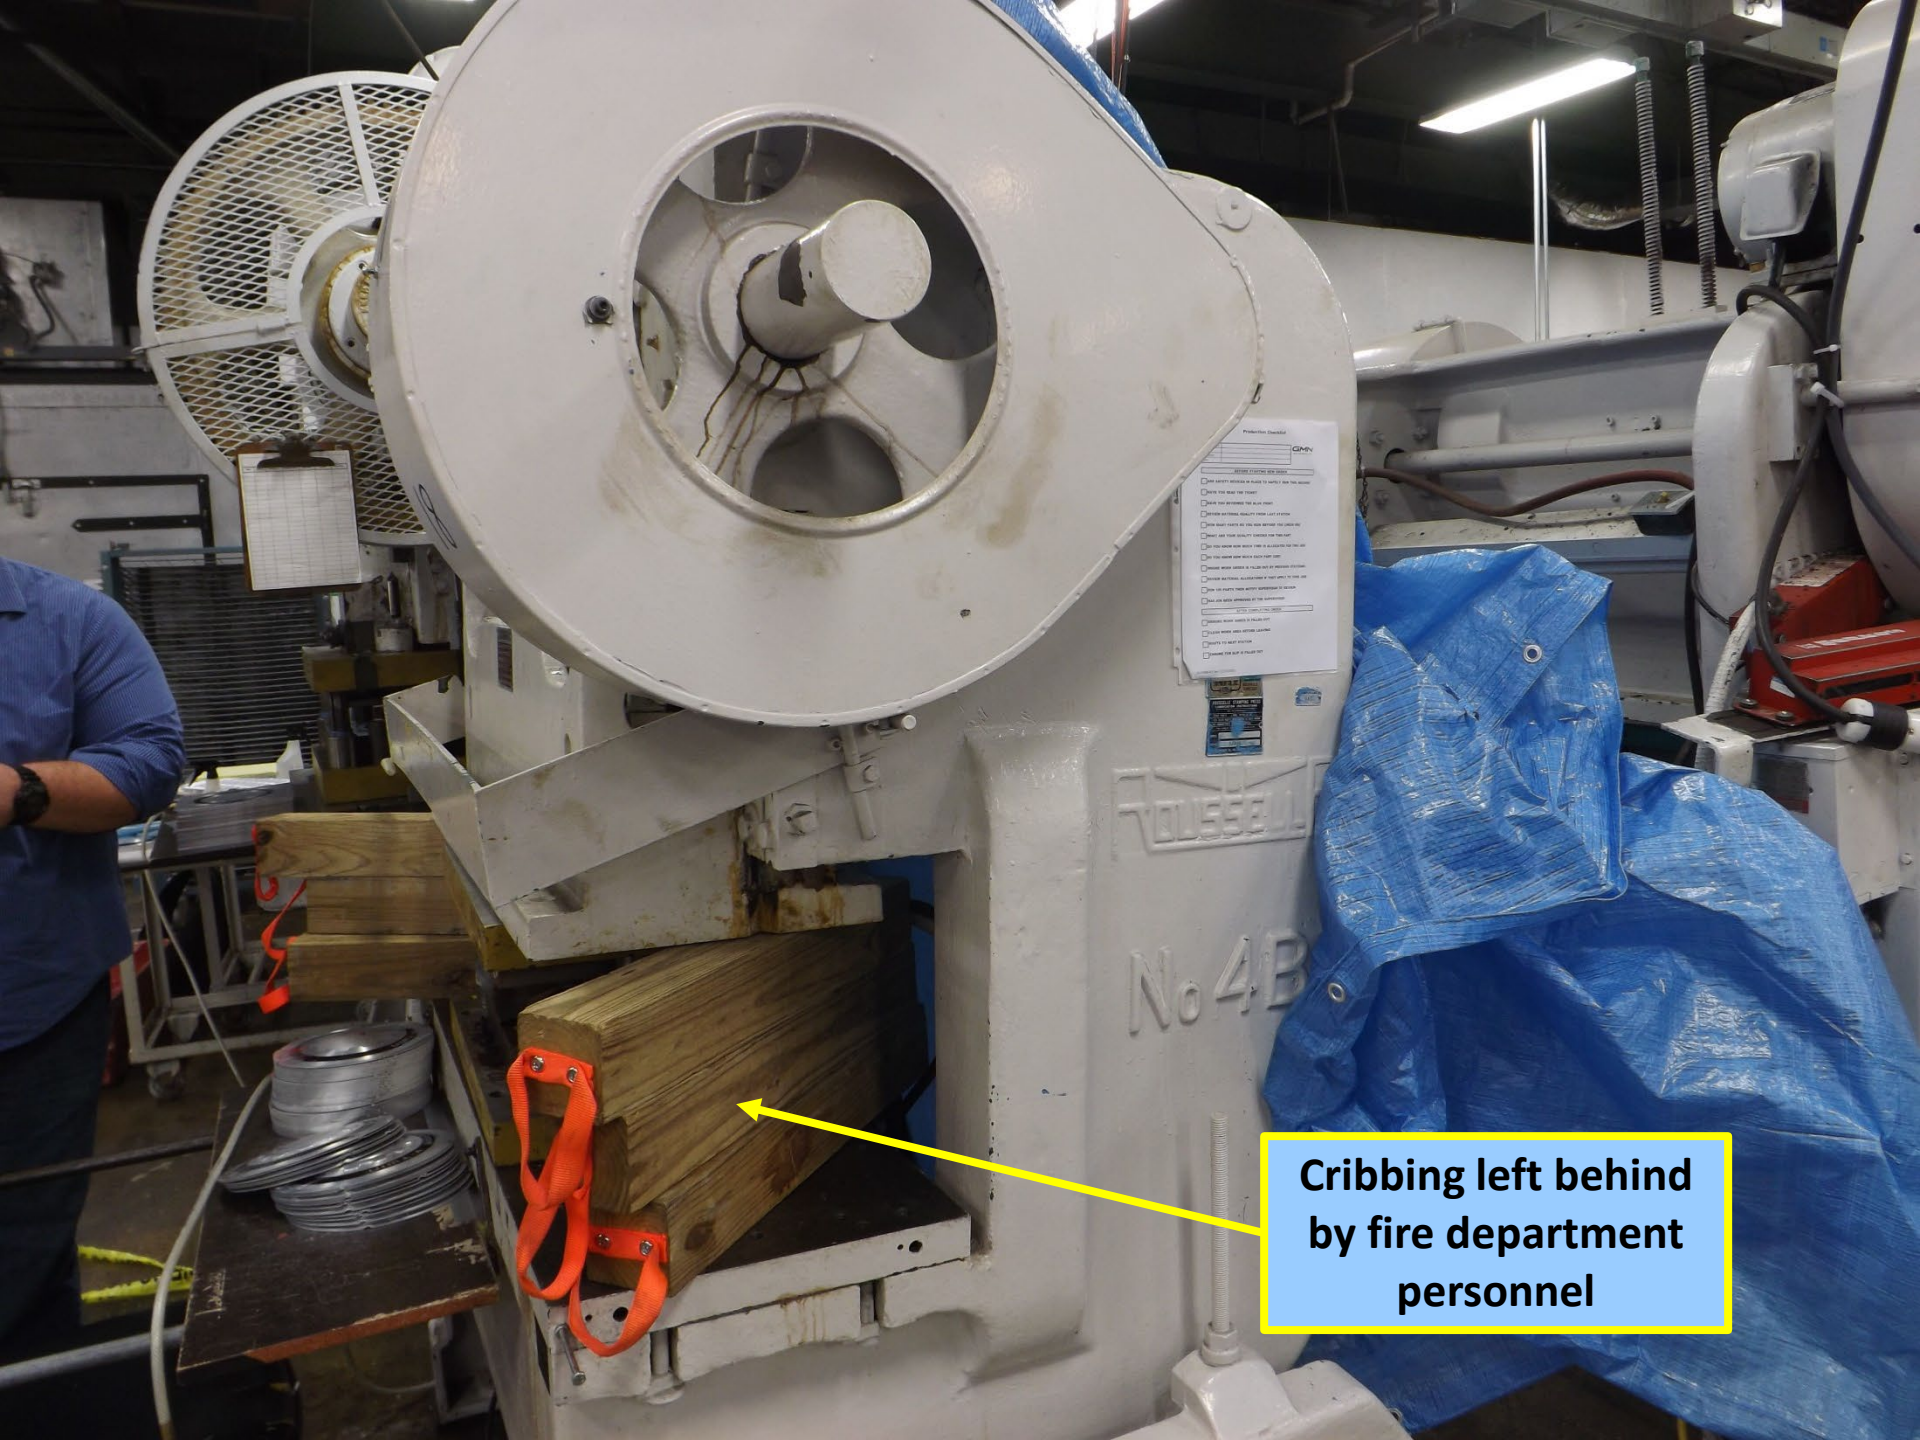
**Cribbing left behind  
by fire department  
personnel**

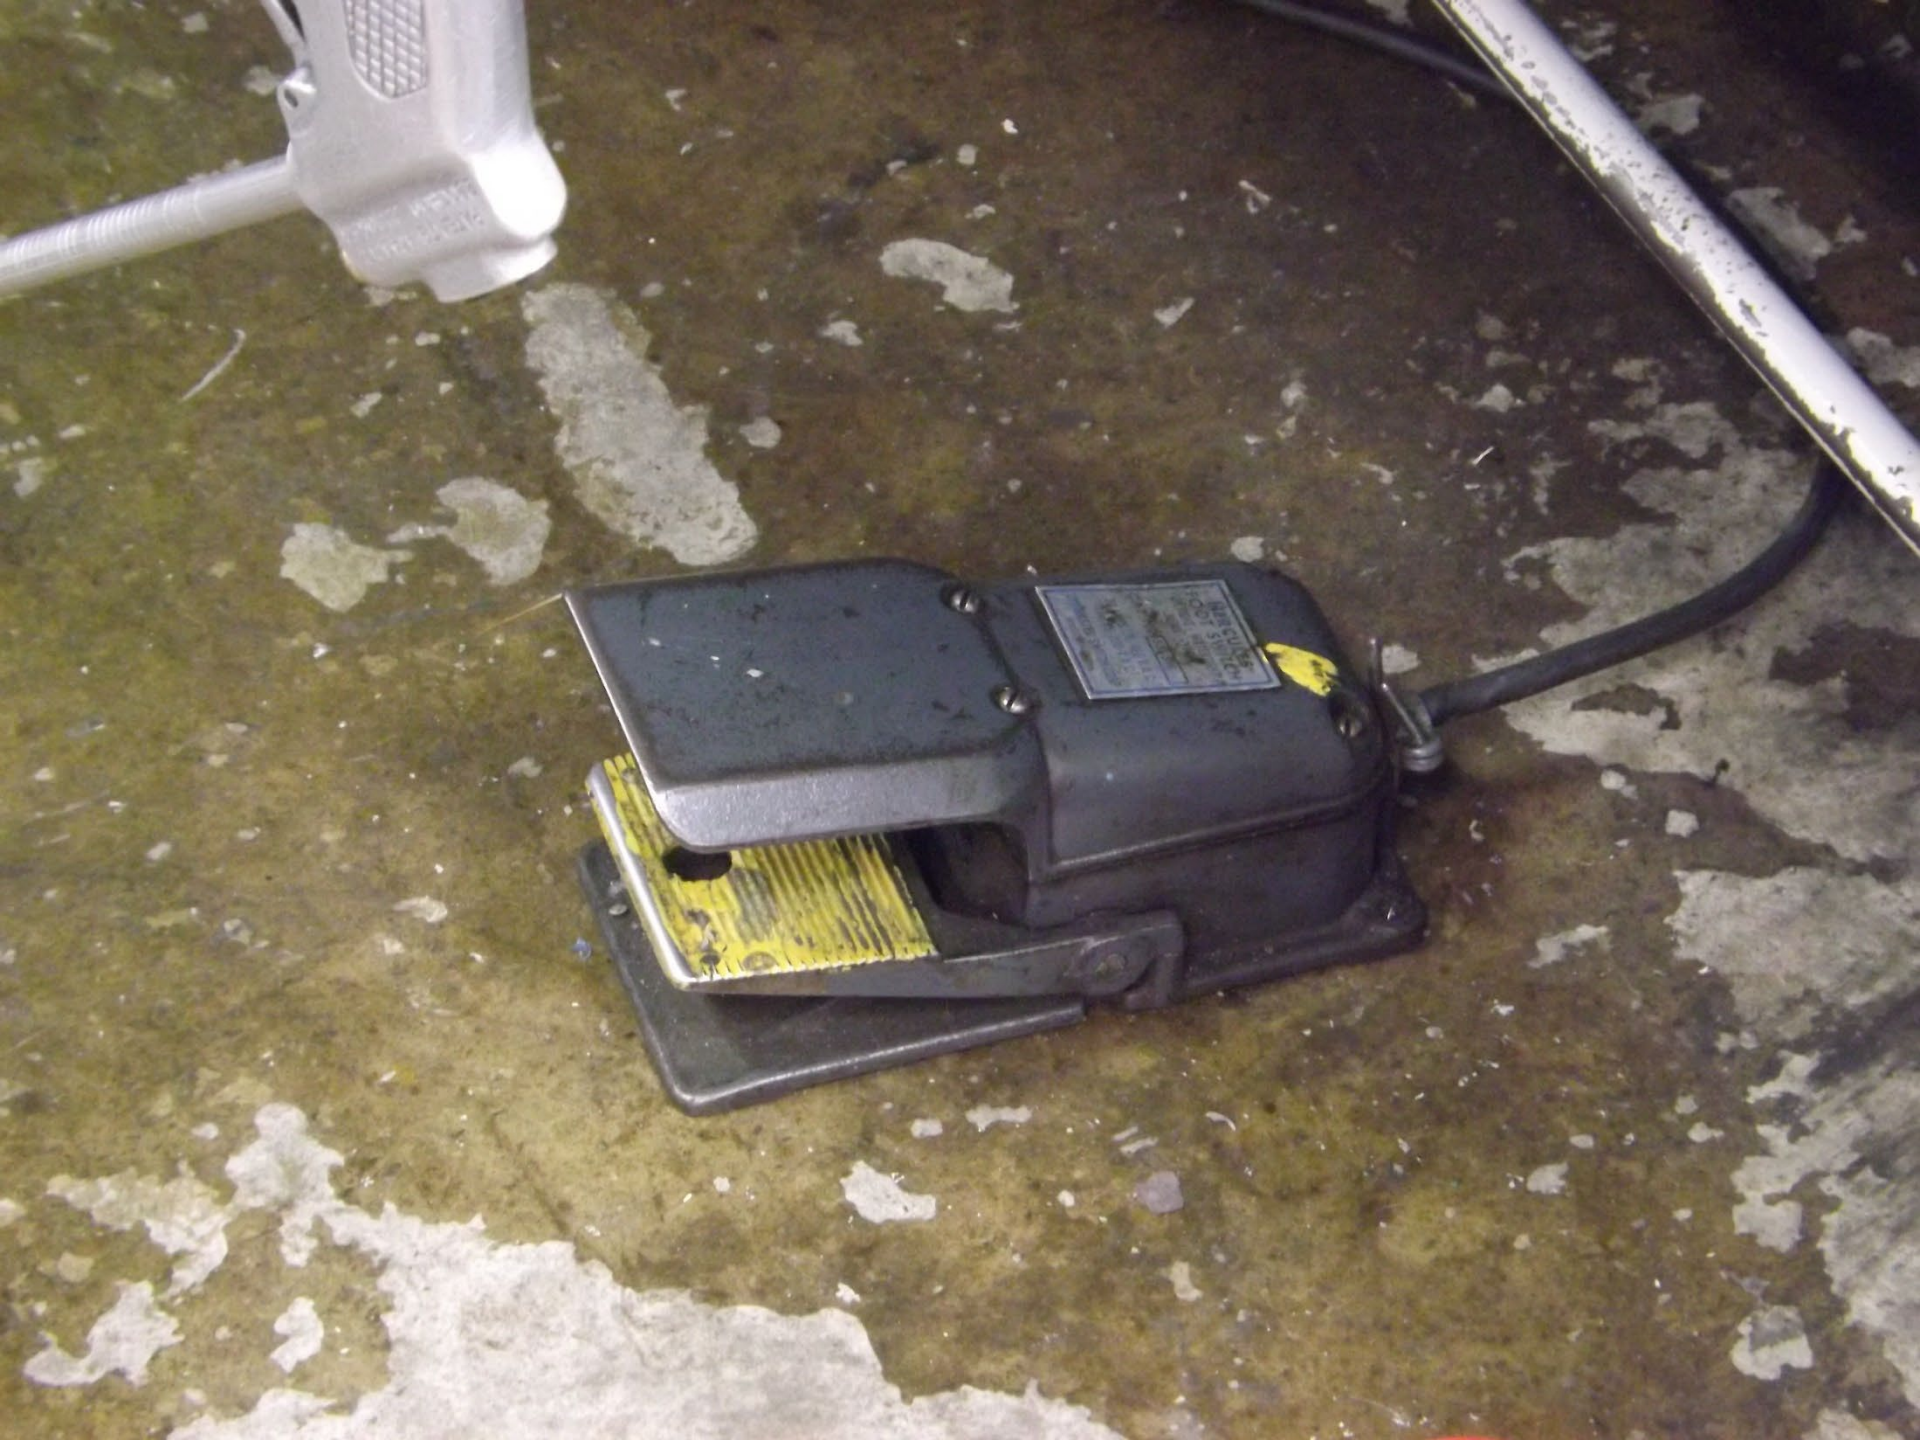
Suction wand to  
load/unload press

Hand  
restraints

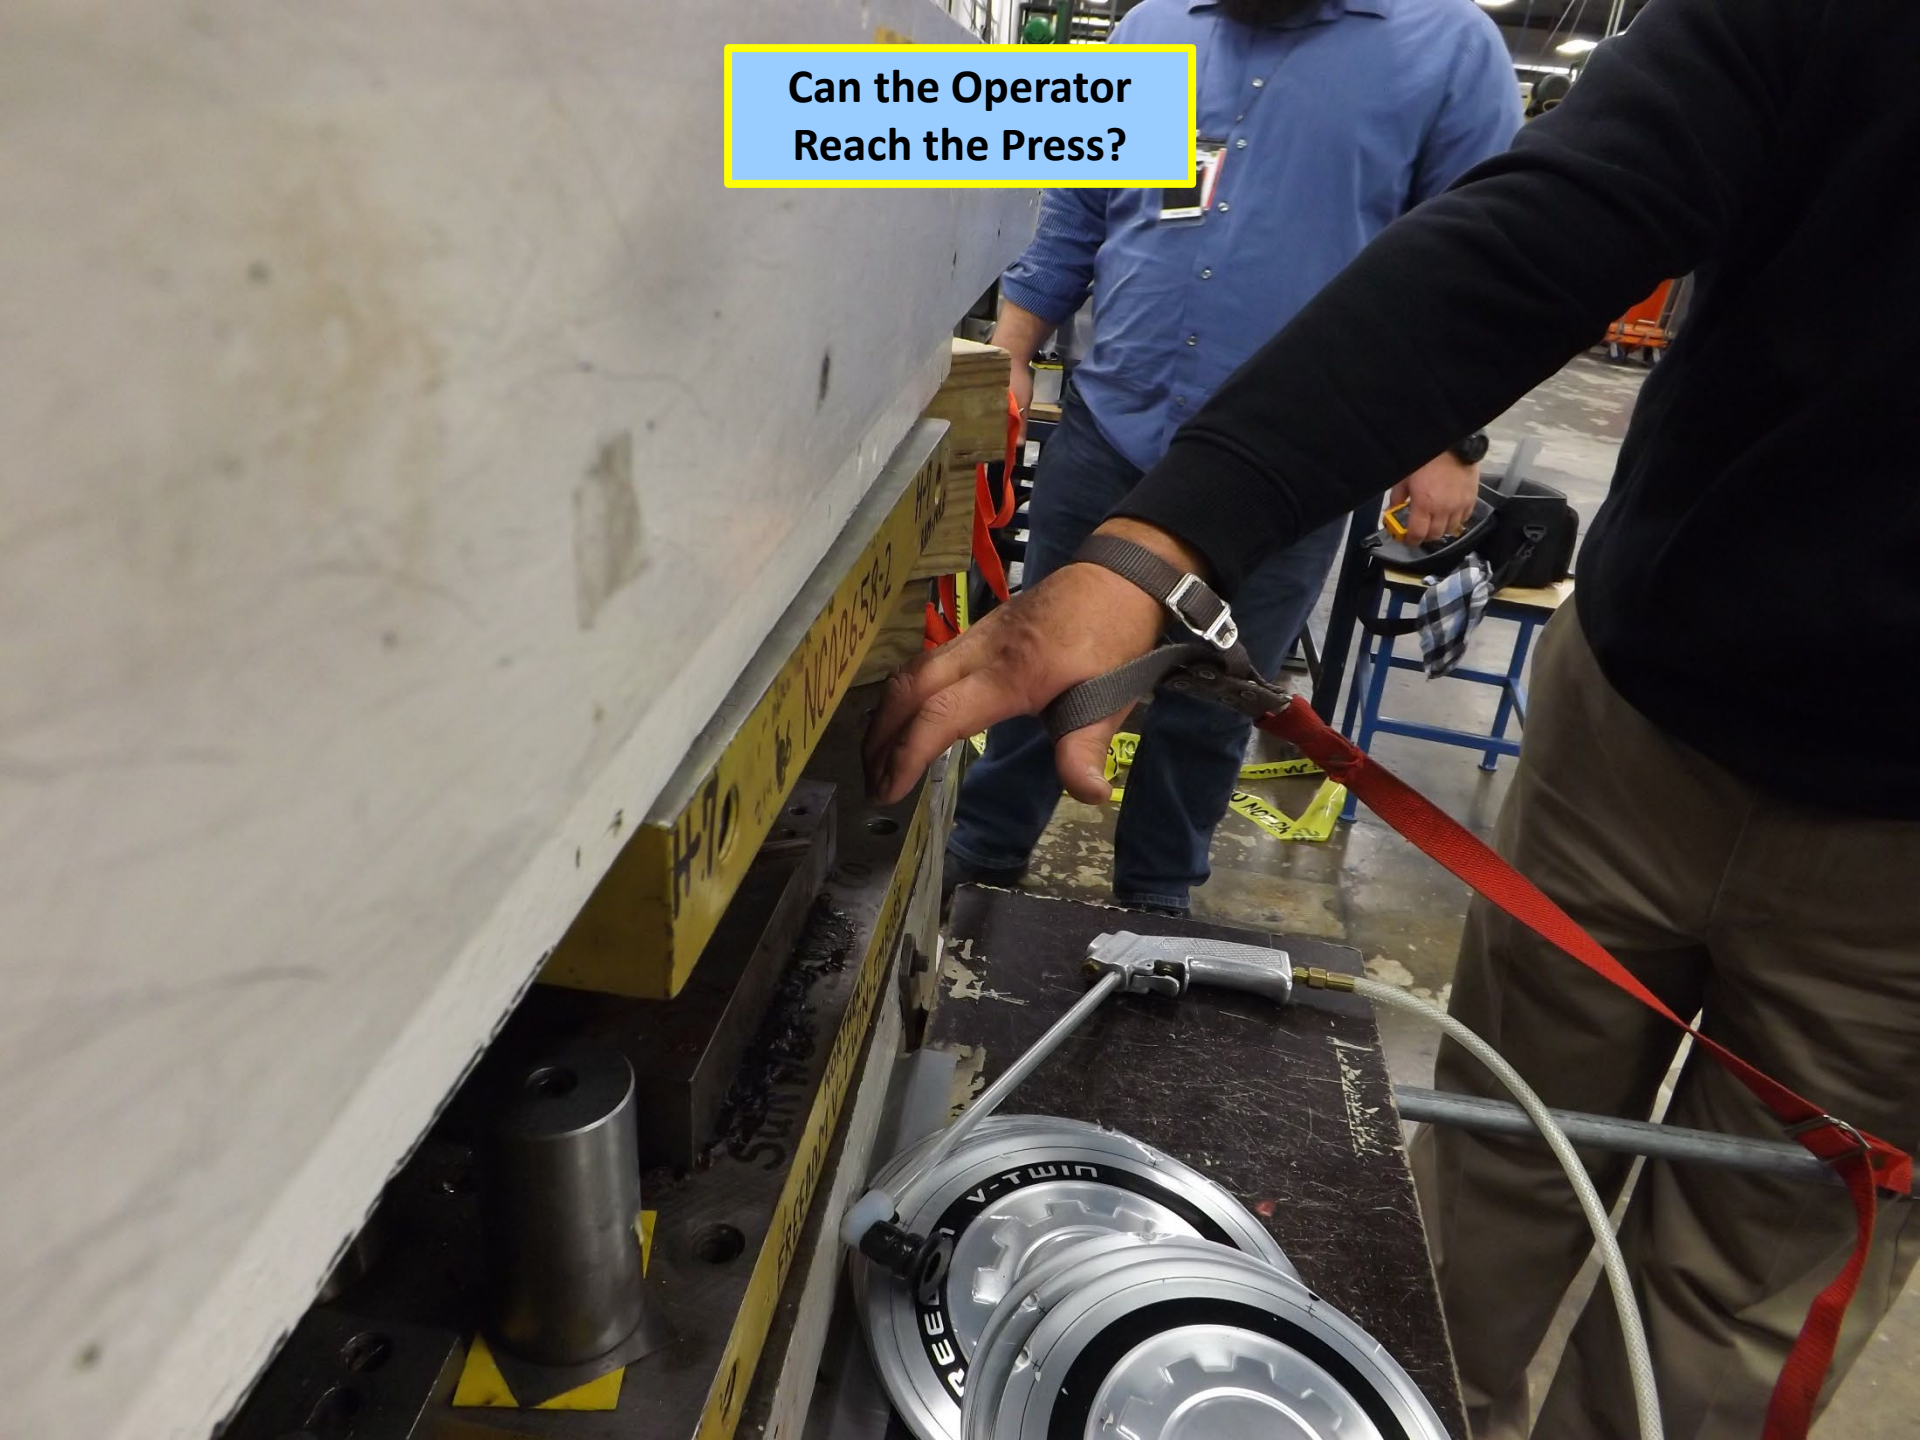
**Can the Operator  
Reach the Press?**

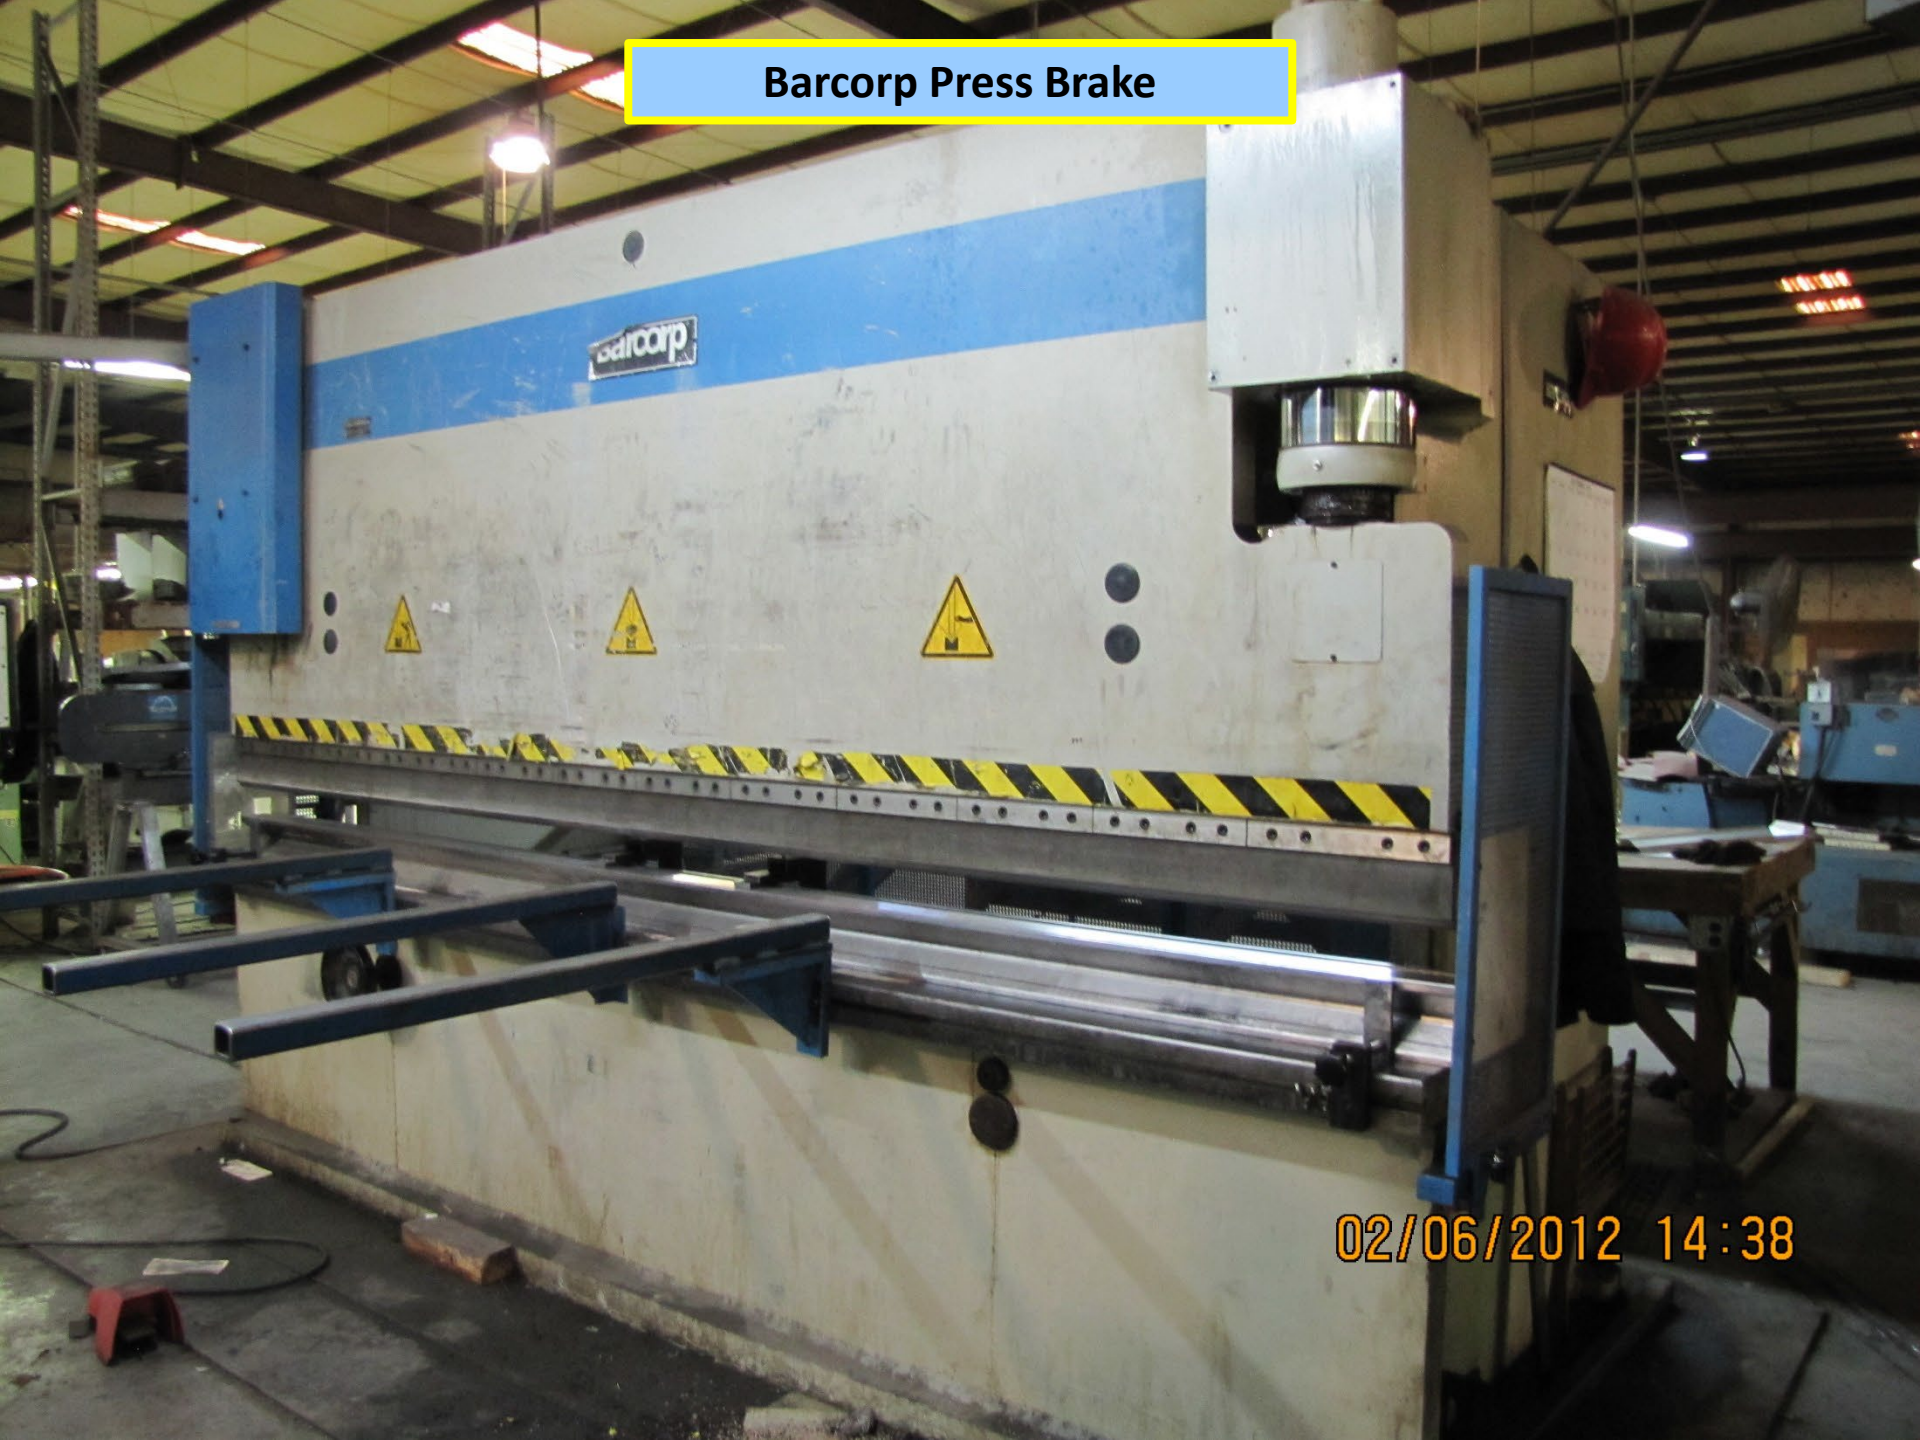
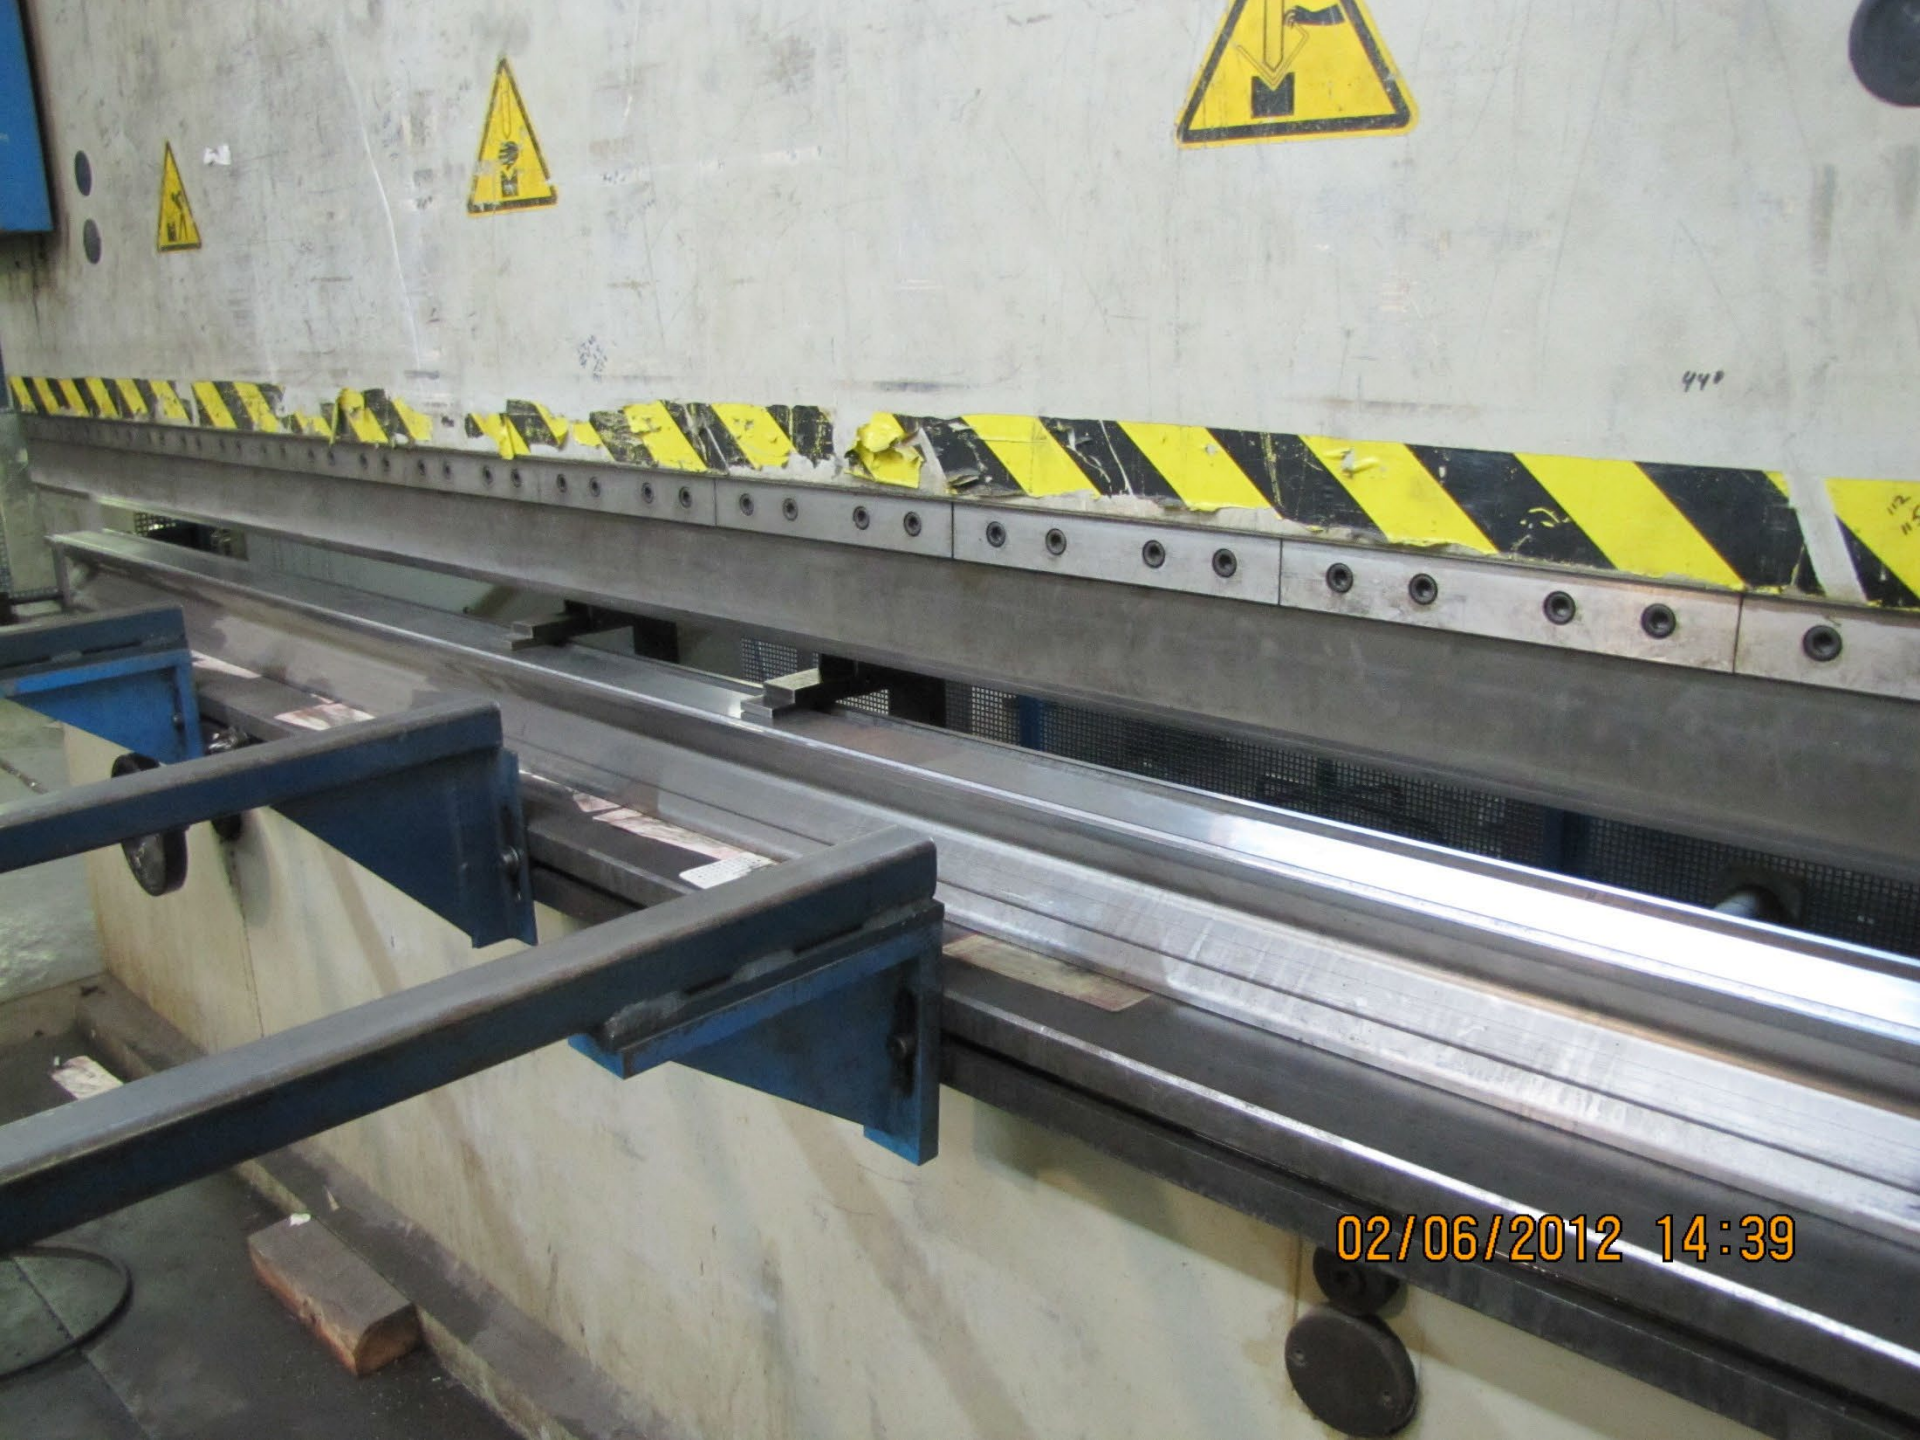
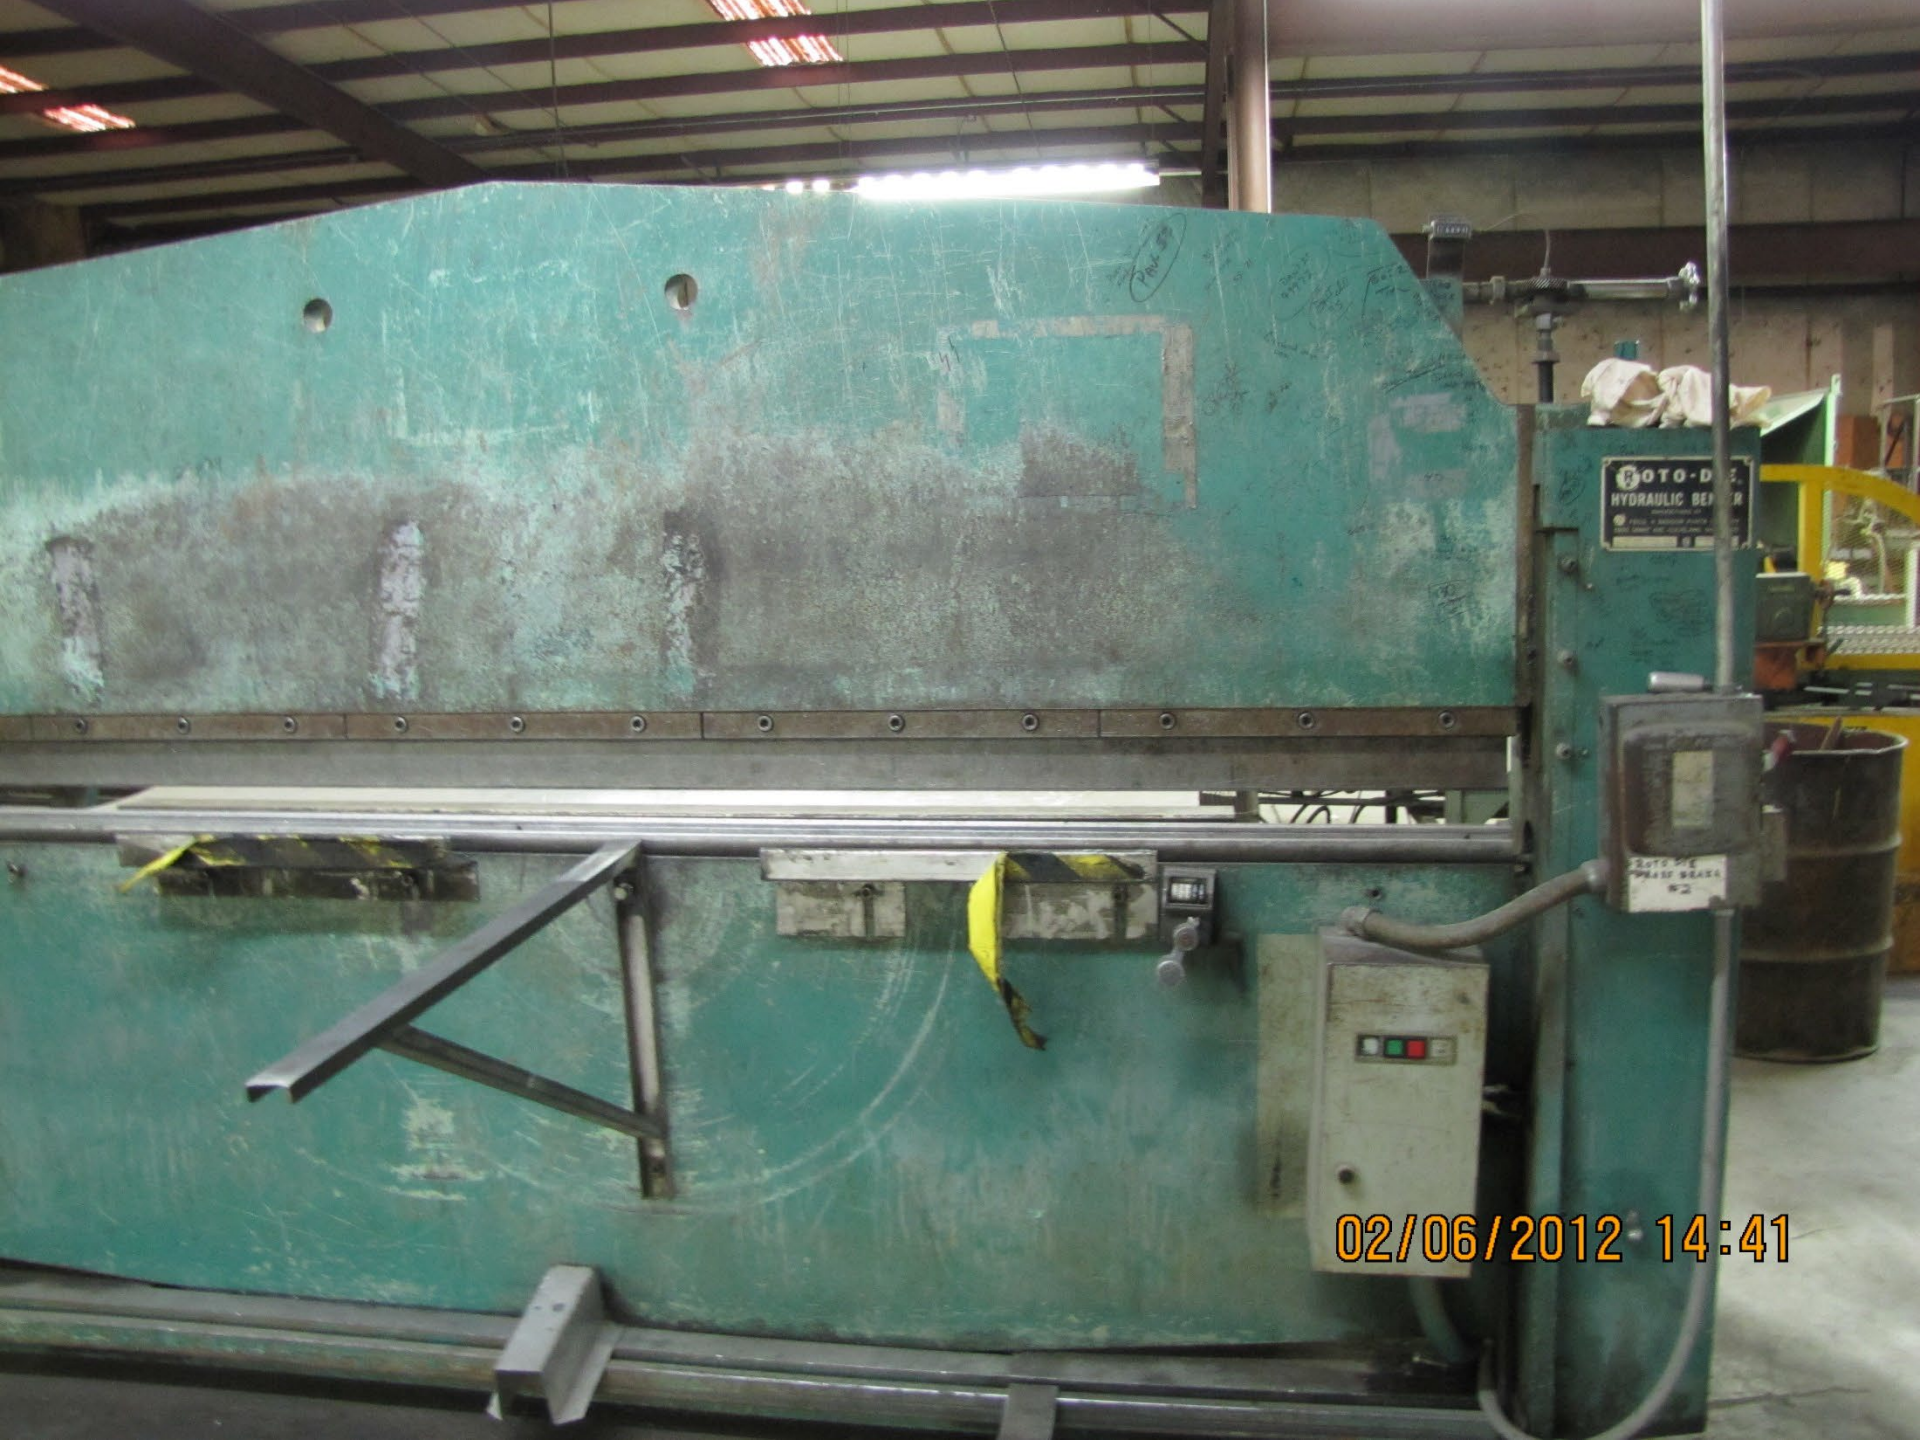
# Barcorp Press Brake

b) No point-of-operation was provided on the 2 Roto-die hydraulic press brakes. The press brakes are used to bend metal for duct fabrication. On March 4, 2004 HCOs observed Robert Crowder and another employee operating one the the press brakes. The employees were bending a 1/4-inch tabs on the duct. Employees had to line up the tab and then one employee activated the foot pedal. The employee's hands were within 1-inch of the point-of-operation. The potential exists that employees could accidentally activate the machine while
